CHAPTER – VII

Ministry of Water Resources

7.1 Maintenance of Farakka Barrage and its ancillaries

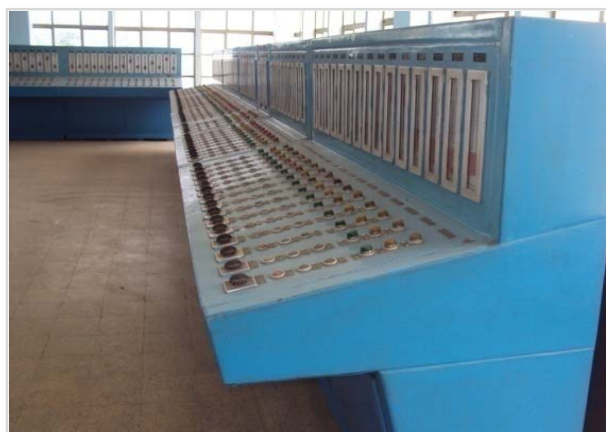
Audit noted that the remote control system was out of

order since 1985. The existing operating system of Farakka Barrage had also become obsolete, resulting in errors in operation of the gates. In order to remedy the situation FBP carried out consultations (between 1990 and 2003) with two agencies viz., Central Water Power Research Station, Pune (CWPRS) and Electronics Research and Development Corporation of India, Kolkata (ER&DCI) for rectification of the system. Both agencies suggested replacement of the system with a new system with latest technology. The TAC, however, declined (99th Meeting in 2003) the proposal as it would entail huge cost and recommended rectification instead. The projected cost of replacement suggested by the consultants or worked out by the FBP was not found on record. However, the TAC decided (101st Meeting in 2005) to opt for up-gradation as no agency was found for undertaking rectification as earlier recommended by TAC.

Though the EFC provided ₹1.50 crore during Eleventh FYP Period (2007-2012) for completing the first phase of installation of the new operating system, no work was done till April 2012. Consequently, the gates continued to be operated without the remote control system for more than 25 years and no action for rectification/up-gradation of the existing system was initiated in over 20 years since the first consultation was undertaken for the purpose.

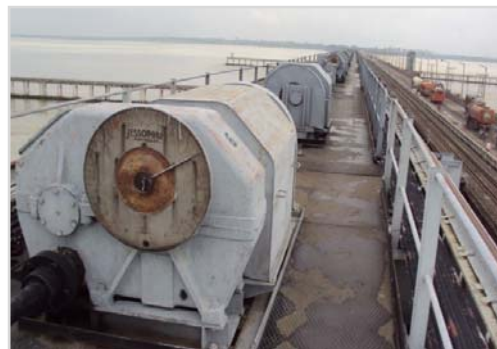
Audit observed that the local system remained intermittently inoperative due to poor maintenance work which consequently led to frequent manual operation of the gates.

FBP Management stated (July 2011) that replacement of the remote control system would be undertaken only after all the gates were replaced because phased replacement of remote control system would be technologically problematic and cost ineffective. Regarding local control system Management stated that efforts to repair the system were futile and as the

system had outlived its useful life, action for its replacement along with the respective gates had been initiated.

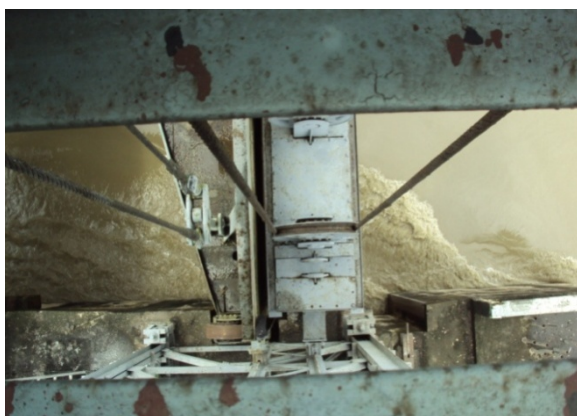
There was no further development in this regard as of June 2012 even though the EFC had provided ₹ one crore for replacement of hoist ropes and stay wires during the XI FYP period (2007-2012) on account of deterioration through prolonged use.

It is evident from the above that the FBP paid no heed to the advice of different expert committees (GRC and TAC) for repair and maintenance of the steel ropes. Non-adherence to the experts' advice regarding repair/replacement, coupled with absence of periodical inspection, is fraught with the risk of the gates collapsing and thereby creating an avoidable crisis.

The FBP Management stated (July 2011) that CIMFR could not perform the testing work of hoist ropes as the technology was not commensurate with the operational characteristics of the hoist ropes and stated that as the ropes were in use for more than 35 years, it was decided to replace the hoist ropes also along with the gates, as envisaged in the action plan.

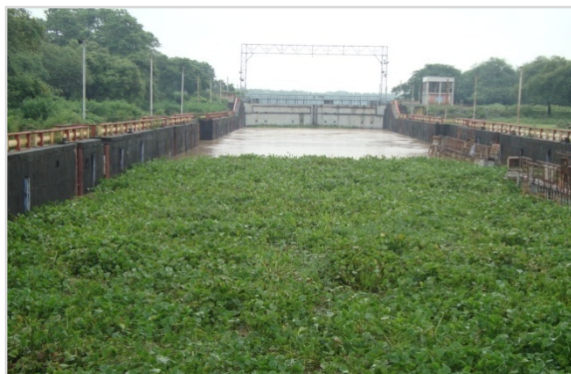
Audit observed that the FBP failed to carry out routine maintenance of the different components of the Navigation Lock in spite of having a maintenance manual. Besides, the FBP took no initiative to repair/restore the machinery/equipment lying inoperative

- a) There was displacement in different parts of the gear system of Mitre and Radial valve gates' hoisting devices. Consequently, the gates of the navigation lock had to be operated with great difficulty and there was considerable leakage of water through the rubber seals at most times. As such, the possibility of the gate operating system becoming totally non-functional at any point of time cannot be ruled out.

FBP Management stated (July 2011) that provisions were made in the XII FYP for repair and maintenance of the navigational lock and its appurtenant structures and efforts were being made for modernisation of the navigational lock.

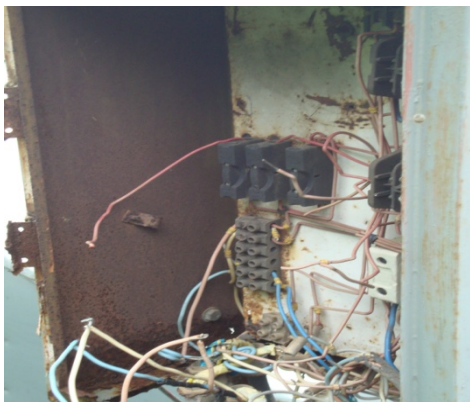
Electrical Panels of the Lock Gate

- d) Most of the electrical operating panels of the Lock Gate at Farakka were operated without any switches, the electrical wirings of the machines and other different structures were in a very bad and unsafe condition and civil structure housing electrical components was dilapidated. Such hazardous conditions might cause a serious accident at any point of time during gate operation.

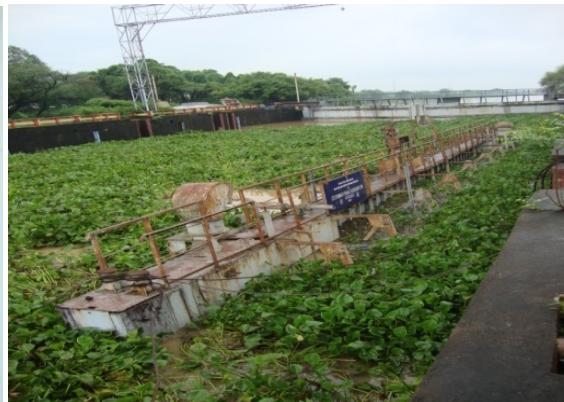
- e) Caisson Gates (Stop logs), meant for servicing and maintenance of Mitre Gates, were not positioned in proper place in the lock channel and remained non-functional since inception. This resulted in non-maintenance of Mitre gates.
