CHAPTER – VI

Disaster Management

6.6 Lapses noticed in dealing with flood of June 2013 in DGPS and TPS of NHPC

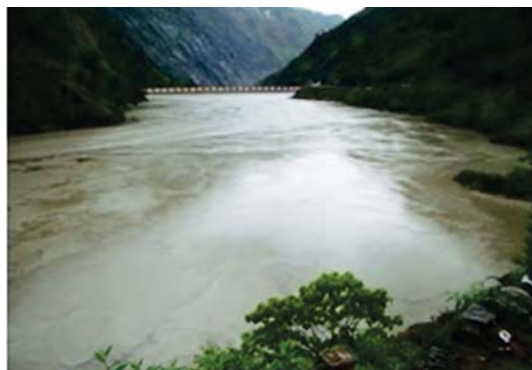
Dhauliganga Reservoir

- (ii) ROM prescribed maintenance of reservoir level at Minimum draw down Level (EL 1330 m) during monsoon period (from 1 June to 15 October) in order to minimize the sediment accumulation in live capacity zone of reservoir as well as for management of flash flood. Against this, the reservoir was maintained around Full Reservoir Level (*i.e.* 1345 m) right from start of monsoon period on 1 June till the date of flooding on 16 June 2013, except on 11 and 12 June 2013 when it was 1338.80m and 1337.49m, respectively.

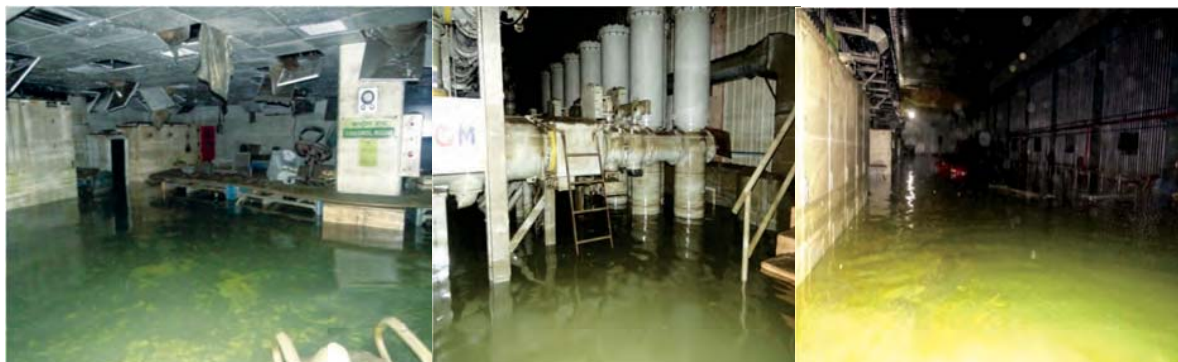
During the flood of 16-17 June 2013, despite maximum discharge 2051.72 cumecs as against design flood of 3210 cumecs, substantial damages occurred to the power station components *viz*; power house was submerged up to half the level of office floor (EL 1045 m) and there was heavy accumulation of silt on all the floors²³ the outlet of Tail Race Tunnel (TRT) was choked, four pole structure near the sub-station was washed away; hence grid power supply to power house was not available.

Flooding in Dhauliganga Power House

(v) DMP of DGPS provided that in the situation of flooding of power house, maintenance staff should be informed by operation in-charge for lowering of DT gate²⁶ and as soon as the gate is lowered, the DT drain valve should be opened. However, from the sequence of events recorded in power house just before the flood, it was noticed that at any stage maintenance staff was not asked by operation in-charge to lower the DT gates. Consequently, water entered the power house from TRT and damaged it.

CEA recommended (August 2015) that utilities may undertake suitable measures to avert the flooding of powerhouse.

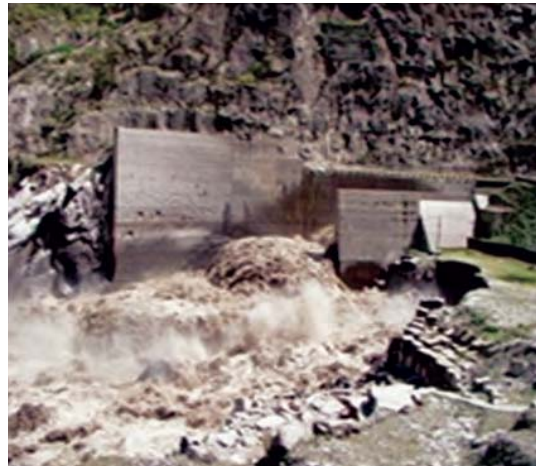
Flood water discharge form Radial Gate

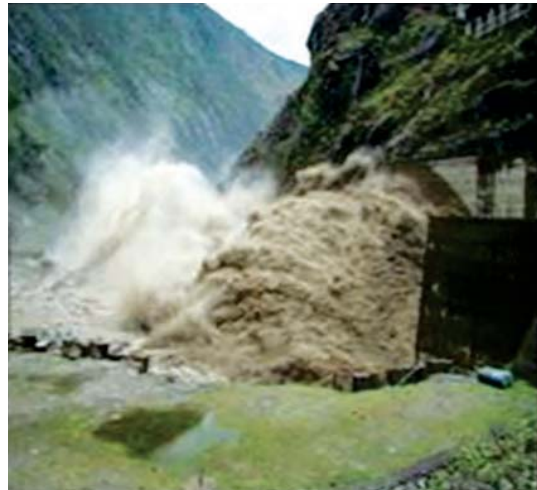
Picture showing the intensity of Flood

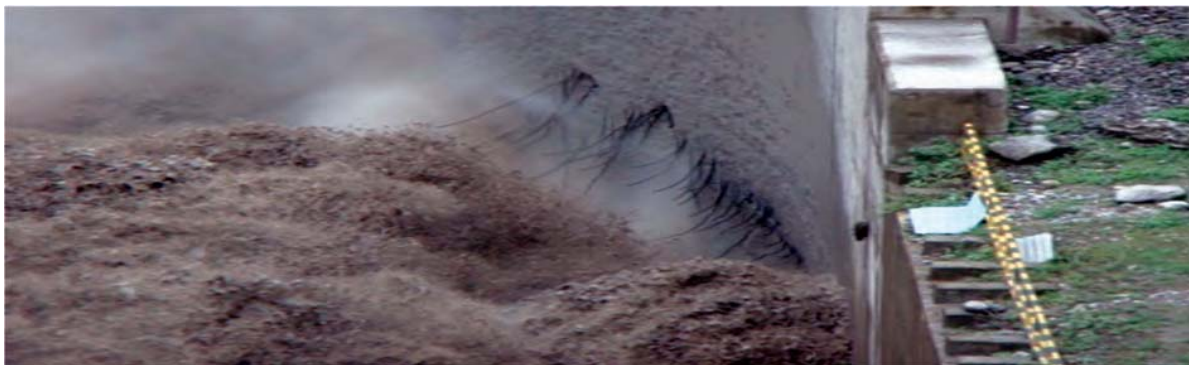
Damage to Dhauliganga dam site due to flood
