Chapter-7 : Joint Physical Verification

7.1 Introduction

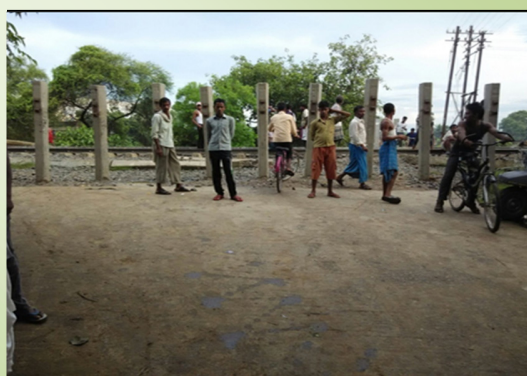
Connectivity was not provided to habitation because road was blocked by cement concrete pillars on both sides of railway track (in package no - BR-06R-148, Bhagalpur district, Bihar)

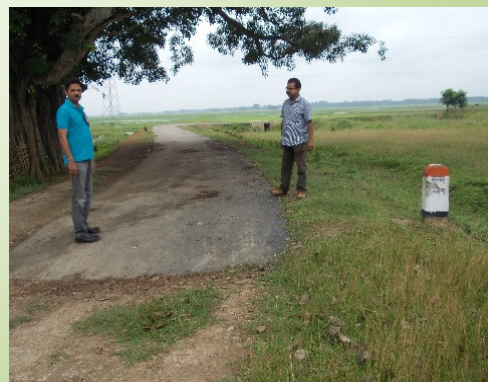
Dead end of road not constructed (Road from 'Chanchaki to K.A. Road- in Assam, HPIU, Nagaon Road Circle, Nagaon- AS 19-246).

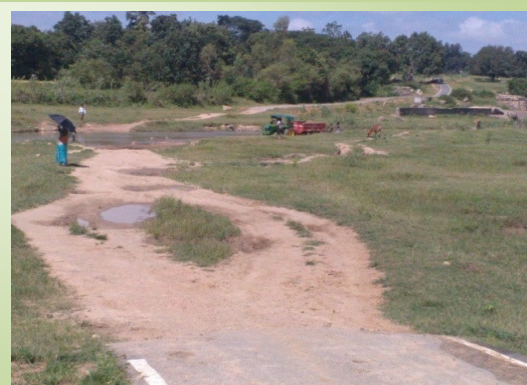
Habitation Kumhardab (Jashpur district, Chhattisgarh), was not provided connectivity due to non-construction of long span bridge

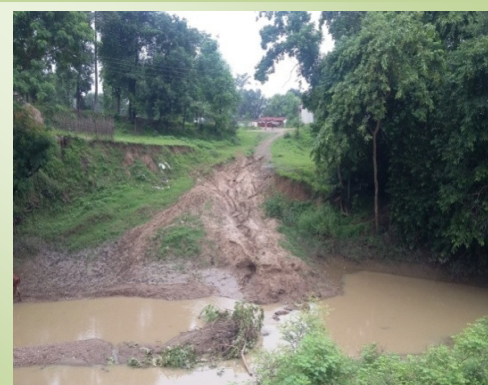
Cross drainage work not executed (Road work 'T02 KULI KUKDA - BASAHA (package CG 0268)' in Bilaspur district, Chhattisgarh)

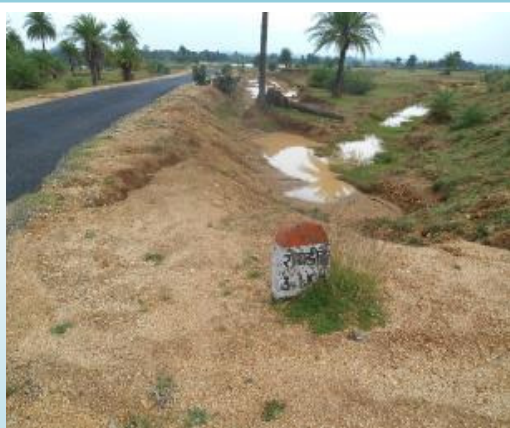
Road Raidih to Rajsar was completed without providing connectivity to Rajsar which was about 8 km. away from the end point of this road in Deoghar district, Jharkhand

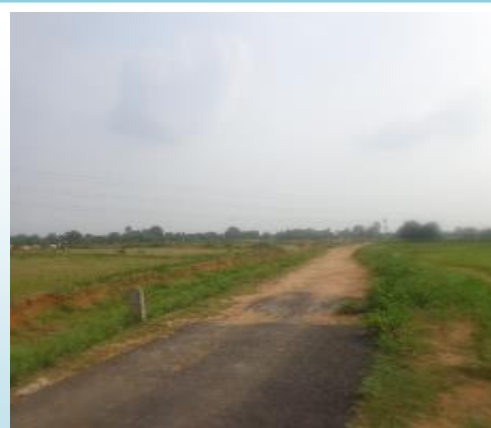
Unconstructed portion of road (more than 500m) left the habitation as unconnected (in L046 to Jala, Block Garhwa Hazaribag district, Jharkhand)

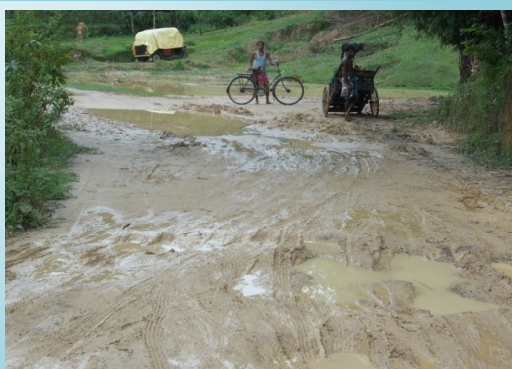
Road found full of mud and big potholes during construction period under package no. AS 13-59 in district Silchar, Assam

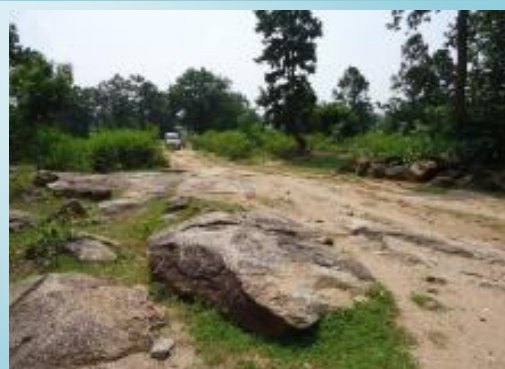
Hard rock and forest land lying in path of the road 'L059-REO main road Kutmakachhar to Murambatoli via Jhimari 'in Simdega district, Jharkhand

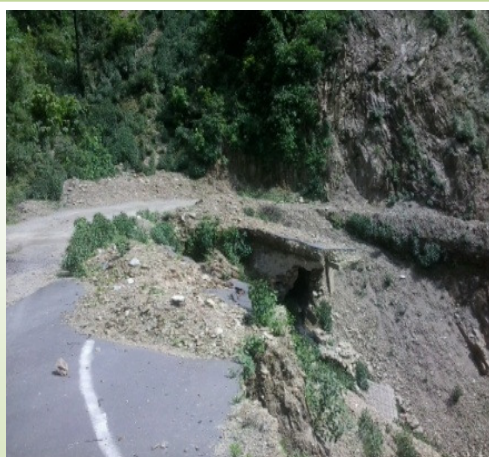
Road Naugaon-Bhukhandi was found damaged in Pauri district, Uttarakhand

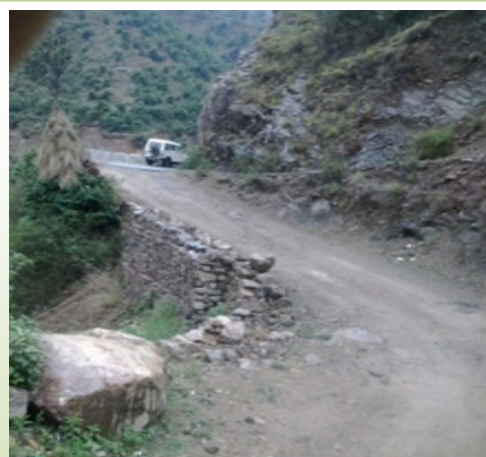
Road work from Chopda to Nalai, the quality of bituminous work was found poor at various places in Pauri district, Uttarakhand

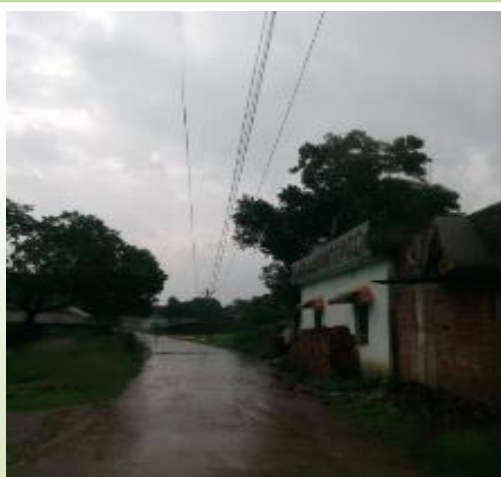
Non-construction of side drain in Baidynathpur to Bahadurpur in Deoghar district, Jharkhand

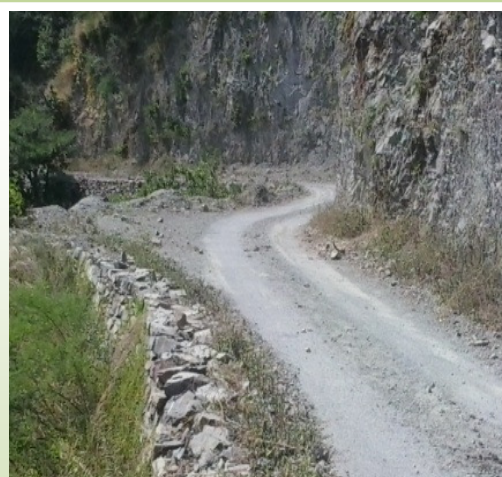
Poor quality of road construction in Bhorso-Pinro, Nainital district, Uttarakhand

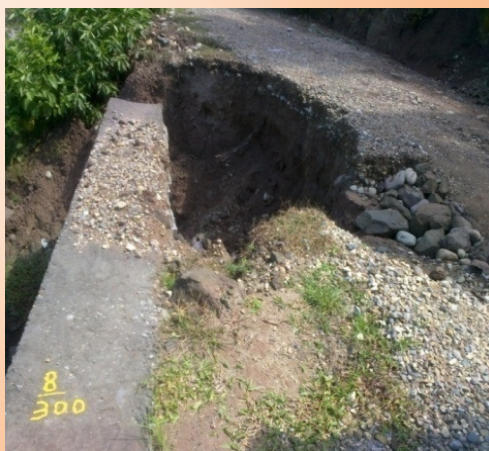
Non- construction of adequate number of cross drainage and poor construction in road Galak to Upper Rajwalta in Kathua district, Jammu and Kashmir

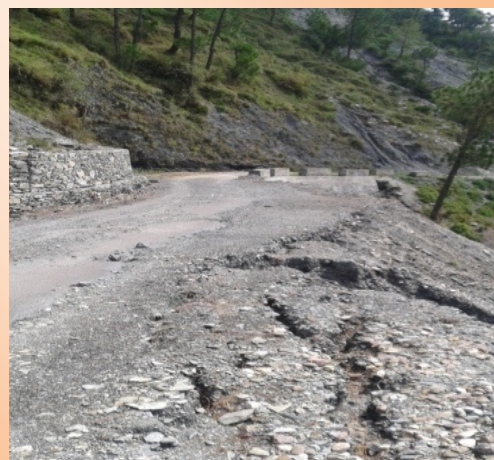
Unpaved and without revetment of Rumehar-Lam road in Kangra district, Himachal Pradesh

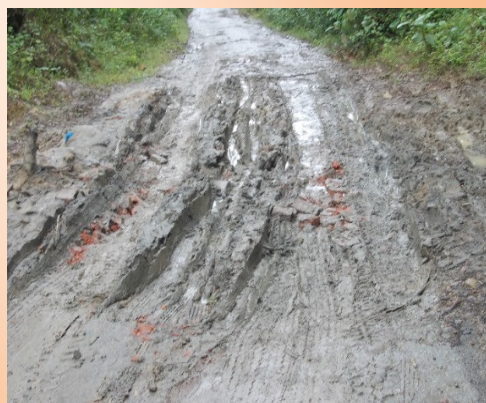
Deplorable condition of road 'Baraigram to Pecharpar', AS 13-36 due to non-maintenance in, Karimganj district, Assam

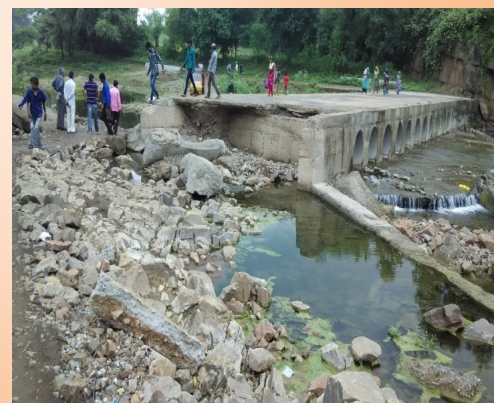
Part of vented culvert at the chainage 1/800 of road 'Kamboi Patel falia' washed away due to non-construction of pipes to allow the water to cross safely in Dahod district, Gujarat

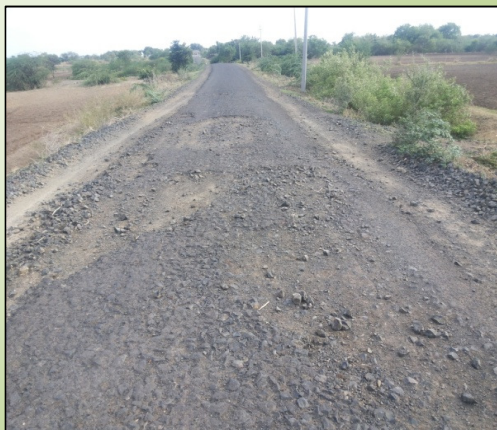
Deplorable condition of road 'KN 15-67-T-02 (Bankalga Cross) to Maharashtra Border' at Afzalpur Taluk in Kalaburgi district, Karnataka

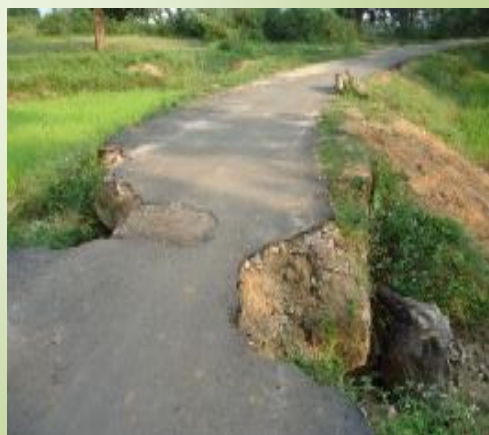
Damaged Culvert of road 'Pandripani Jaldega to Pandripani' in Simdega district, Jharkhand

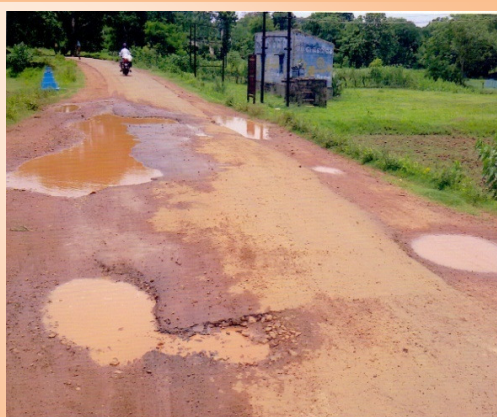
Potholes developed on Marthapur-Jamunakote road due to non-maintenance of road Dhenkanal district, Odisha

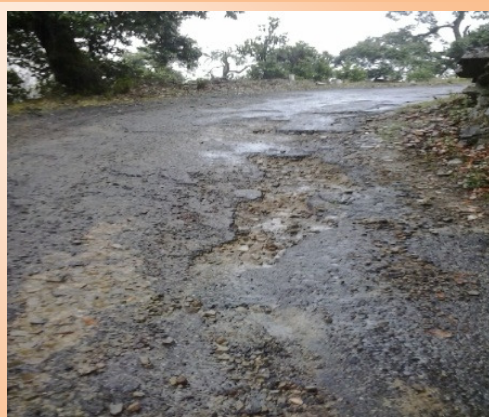
Bituminous work of road Mailsain to Chopda was found damaged at various places in Pauri district, Uttarakhand
