Monitoring and Evaluation

Table 7.1: Observations relating to joint site visits of projects under Flood Management Programme

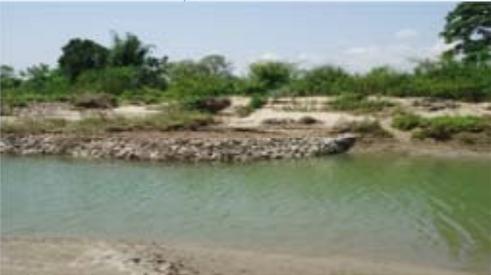
States	Project	Deficiency noticed
Arunachal Pradesh	ArP-6: Anti-erosion works of Noa Dehing river to protect Diyun Circle in Lohit river.	<p>Construction of Spur: Out of two spurs, Spur no.1 was found about 200 m away from the flow of the river while Spur No. 2 was completely damaged and submerged in sand.</p> <p>Construction of bank revetment with Launching Apron: Against a total provision of 1,005 m, a length of 413 m was constructed. The revetment was damaged and washed away on most stretches of the river bank and only patches of the structure remained as on June 2016.</p> <p>Construction of Earthen Embankment: Earthen Embankment of 1,500 m was constructed, without the provision for Grass turfing and providing non-woven Geo-textile, as required. Further, the prescribed height of the embankment as per design was 2.5 m with base width of 14.50 m, but it was found to be about 1 m and 8 m respectively.</p>

The Revetment damaged and washed away on most stretches of the bank of the Lohit river.

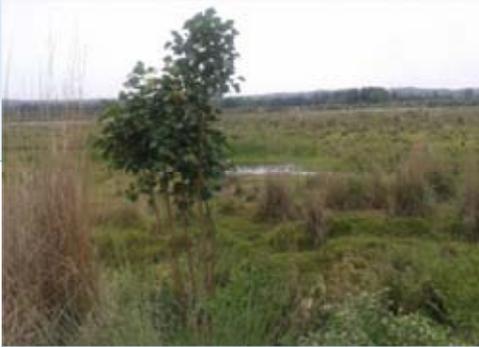
Tree and bushes growing on embankment under HP-2 at km 42.900.	Approximately 1,600 m of earth embankment and eight studs/spurs were physically verified. Earth embankment executed at Pandorian was found 20 per cent damaged and 10 per cent studs/spurs were found partially damaged at Pandorian and Jakhole. Modern geo-textile/geo-synthetic material/geo bags, etc. were not used for longevity and durability of vulnerable embankments as prescribed. No plantations were made along the earth embankments.

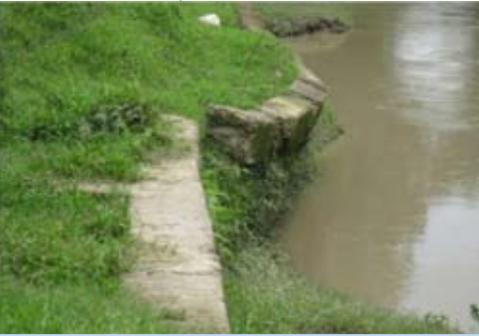
Jharkhand	JHK-03: Anti-Erosion work in the right bank of river Ganga from Kanhaiyasthan to Budhwaria in Sahibganj District	Works related to apron were not visible. The Ganga Pump Canal Division, Sahibganj stated that siltation had occurred on the bank of the river. Several acres of land were being used for agriculture. Apron was beneath the earth.

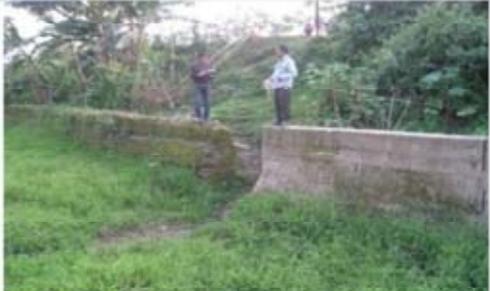
Man- 11: Anti-erosion Project of Iril River from RD 0.00 km to 30.00 km	<ul style="list-style-type: none"> i) In the construction of Reinforced Cement Concrete (RCC) Bored pile along Iril river Right Bank Bund at Sawombung bridge in portion II, the bracing structure was found broken/separated and tilted towards the river. ii) Cement Concrete retaining wall of 40 m length was constructed on Right Bank Bund (R/B/B) instead of Left Bank Bund of the river from RD 18.00 km to 18.04 km. This indicated discrepancy between actual site of execution and measurement records. iii) Construction of Cement Concrete retaining wall for the chainage 14.400 to 14.470 km at R/B/B of the river was found executed by two different agencies.

<p>During site visit, marked difference was seen in the quality of works between these two retaining wall structures; while the Retaining Wall (R/Wall) at 14.400-14.440 km was found in good condition, the other R/Wall executed over 14.440 to 14.470 km by another agency was found in poor state.</p>	
<p>MAN-11- poor execution of work in one portion of the retaining wall</p>		
<p>Odisha</p>	<p>OR-21:Bank protection work on left bank of river Subarnarekha near village Namkana from RD 00 to 200 m and village Palasahi from RD 00 to 400m</p>	<p>The work was executed after witnessing devastating floods in 2006 and 2007 which caused erosion of river bank. At Palasahi, stone protection work was damaged due to slipping of stones due to lack of periodical repairs and maintenance. The fact was accepted by the Balasore Irrigation Division.</p>
<p>Sikkim</p>	<p>Sik-14:Anti Erosion works in and around Mangan in North Sikkim.</p>	<p>WRRDD undertook the work in two phases, viz. (i) Jhora Training Work (JTW) along Rafong Khola, Mangan and (ii) JTW along Rimit Khola, Mangan which was completed in December 2010. During the joint site visit, the work relating to the JTW along Rafong Khola, Mangan valuing ₹ 2.57 crore was found totally washed out.</p>

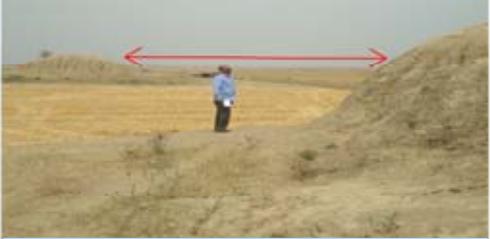
<p>Big gap in embankment of project UP-1 (as on 04.05.2016).</p>

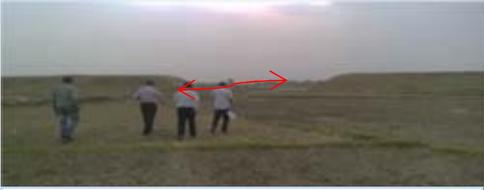
<p>Big gap in embankment of project UP-4 (as on 07.05.2016)</p>	<p>UP-4: Construction of Mahadeva Uska Bund in district Siddhartha Nagar</p>	<p>Against the sanctioned length of 15 km, only 8.12 km could be completed with the gap of 400 m. None of the six regulators were constructed as provisioned in the approved project resulting in six gaps of 50 m to 60 m. No plantation work was carried out on the embankment though provisioned in the approved estimates.</p>
	<p>UP-12: Construction of Marginal Embankments & FPW along left & right bank of river</p>	<p>Out of 3.900 km embankment sanctioned, filter layer with course sand, brick ballast and boulder pitching work at river side slope of Harishchandra Ghat to Udaya Ghat was not done in the length of 1.050 km. Street light were provisioned for the entire length of 3.9 km, however, only electric poles were installed in 2.390 km and no electrification was done as of April 2016. Bituminous road of 2.390 km was constructed instead of approved length of 3.900 km of the embankment.</p>

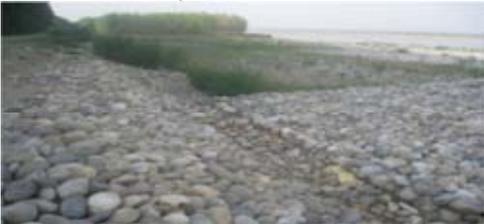
<p>Showing plantation deep inside marginal bund</p>	<p>UK-1: Construction of Right Marginal bund on river Ganga from Bhogpur to Balawali.</p>	<p>i) There was a deep vertical cut in the marginal bund at the starting point at Bhogpur, downstream close to the spur which was used as an approach road to river side by tractors/Buggies. Such a cut posed a risk for the water to spill into the nearby Bhogpur village in case of monsoon flood, if any, besides leaving the marginal bund susceptible to damage.</p> <p>ii) The construction of 120 m spur at km 6.500 and stone pitching of embankment in its vicinity was undertaken as a strengthening measure of marginal bund under project UK-1. We noticed substantial long standing plantation inside</p>

the bund and soil erosion in downstream bank. Existence of plantation inside the bund area was likely to increase the possibility of soil erosion and consequent weakening of the bund structure. This was evident from the damages to the spurs and repeated damage control measures being taken.
West Bengal	WB-14: Bank protection works along both banks of the river Bhagirathi at Sundarpur & Basantpur, Kazipara to Nabagram & Saharwati to Uttarasan	Almost entire stretch (2,000 m) of the protection work in Sanyalchar executed under the project was engulfed into the river. After damage by flood in July 2011, the Irrigation and Waterways Department did not execute any repair or maintenance work and the entire place was in very vulnerable condition. The Department opined that before undertaking any protective measures, morphological studies need to be undertaken.

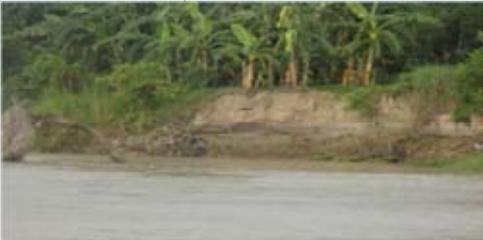
<p>Vulnerable condition of Sanyalchar embankment</p>

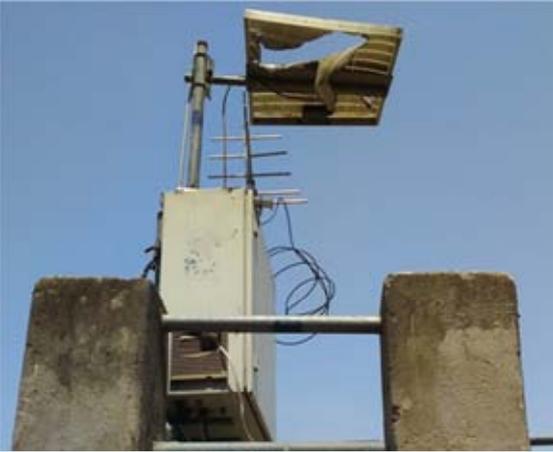
<p>Solar panel and RCC block for bubbler was in damaged condition at Phaphamau, Allahabad at Ganga</p>	<p>Solar panel and RCC block for bubbler was in damaged condition and bubbler was not linked to the system. Two-gauge level measurement pillars were broken at Phaphamau, Allahabad at Ganga. The solar panel of telemetry system was missing, due to which the system not in working condition. The bubbler chamber was covered with dirt and silt at Birdghat, Gorakhpur at river Rapti. Parts of Telemetry station were dismantled and kept in office. The bubbler chamber was covered with soil due to ongoing work at Hanuman Setu, Lucknow at River Gomati.</p>
--	---

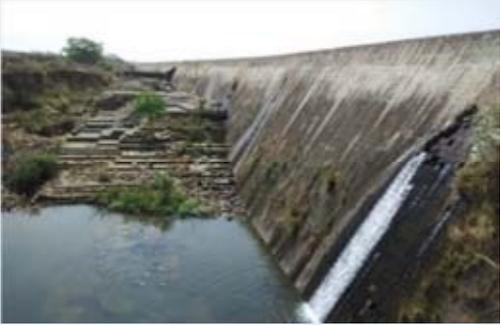
<p>Seepage in the Lower Khajuri weir</p>	<p>i) Several seepage points were noticed at Lower Khajuri weir at Mirzapur.</p> <p>ii) Flood control room was not established at Sirsi dam at Mirzapur. Tools and plants and instrument were not available at the time of site visit at Sirsi, Meja, Dhandraul, Lower Khajuri & Upper Khajuri dams. Seepage register was not being maintained at site.</p>
<p>Uttarakhand</p>	<p>Leakage of water from the flushing conduit gates at Ichari Dam was noticed.</p>

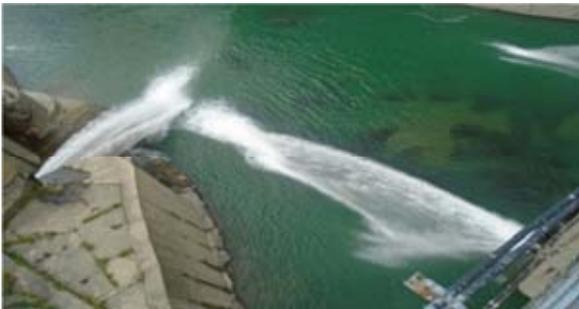
<p>Leakage of water from the flushing conduit gates at Ichari Dam.</p>
