3 Chapter

Collection and conservation of storm water

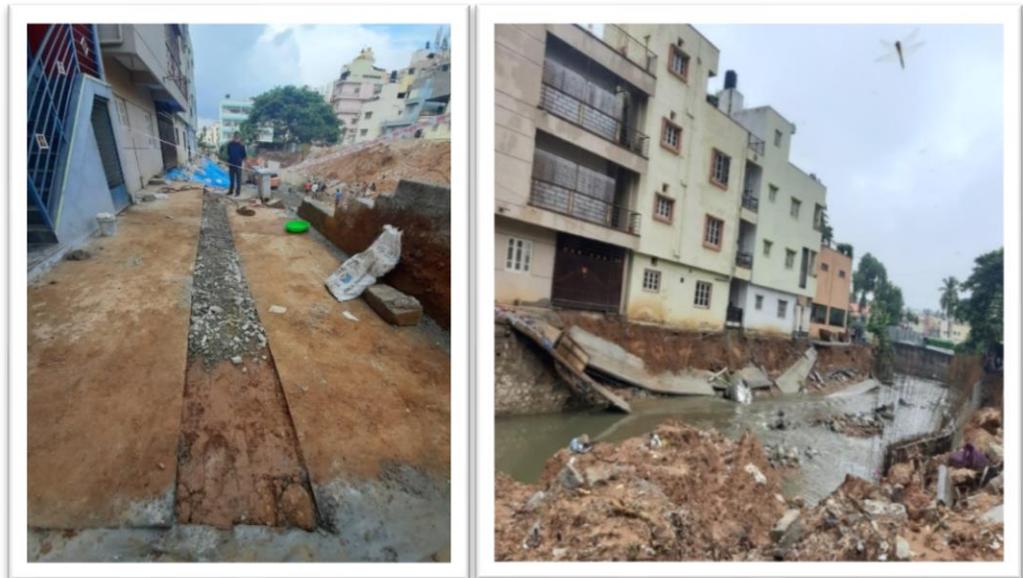
The AEE, SWD division of RR Nagar Zone, BBMP registered (22 October 2020) an FIR against the AEE, BWSSB, Banagiri sub-division alleging that BWSSB had dug up the concrete road (Ward no. 160, 1st cross, 2nd main, Gurudatta Layout, Girinagar, Bengaluru-560062 under RR Nagar Zone) laid by BBMP without obtaining the necessary permission from the respective zonal office of BBMP or SWD division to lay underground drainage pipes and construct manholes. The road had a SWD retaining wall on one side and apartments/houses on the other side. He, further alleged that BWSSB had carried out the work unscientifically and without taking necessary precautions; because of which the road was filled with rain water after the rainfall that occurred on 21 October 2020 which resulted in collapse of the retaining wall and damage to the road thereby putting the public to risk (Exhibit 3.1).

Exhibit 3.1: Damage to SWD retention wall and concrete road

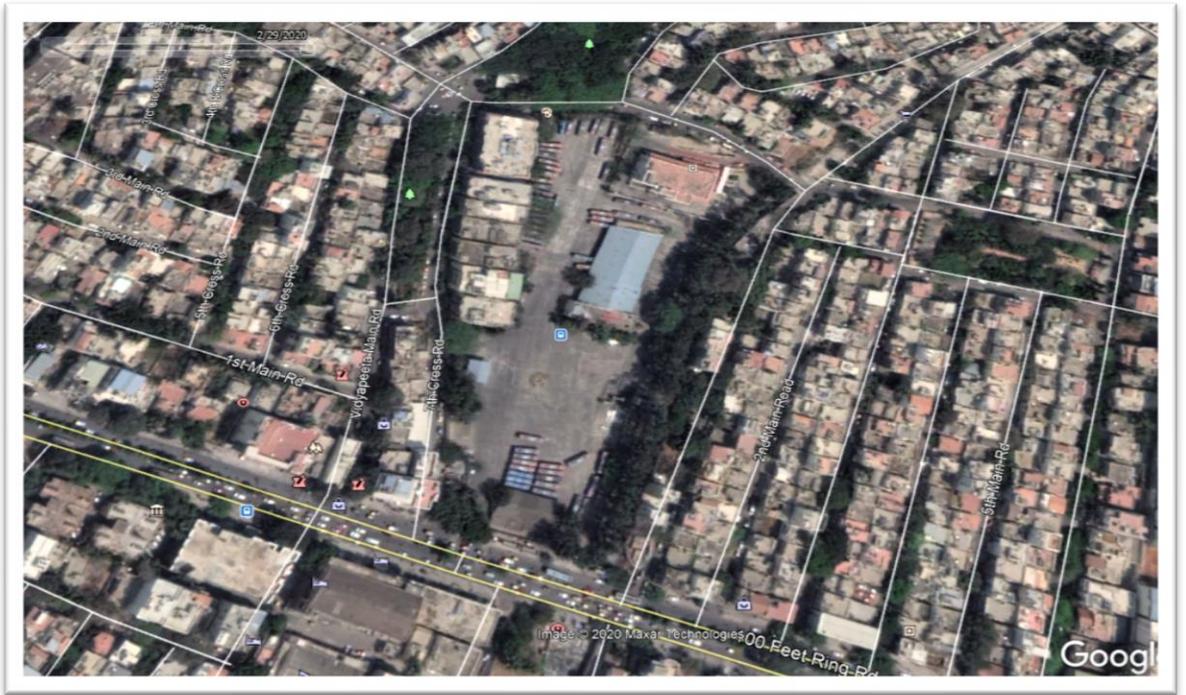
Chennamma kere

It could be observed that while 66 lakes were yet to be developed, 18 lakes with a total area of 254 acres and 17 guntas were reported as disused lakes. The current status of the disused lakes as per the Google Earth images is shown in **Exhibit 3.2** and the list of disused lakes is given in **Appendix 3.2**. There is a significant risk of these lakes being vulnerable to encroachments and future conversions.

Exhibit 3.2: Current status of disused lakes

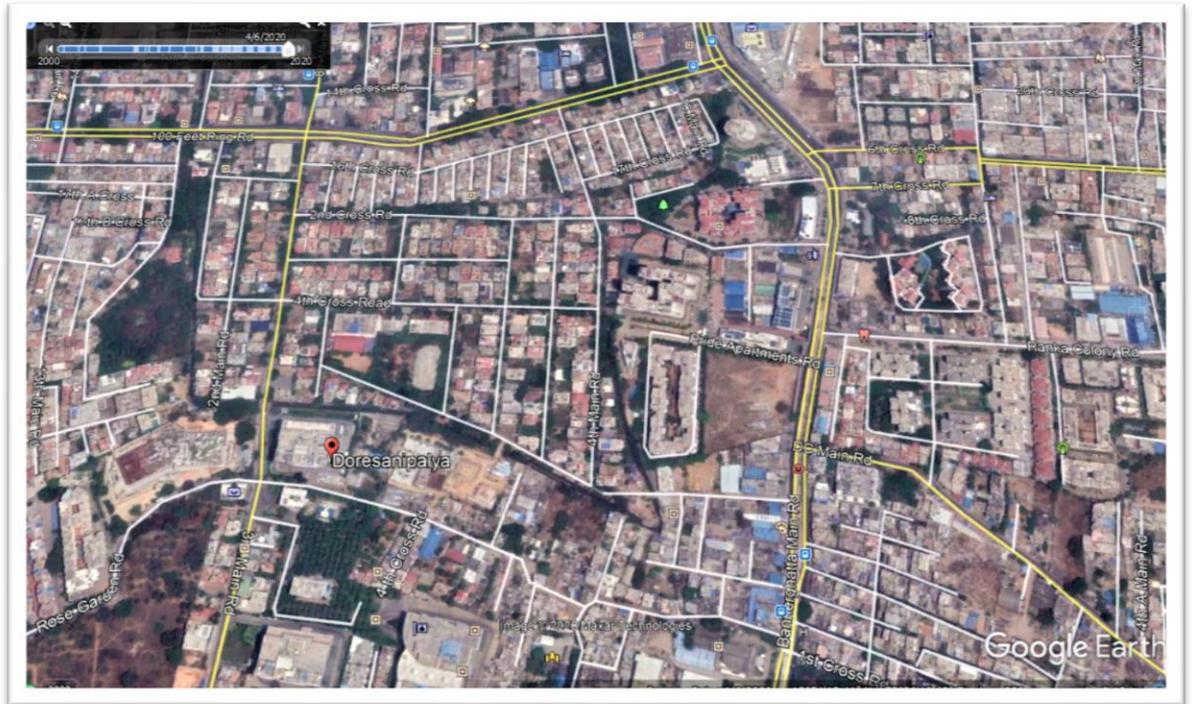
Doresanipalya kere

Exhibit 3.2: Current status of disused lakes contd....

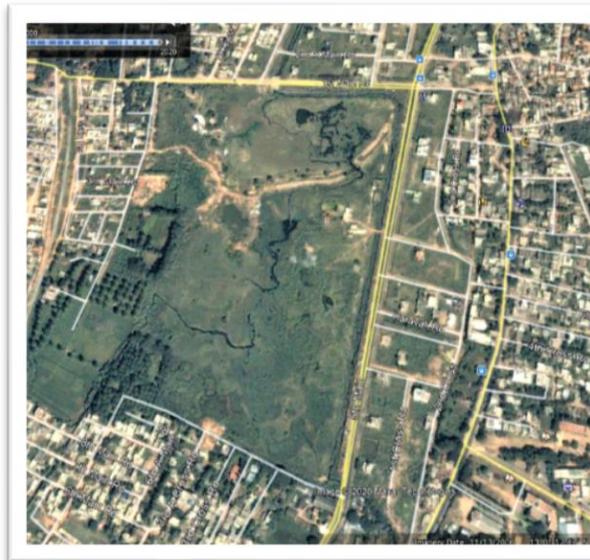
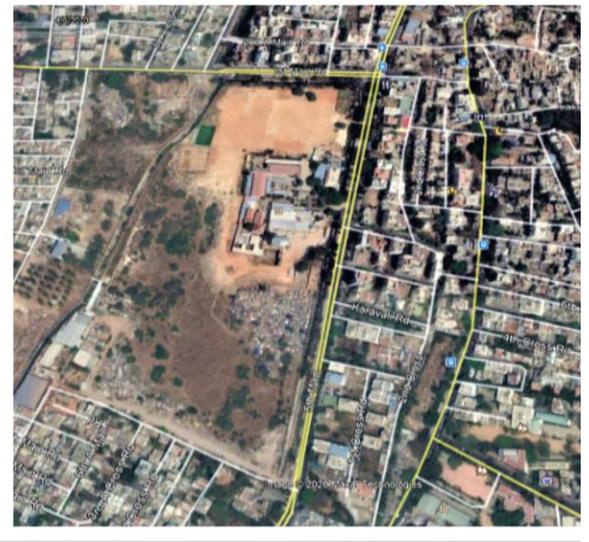
Lingarajapuram kere 2000

Lingarajapuram kere 2020

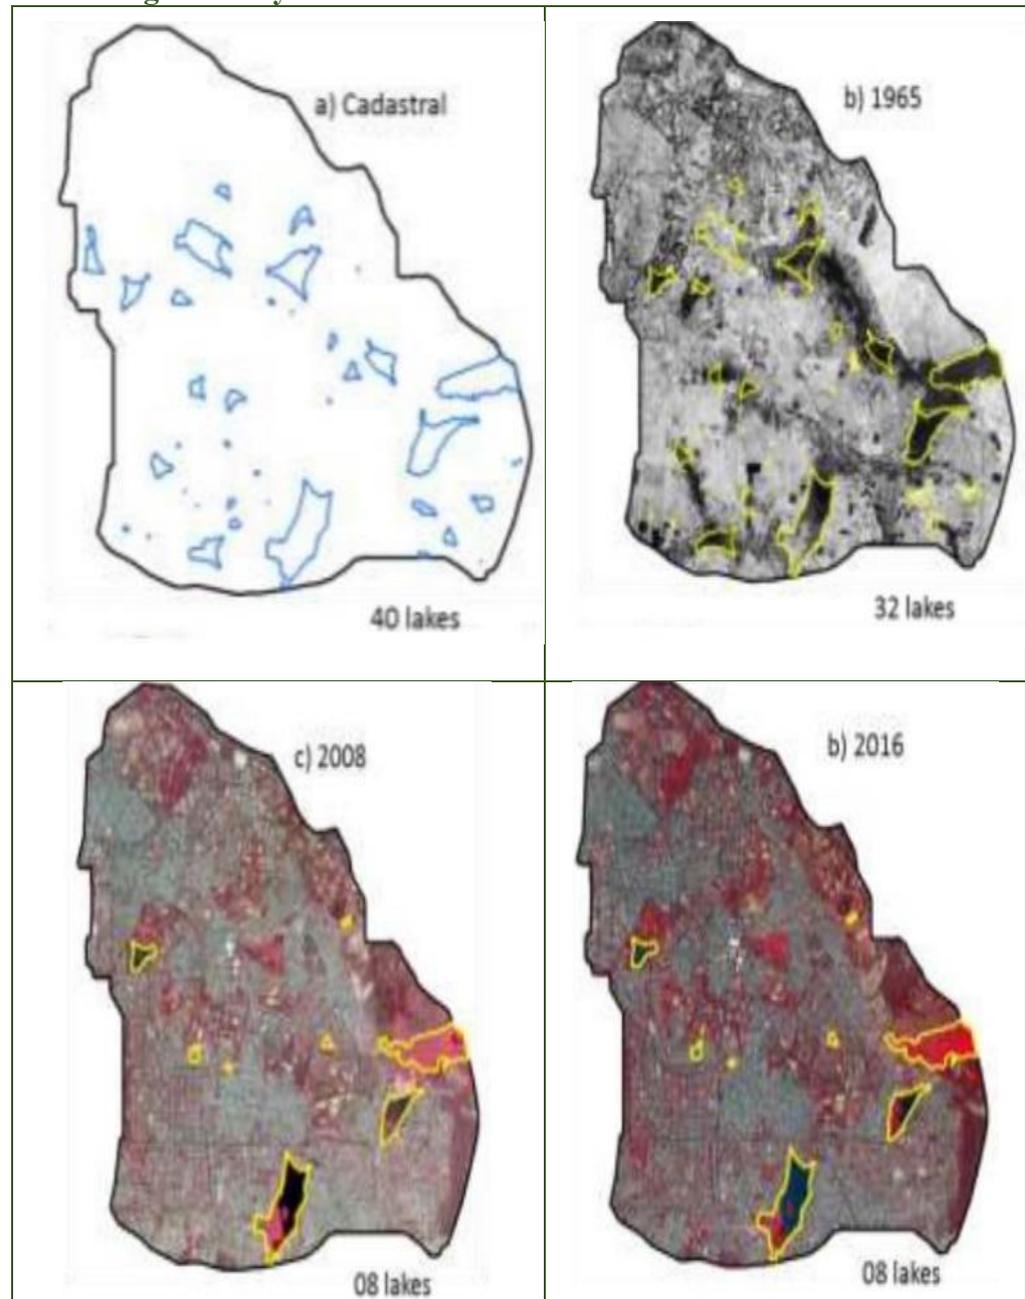
Koramangala valley

The study revealed that about 41 and 51 water bodies, which existed in Koramangala and Vrishabhavathi valleys respectively as per the cadastral map (prepared through field survey during early 1900s) were reduced to 8 and 13 by the year 2008 indicating the severity of lake conversion. Further, the wetland system (lakes, tanks, *kere* and *katte*), which contributed about 479.48 ha (0.75 per cent) and 215.46 ha (2.24 per cent) to the geographical area of the valleys as per the cadastral map decreased to 262.37 ha and 62.05 ha during 2016/2017 indicating erosion due to land use changes. The time series map showing the changes in lakes/tanks is indicated in **Chart 3.1**.

Chart 3.1: Time series maps showing changes in lakes / tanks

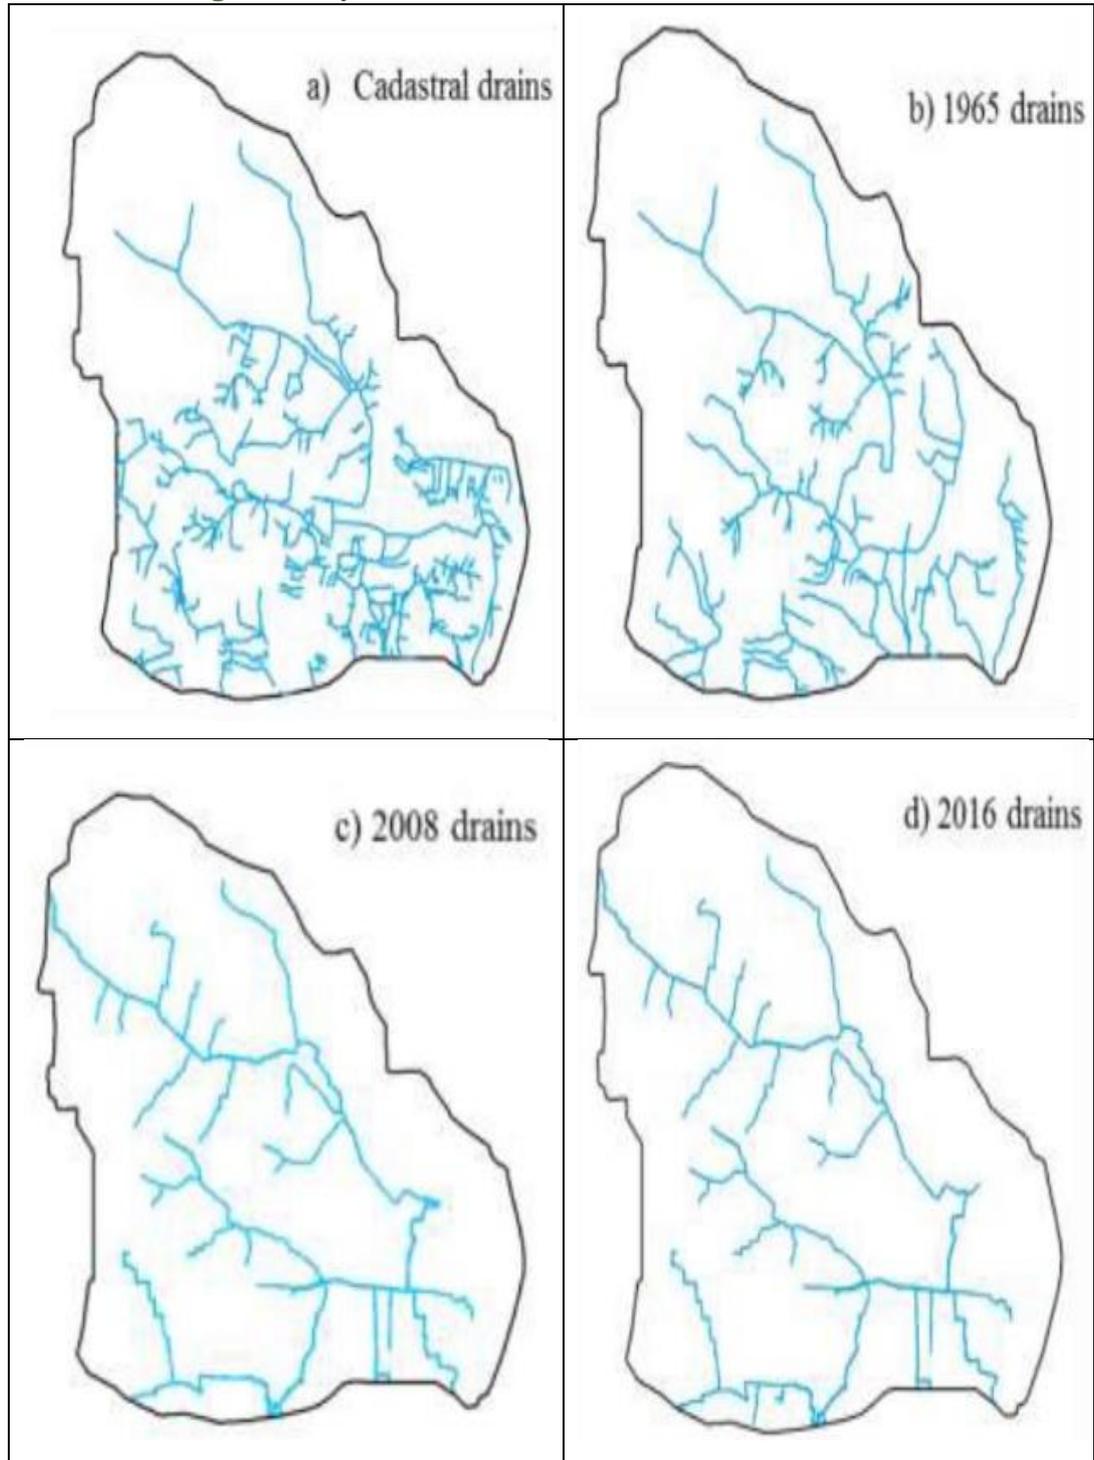
Koramangala valley

Natural drainage/stream systems were concretised into storm water drains with increase in urbanisation. As per the study, total length of drains (primary and secondary) as per cadastral maps (early 1900s) was 113.24 km and 226.29 km in Koramangala and Vrishabhavathi valleys respectively, which was reduced to 62.84 km and 111.72 km by 2016/2017. The time series drainage maps showing the changes is indicated in **Chart 3.2**.

Chart 3.2: Time series drainage maps

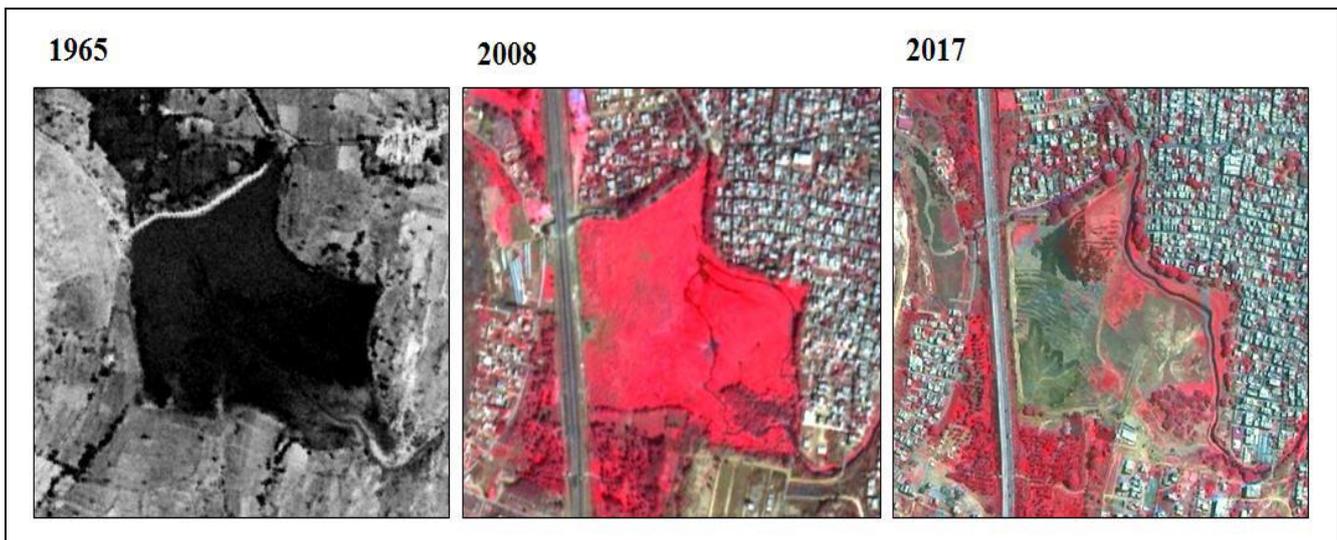
The spatial analysis also showed significant changes in the alignment of drains mainly due to remodelling. For example, in Koramangala valley, the length of two drains which merge before entering into Bellandur Lake was reduced from 338 m to 136 m (**Exhibit 3.4**) between the years 2008 and 2016 which allowed constructions thereby affecting the free flow of storm water. In Vrishabhavathi valley, the drain passing along the border of Hosakerehalli lake was remodeled and diverted to flow through the lake thereby reducing the area of the lake (**Exhibit 3.5**).

Exhibit 3.5: Realignment of drainage network near Hosakerehalli Lake

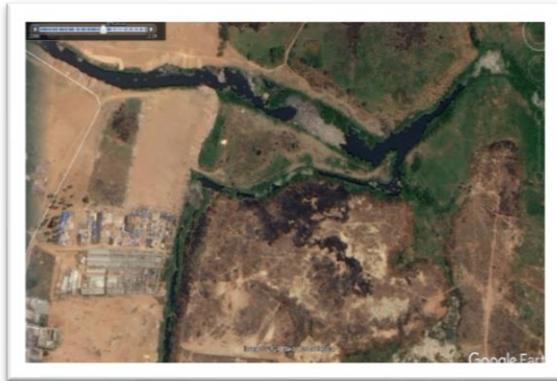
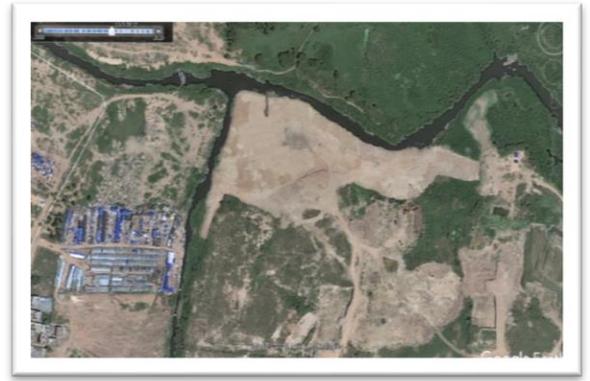
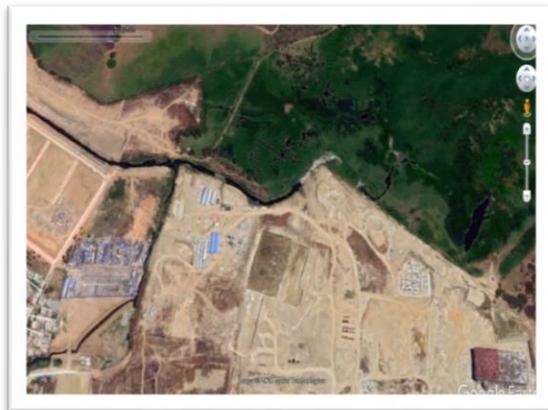
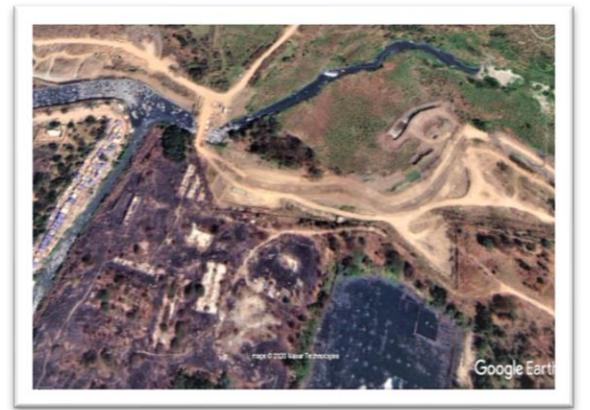
The reply cannot be accepted as in the instant case of Bellandur lake, the realignment was done in such a manner that it facilitated unauthorised developments in and around the lake area as can be seen from the Google Earth images taken over a period of time as exhibited (**Exhibit 3.6**).

Exhibit 3.6: Google earth images showing the realignment of drains
