CHAPTER IV IMPACT OF CHANGE IN LAND USE AND LAND COVER

4.2. Illegal constructions on Cheruthoni riverbed in Idukki district

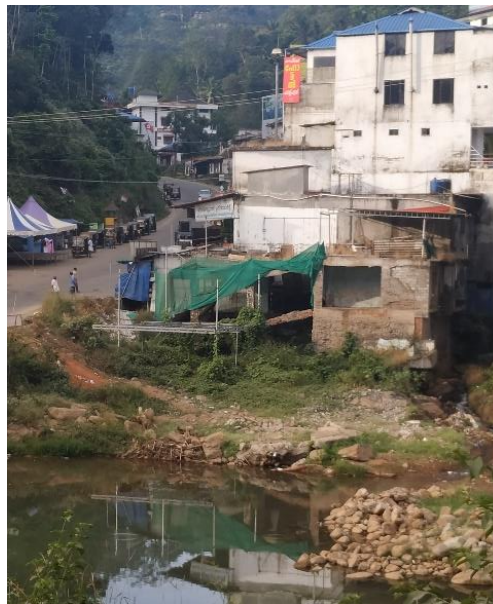
Consequent to a mass petition filed by residents of Idukki (March 2008) before Hon'ble Chief Minister regarding illegal constructions of multi-storied buildings in CFZ at Cheruthoni, a detailed enquiry by the LSGD and Power departments identified 62 buildings in the CFZ which would be inundated in the event of opening of dam shutters. Though GoK directed (November 2009) Secretary, Vazhathope Grama Panchayat to remove the buildings constructed in CFZ, no action was taken to comply with the direction resulting in many buildings and houses⁹⁶ being washed away and foundations of several buildings getting damaged consequent to the opening of shutters of Cheruthoni dam during the floods of August 2018. More importantly, the Tahsildar Idukki reported (April 2019) that new buildings were again coming up in the area where the buildings were washed away in 2018. The constructions were in violation of the orders (August 2016) of the District Collector in his capacity as Chairman of DDMA prohibiting construction in areas within the MFL of the Cheruthoni River. The Deputy Superintendent of Police, Idukki also reported (April 2019) that there was reconstruction of old buildings which were damaged in the floods of 2018, in violation of the order of District Collector. No action has also been

Figure 4.1: Reconstruction of hotel building washed away in flood of 2018. 20 December 2019, Cheruthoni riverbed, Idukki District, Photo taken by Audit party, attested by Tahsildar, Idukki Taluk

taken to remove or relocate 155 encroachments identified by a joint verification team⁹⁷ constituted (November 2019) by the District Collector. Complaints on encroachments received by the Revenue Department were also not acted upon by the department. The Tahsildar (Land Records), Idukki affirmed to Audit (November 2019) that none of the 34 complaints received upto 2019 by the Taluk Surveyor/ Village Officer relating to encroachment of rivers/ canals were acted upon.

Lack of continuous monitoring and timely action to evict the encroachers led to the obstruction of free flow of the river and consequent damages in 2018 floods. Further, the encroachment caused operational bottlenecks for spillway opening as the people occupying these illegally constructed buildings were to be given sufficient time for evacuation before the gates were opened.

Recommendation 4.2: The Government needs to prioritise speedy resolution of the issues relating to removal of unauthorised constructions from the construction free zone in Cheruthoni as also to ensure no new construction is allowed to come up in future within the demarcated zone.

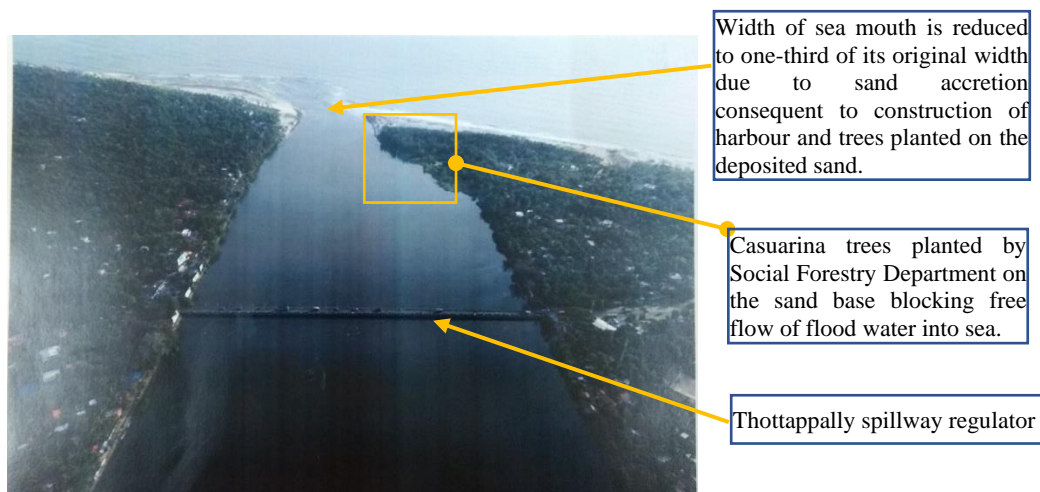
property of people in Kuttanad. TSW was to include a regulator cum bridge 365 m long having 40 vents and a leading channel 1,310 m long and 365 m wide, starting from the confluence point of Pamba and Achencovil rivers at Veeyapuram. Audit scrutiny of records revealed that in the upstream side of the spillway, the width of the leading channel was only about 80 m from Veeyapuram to Thottappally, which reduced the discharge capacity of TSW to 700 cumecs against the envisaged capacity of 1800 cumecs.

Scrutiny of records at Office of the Chief Engineer, Kuttanad¹⁰⁸ indicated that there was gradual accretion of sand on the south side of a breakwater which was constructed (2004) to facilitate opening of Thottappally Fishing Harbour about 100 m north of spillway mouth. The width and carrying capacity of the spillway mouth was further reduced to one third of its original state, after the Social Forestry Department, without seeking permission from Irrigation Department, planted (2010) casuarina trees on this sand base, right inside the spillway mouth. Incomplete dredging and widening of leading channel of Thottappally spillway and delay in removal of the trees planted inside the spillway mouth resulted in reduction of capacity of the spillway, thus contributing to the flood situation in Alappuzha in August 2018.

Figure 4.2: Thottappally spillway aerial view, July 2018, Alappuzha District

In the aftermath of the August 2018 floods, the Principal Chief Conservator of Forests (PCCF) issued instructions (May 2019) to cut down the trees in view of the risk of an impending disaster. However, the Social Forestry wing of the district, citing environmental reasons, did not comply with the order. Orders of the District Collector invoking the provisions of Disaster Management Act 2005 (June 2019), for taking immediate action to cut down these trees which were obstructing natural flow through the spillway mouth were also not complied with.

Chief Engineer, Kuttanad informed Audit during the joint site verification (04 October 2019) that though attempts were made to cut down the trees on the basis of District Collector's order, only four trees could be removed as the local people had vehemently resisted the move, stating that these trees acted as a protective shield against wind.

Water Resources Department confirmed (November 2020) that discharge envisaged through the spillway had been reduced from 1800 cumecs due to the siltation in the leading channel. Further, any change in width of the upstream channel requires rehabilitation of people from the heavily populated banks. Additional Chief Secretary, Water Resources Department informed (November 2020 and April 2021) Audit that 550 casuarina trees planted within the 380m width of the downstream, and reckoned to be obstructing the flow of floodwaters were cut down by the District Administration, Alappuzha on 22 May 2020, by which the width at the spillway mouth was extended by 230m thereby reaching the required width of 380m.

It was also informed that with a view to deepen and widen the estuary, Irrigation Department started removal of mineral sand from spillway mouth and downstream of the spillway on 20 May 2020. Accordingly, an estimated quantity of 2,42,831 cu.m sand was dredged; out of which a quantity of 1,75,319 cu.m sand was removed. Within a few months after completing the dredging, a sand bar has been formed at the spillway mouth, occupying a width of 75 m. The present accumulation of mineral sand at the downstream is

Recommendation 4.4: Government may, prioritise works such as deepening of the leading channel upstream of TSW and timely breaking of developing sand bar, if any, at the sea mouth so as to ensure unhindered flow of flood waters to the sea, giving due consideration to extant environment related instructions while so doing.
