Chapter 5

Infrastructure and in-school facilities

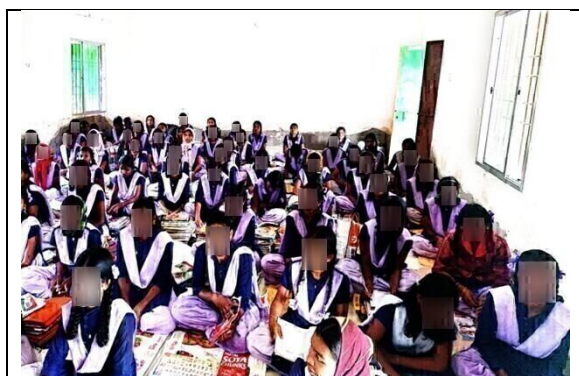
- **Overcrowded classrooms:** In 15 (17 per cent) of the 95 sampled schools, 32 classrooms were overcrowded, where 53 to 160 students were seated in a single classroom. Audit noticed that in 11 such overcrowded classrooms, 53 to 121 students of Primary and Upper Primary classes were seated. Similarly, in another 17 overcrowded classrooms, 71 to 130 students of Secondary classes were seated, whereas in other four overcrowded classrooms, students ranging from 119 to 160 of Higher Secondary classes had been seated, as shown in **Pictures 5.3 and 5.4**.

<p>Picture 5.3; dated 23.09.2023</p>	<p>Picture 5.4, dated 23.09.2023</p>
<p>Around 90 students of CI-IX sitting in single classroom in Govt SSD Girls HS, Karchamal, Nabarangpur</p>	<p>Around 110 students of CI-X sitting in one classroom in Govt SSD Girls HS Karchamal, Nabarangpur</p>

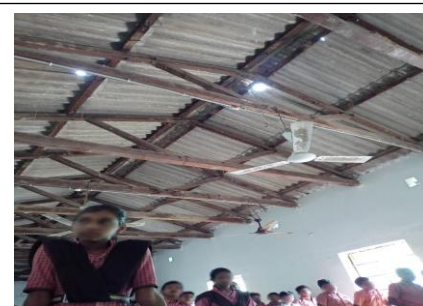
- Damaged/ unsuitable classrooms:** In 14 (15 per cent) out of 95 sampled Government/ Government aided schools, damaged walls, ceilings and roofs were noticed in classrooms (**Picture 5.5**). The schools, block and district-level authorities, thus, failed to ensure a safe learning environment for the students. Details are in **Appendix 5.3**.

Picture 5.5; dated 25.07.2023
Class VIII students sitting under broken Asbestos Roof in Krupasindu Govt. High School, Bhadrak

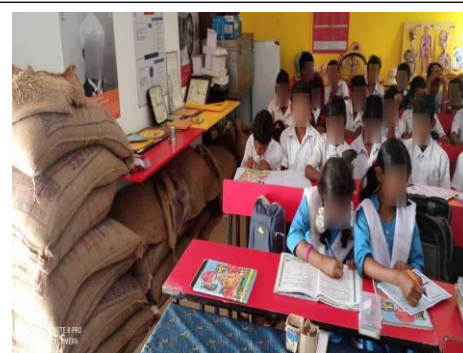
- Classrooms used as multi-purpose rooms:** In eight schools, the classrooms were used as classroom-cum-store room for keeping Mid-day Meal (MDM) stuff and other materials due to the absence of sufficient space/ storeroom (Details are in **Appendix 5.4**) (**Picture 5.6**), whereas, in five schools, the classrooms were being used as kitchens for preparing Mid-day Meals, due to the absence of dedicated and proper kitchen/ shed.

Picture 5.6; dated 04.07.2023
Classroom being used as classroom cum storeroom in Mukhibidai Upgraded High school, Koraput

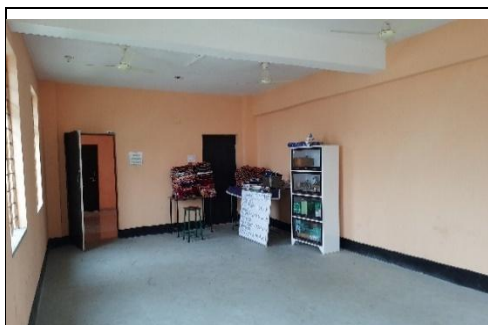
- **Absence of functional integrated/ science laboratory room:** In five (11 *per cent*) out of 46 sampled schools imparting education to students of Secondary classes (IX to X), the existing laboratories lacked requisite instruments/ connections/ facilities. Hence, the same were not being put to effective use for the benefit of students. Similarly, in one (nine *per cent*) out of 11 sampled schools imparting science education to students of Higher Secondary classes (Classes XI to XII), the laboratories (four) were not being used by the students due to non-availability of requisite furniture and facilities and absence of demonstrators (**Pictures 5.7 and 5.8**). Details are given in **Appendix 5.5**.

*Picture 5.7; dated 03.08.2023
Botany lab without requisite set up &
demonstration facilities in SSD Higher
Secondary School, Sunabeda*

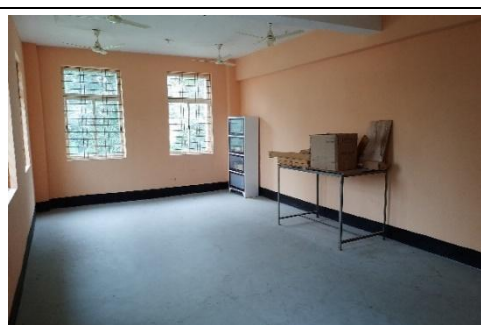
*Picture 5.8; dated 03.08.2023
Physics lab without requisite set up &
demonstration facilities in SSD Higher
Secondary School, Sunabeda*

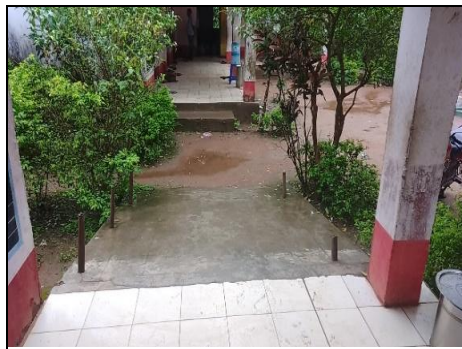
- **Unsafe ramp and railing:** In two schools (Pendapada Project Upper Primary School, Hataguda Upgraded High school, Koraput), Audit noticed unsafe ramps and ramps with broken iron angles, which were not fit for use both by CwSN as well as for normal students and could cause serious accidental injury as shown in **Pictures 5.9** and **5.10**.

Picture 5.9; dated: 12.08.2023
Ramp with broken angle in Pendapada Primary and Upper Primary School

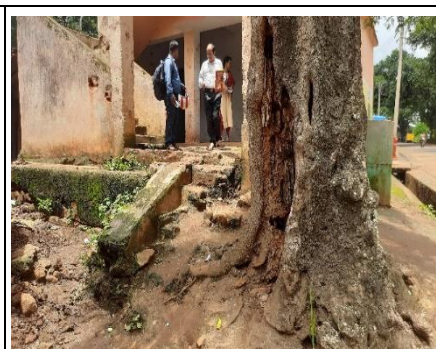
Picture 5.10; dated: 13.07.2023
Unsafe ramp/ entrance to Classes VI and VIII at Hataguda Upgraded High school

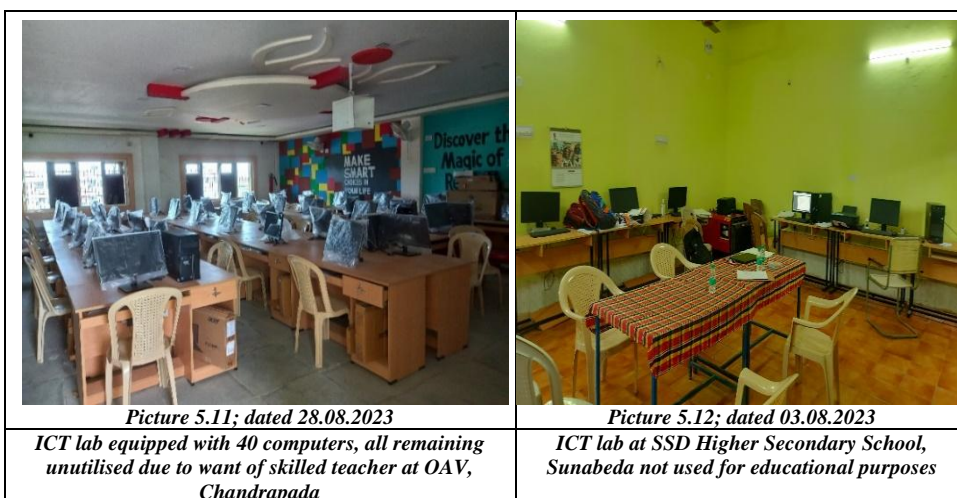
- **Non-utilisation of ICT facilities:** In 13 (14 *per cent*) out of 95 sampled schools, the available ICT facilities in the schools had not been used due to the absence of skilled manpower/ instructor (list of schools detailed in *Appendix 5.6*). Additional ICT lab was under construction in one (SSD Girl's High School, Baligaon) despite non-utilisation of existing ICT facilities. Besides, ICT labs with computers were not utilised by the students due to want of skilled teachers and not used for educational purpose as shown in *Picture 5.11* and *Picture 5.12*.

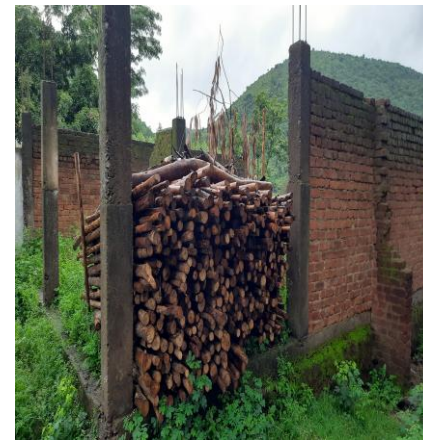
The Renu Project Upper Primary School (Semiliguda Block under Koraput district) imparts education to Class I to VII. The DPC, Koraput sanctioned (2011-12) ₹ 4.22 lakh and released ₹ 4.09 lakh in favour of the headmaster of the school for the construction of additional classrooms (December 2013). The work was scheduled to be completed by June 2014. In the JPI (July 2023), Audit noticed that the entire amount of ₹ 4.09 lakh had been utilised. However, the work was lying incomplete even after a lapse of more than nine years of the scheduled date of completion. The DPC Koraput, while accepting the fact, stated that ₹ 4.40 lakh had been recovered from the concerned Headmaster of the school and action was being taken for completion of the project departmentally.

Picture 5.13; dated 10.07.2023
Incomplete Classroom inside the premises of
Renu Project Upper Primary School

The Department stated (October 2024) that steps had been taken for completion of the work by following due procedure.
