Report of the
Comptroller and Auditor General of India
on

Capacity Utilisation, Electricity Generation, Sale and Collection of Revenue
including Disaster Management by Hydro Power CPSEs
(NHPC Limited, SJVN Limited, THDC India Limited and NHDC Limited)

Union Government (Commercial)
Ministry of Power
No. 41 of 2015
(Performance Audit)

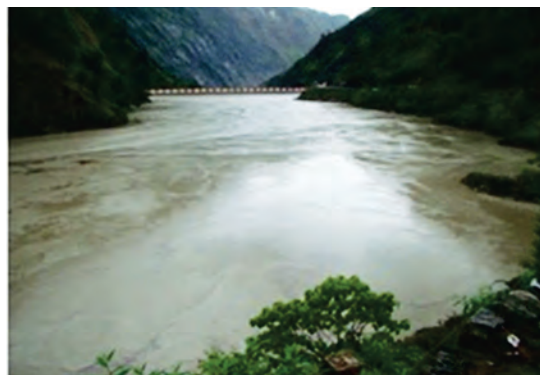
Dhauliganga Reservoir

During the flood of 16-17 June 2013, despite maximum discharge 2051.72 cumecs as against design flood of 3210 cumecs, substantial damages occurred to the power station components *viz*; power house was submerged up to half the level of office floor (EL 1045 m) and there was heavy accumulation of silt on all the floors²³ the outlet of Tail Race Tunnel (TRT) was choked, four pole structure near the sub-station was washed away; hence grid power supply to power house was not available.

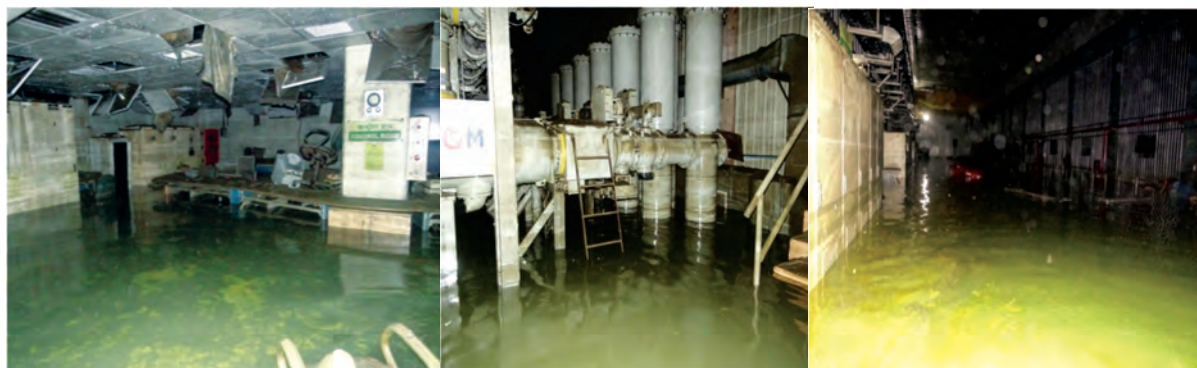
Flooding in Dhauliganga Power House

Besides, eight blocks of B-type quarters (48 quarters) were completely washed away, C and D type quarters, field hostel, co-operative store, nursery school, workshop, colony roads, Central Industrial Security Force (CISF) colony and central store at Dobat suffered severe damages. In this regard NHPC informed MoP immediately after the disaster on 17 June 2013 that due to cloudburst and heavy unprecedented rainfall in upstream reaches of Dharchula area of Pithoragarh District during last two days and subsequent flood in river Kali, water entered the TRT and all systems of powerhouse had submerged in the early hours of 17 June 2013. Besides, a team from NHPC Corporate Office, consisting of Executive Director (Projects), Executive Director (Commercial) and GM (Design and Engineering) who visited the power house site and colony areas of DGPS on 19 and 20 June 2013, submitted its report on 21 June 2013; wherein it mentioned the extent of damages and restoration works required to be carried out. In addition, DGPS prepared (21 June 2013) a report on sequence of events. The reports did not critically examine the sequence of events and adequacy of efforts to mitigate the impact of flood. Restoration activities started from July 2013 with dewatering of power house and three out of four generating units of DGPS were re-commissioned in May-June 2014. Unit no. 1 was put on generation on 22 May 2015.

CEA recommended (August 2015) that utilities may undertake suitable measures to avert the flooding of powerhouse.

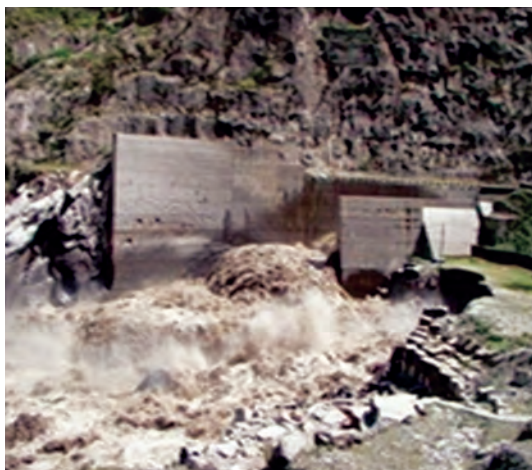
Flood water discharge form Radial Gate

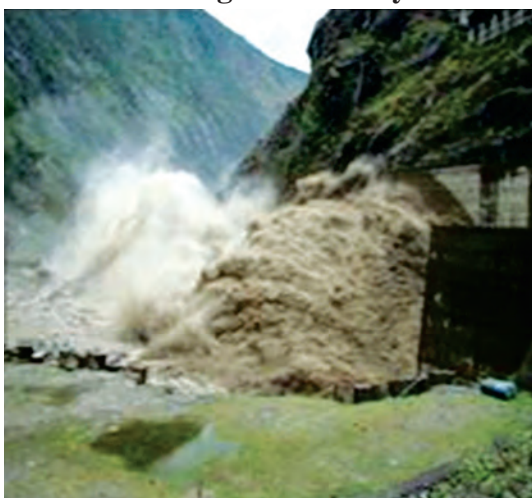
Picture showing the intensity of Flood

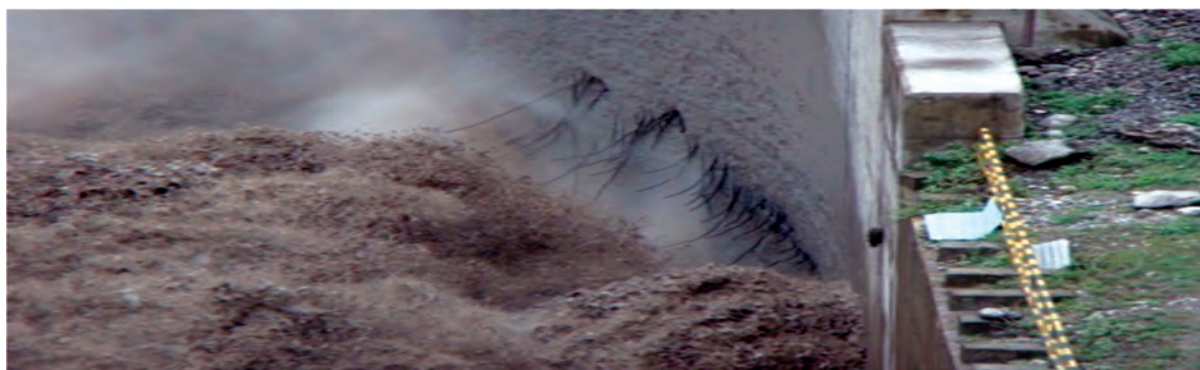
Damage to Dhauliganga dam site due to flood
