# Chapter 1 Disaster Management in Indian Railways

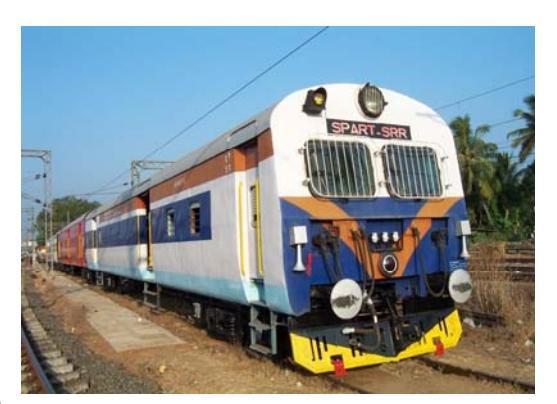
- The stock register of SPART at Chennai Division of SR revealed disposal of various items as 'rat damaged'. Rusty surgical equipments requiring replacement were available and the expiry dates of medicines were incorrectly exhibited.

- Further, on two occasions of major accidents, the SPART located at Chennai Division of SR, which was self propelled, had to be hauled with the assistance of a locomotive. Similarly, during a trial run, SPART the at Palghat Division of SR could not be moved due to an error in its engine, indicating that the SPARTs were not maintained in good fettle.

The SPART at Chennai Division

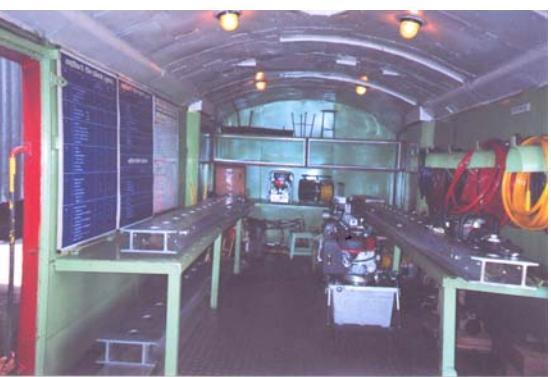
after a mob wrecked the 2124 Deccan Oueen express and two other suburban trains on 30 November 2006 in CR, the diesel light engine, that was requisitioned, took one hour and ten minutes to reach the site, while a slow local train would have taken 12 minutes to travel the distance. As a result the rescue work was delayed

ART Kurla carrying hydraulic rerailing equipment

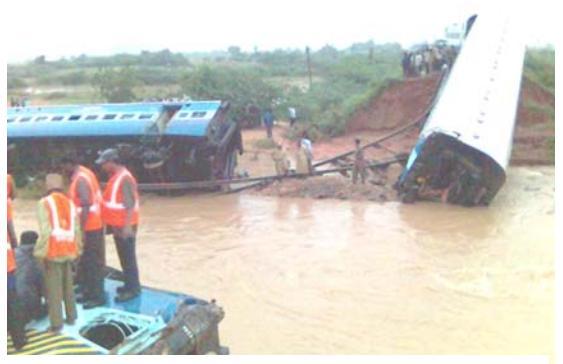
• In the derailment of train no 415 Delta Fast Passenger at 04:22 hours on 29 October 2005 between

block stations Ramannapet -Valigonda at a bridge on SCR, where the train fell into a water flowing underneath the bridge, the rescue team could not maneuver velocity the of the flowing water and though the ARMV from Secunderabad reached the site by 6:50 hours, the

The capsized Delta fast passenger train in Valigonda

rescue work could commence only at 09:30 hours, after the water level receded, with the assistance of the local villagers. The passengers from other coaches helped those in the affected coaches to come out.

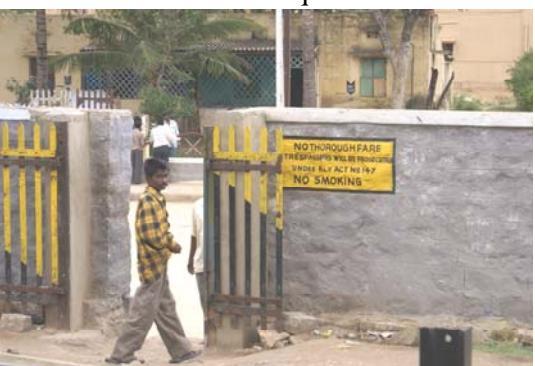
• A majority of the stations had multi entry/exit points, which

An unmonitored entry/exit point at Bangarapet station
