Report of the Comptroller and Auditor General of India

Flood management and response in Chennai and its suburban areas

**Report of the
Comptroller and Auditor General of India
on Performance Audit of Flood Management
and Response in Chennai and its
Suburban Areas**

**Government of Tamil Nadu
Report No. 4 of 2017**

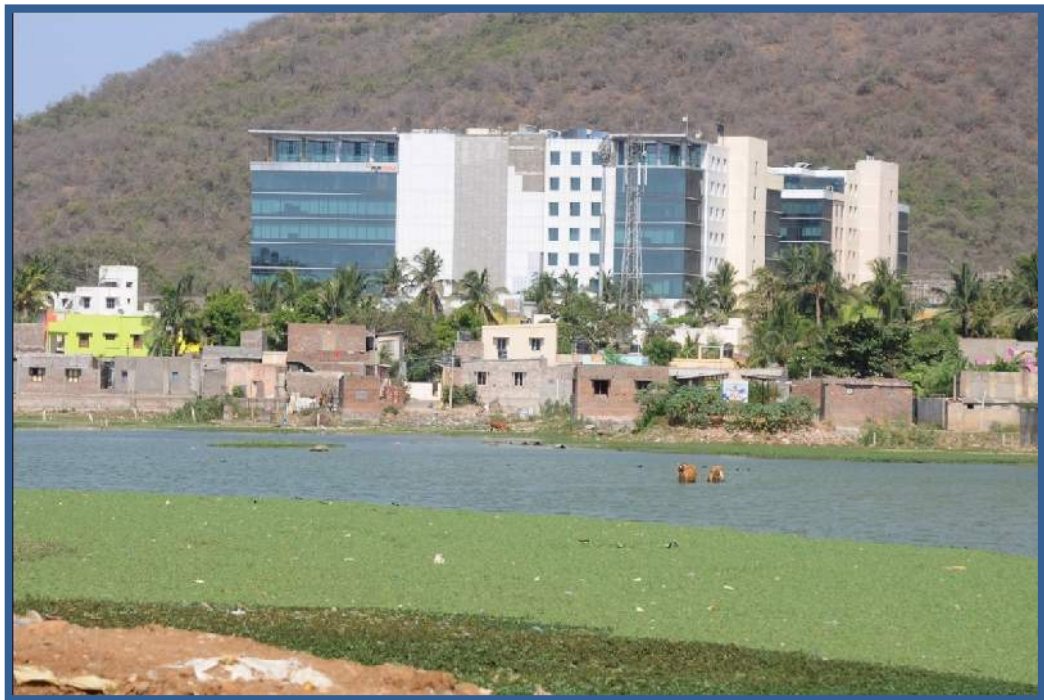
Exhibit 4.1: Encroachment in Perungalathur Big Tank

Thus, despite availability of strong statutory backing and the matter being pointed out in the earlier Audit Reports, majority of encroachments in water bodies continued to thrive without eviction, even after lapse of nine years from the enactment of the Act resulting in non-achievement of objective of preservation of water bodies besides contributing to flooding in Chennai and its suburban areas during December 2015.

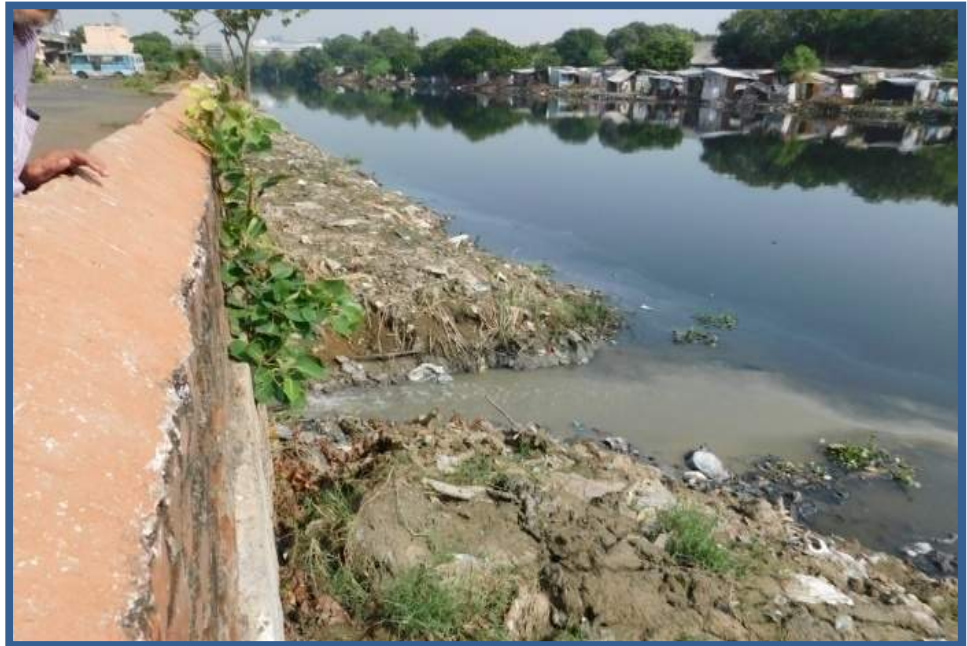
- Along Cooum River, out of the total length of 80 km of the banks, 22.7 km (28 per cent) was encroached by 14,257 slum families and others. We conducted a joint inspection of river bank along with officials of the line departments and found that the slum encroachment along the bund of the river (**Exhibit 4.3**) had reduced the width of its carrying capacity.

Encroachment and sewage outfall (Pallavan Nagar)

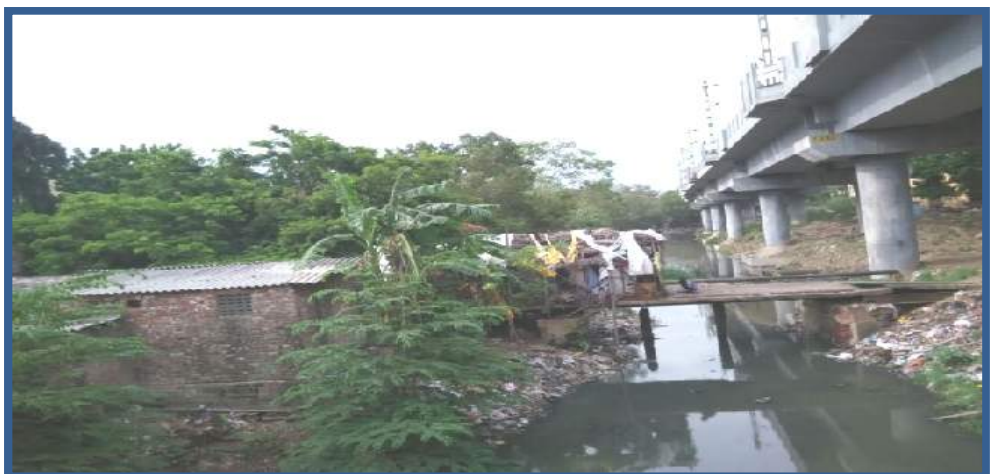
Exhibit 4.4: Encroachment in Buckingham Canal

Thus, the encroachment in the rivers and canals had contributed to flooding in slums and also the adjoining areas of the test checked zones of Adyar, Alandur, Ambattur, Kodambakkam and Perungudi. The District Collector,

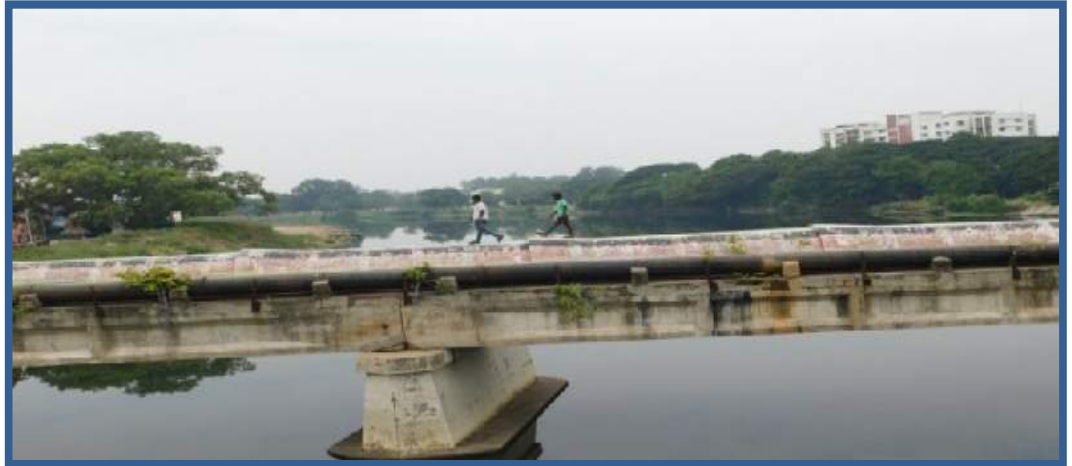
Exhibit 4.8: Old bridge blocking the free flow of water

We are constrained to record the callous attitude of the WRD in allowing these obstructions in the water bodies which contributed to the 2015 floods.

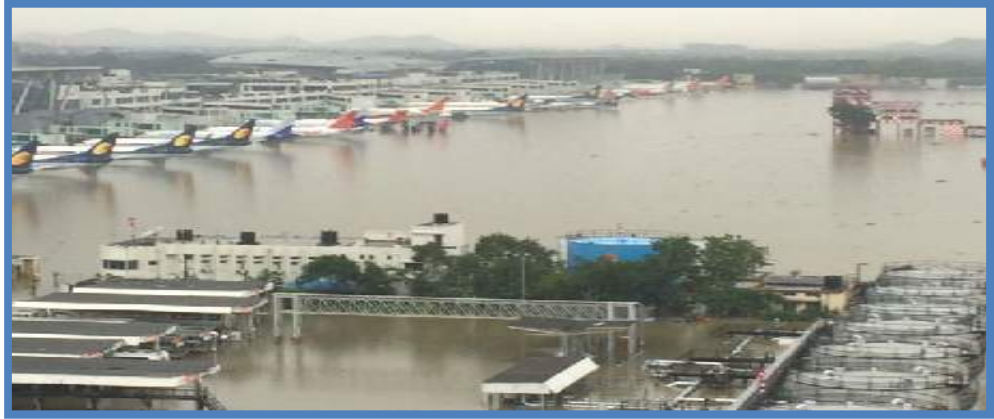
Exhibit 4.9: Flooding of Chennai International Airport

We observed that WRD failed to ensure compliance to the NOC conditions relating to flood protection works and periodical maintenance by the Airport authority. GoTN stated (March 2017) that detailed survey would be done to tackle this issue. The reply did not address the audit findings as compliance to NOC conditions should have been monitored continuously by WRD.

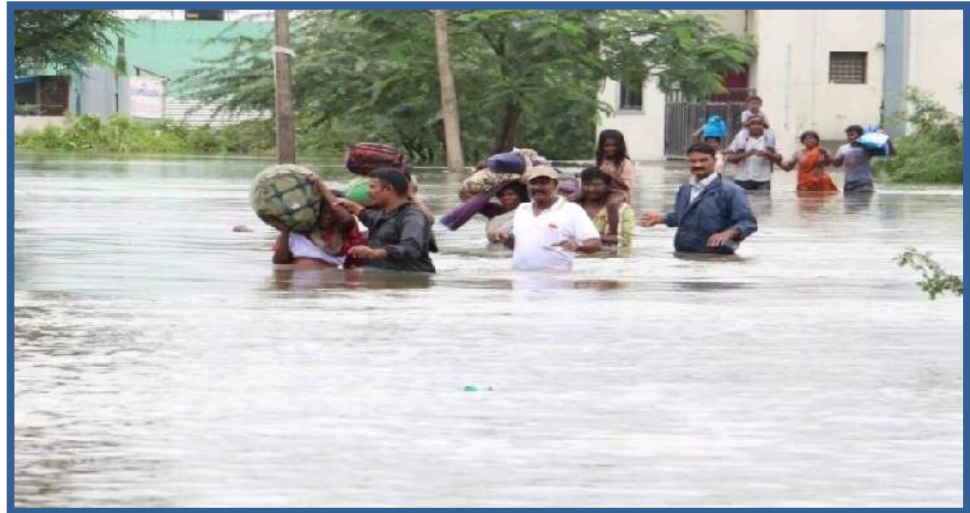
Exhibit 5.3: Heavy inundation in the areas of Ward 32 of Tambaram Municipality

Thus, the failure of CMDA in allowing constructions of residential buildings without preserving water course and WRD's failure in protecting the channel under its jurisdiction resulted in inundation of adjoining areas.
