## **CHAPTER IV**

### **ISSUES RELATING TO ENVIRONMENT**

#### 4.4 Results of field visit by Audit Teams

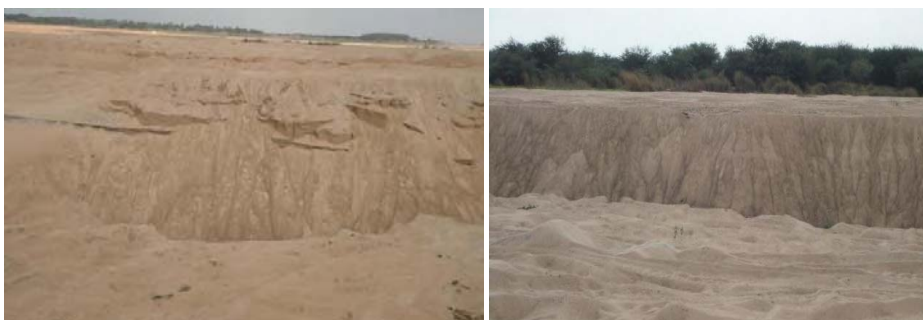
During field visit to Lankapally Sand reach under the jurisdiction of ADMG, Vijayawada (January 2012), audit observed that the lease holder seemed to have quarried the sand into deep levels, which was in violation of the APWALT Rules. GWD had given clearance (April 2010) to quarry the sand in this reach up to a depth of two metres only.

(Two photographs of Lankapally Sand reach, evidencing deep quarrying)

The Government, while admitting (February 2014) indiscriminate sand quarrying stated that though the rules restricted extraction of sand in terms of thickness depending upon availability of sand in the area, the same could not be implemented in view of the policy involving sealed tender-cum-public auctions having no restriction on the bid amounts.

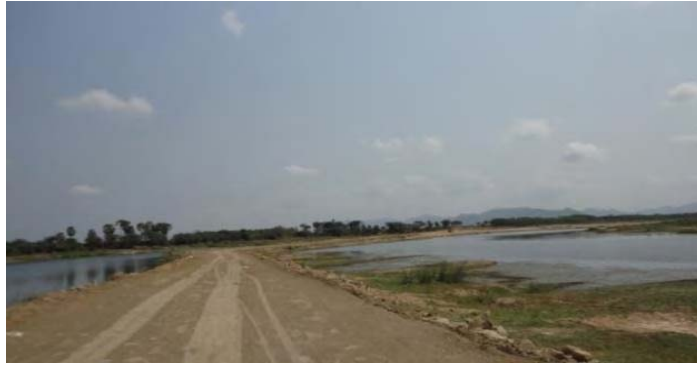
During field visit to Chevitikallu sand reach under the jurisdiction of ADMG, Nandigama, Krishna District (March 2012), audit observed that the lease holder had constructed a path, with a width of 10 metres and a length of five to six kilometres across the river bed, for use as a ramp to transport sand. This extended up to the bank on the other side in Guntur District. The path constructed was inhibiting the free flow of river resulting in stagnant water on either side of the ramp, besides altering the natural course of the river.

(Photograph of obstructing pathway at Chevitikallu sand reach)

The Government replied (May 2013) that the distance to the specified sand shoal/pocket identified for extraction was located far away. The Government further replied (February 2014) that since the double lane road work on Krishna Left Flood bank was being taken up, the ramps were permitted without affecting the progress of the work. A pipeline having two meters diameter was laid along the flow of the river over which way was made by gravel so as to facilitate the movement of vehicles for extraction of sand without violation to the River Conservancy Act while allowing smooth flow of water. The arrangement was made with the consent of Irrigation Department by the lease holder.

No document, however, was made available to audit regarding the consent of Irrigation Department.

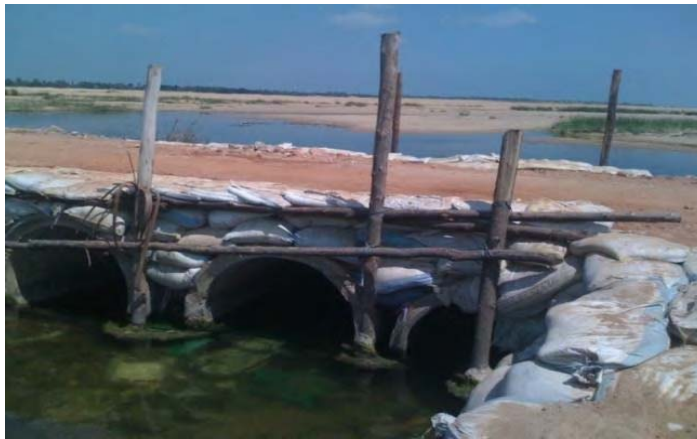
During field visit to Mudivarthypalem reach in SPSR Nellore district, audit team observed that a long path was laid inside the river by the lease holder from the mouth of the ramp for free movement of lorries to places of sand deposit. The path was laid on the river without obtaining the permission of Penna River Conservatory Authority which monitored the river conservation.

(Photograph of long path laid at Mudivarthipalem)

The Government accepted (February 2014) the observation of audit and stated that the Department had noticed the violation in joint inspection by them in October 2011 and had issued demand notice for ₹ 4.27 crore towards the penalty of five times the Seigniorage fee in addition to normal Seigniorage fee on which lessee preferred an appeal before the Government. The appeal was still pending with the Government (February 2014).

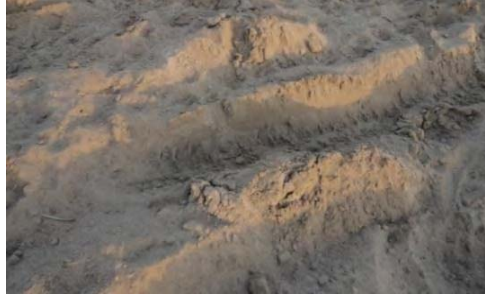
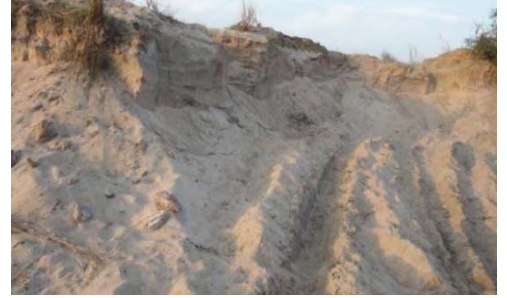
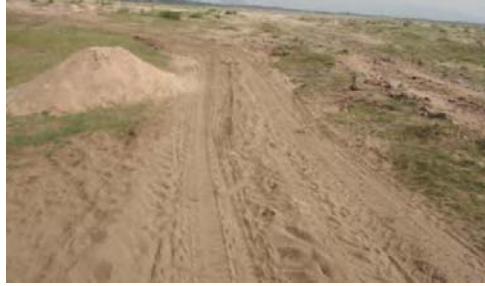
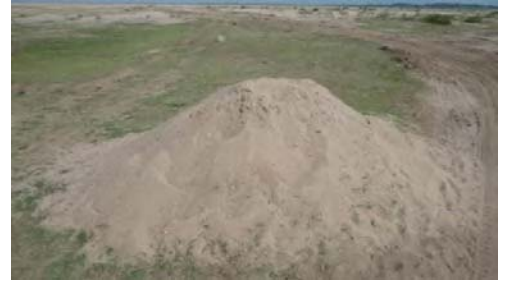
During field visit to Godavarru sand reach of Guntur District (February 2012), audit observed that though the reach was non-working for the past nine months, there was evidence that sand was quarried and transported illegally at three places. During visit to Thulluru sand reach of Guntur District, it was observed that the reach was imprinted with the wet vehicle tyre tracks indicating illegal excavation and transportation of sand. This reach had not been auctioned since 2007. Large quantities were observed to have been quarried at many places. At some places huge heaps of sand were found, indicating probable illegal quarrying.

(Four photographs of Godavarru sand reach evidencing illegal quarrying)

Government stated (February 2014) that the departmental special vigilance squads/ regional mobile squads in addition to monitoring by the vigilance and enforcement department has taken all preventive steps to control illicit quarrying by making surprise checks and collecting penalties. However, such quarrying in the un-auctioned reach was continuing.

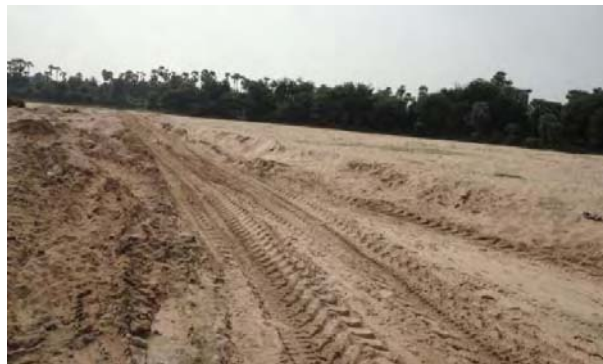
(Photograph of Thulluru sand reach pointing to illegal quarrying)
