# S E C T I O N - I V

Lake specific findings of  
12 test - checked lakes

### Lake specific findings of 12 test-checked lakes

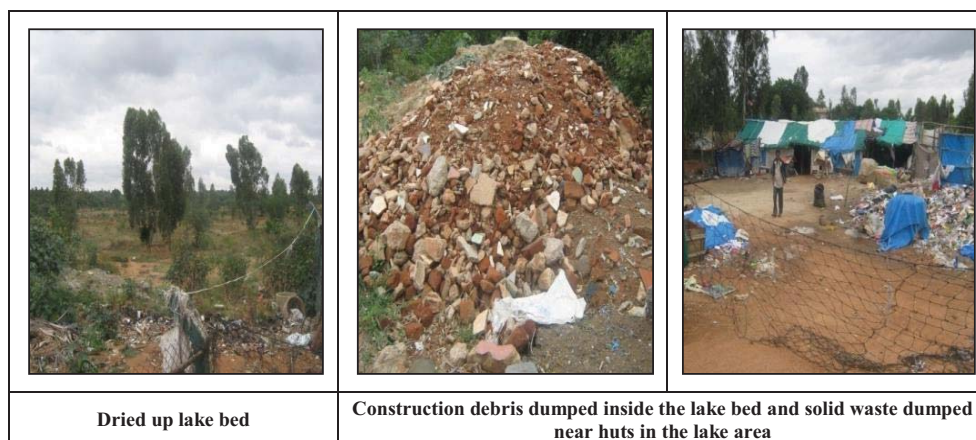
- ❖ The village map and other records revealed that the adjoining Survey.No.63 of Mullur village which was part of the lake is now shown as private land in the latest certified revenue survey map (2010).
- ❖ BBMP had planted trees in the lake bed area and no restoration works were taken up either by BBMP or BDA to revive the lake as a fresh water body.
- ❖ There were no inlets to the lake and thus, the entire lake bed had dried up.
- ❖ Lake was polluted with solid waste and construction debris and the pollution level was also not being monitored by any of the agencies.

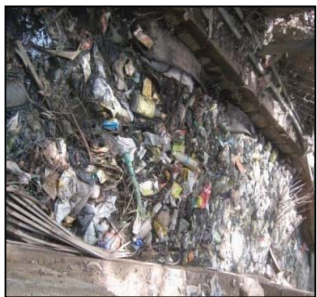
- ❖ The lessee was operating motor boats, violating the agreemental clause and polluting the lake. The LDA stated (April 2015) that lessee had been directed not to use motor boats in the lake.

- ❖ BWSSB's UGD line inside the lake bed was seen overflowing into the lake area. The treated water from STP and untreated sewage was mixed and was entering the lake. The water quality of the lake was not being monitored by any of the agencies. The LDA stated (April 2015) that BWSSB had been directed to make provision for diversion of sewage and lay down separate pipeline for entry of treated water into the lake.

Lake area with solid waste	Motor boats in lake area	Inlet from STP side bringing polluted water

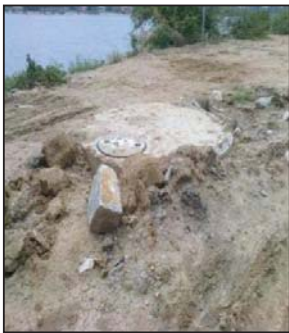
BWSSB trunk sewer chamber close to the water spread area	Lowered waste weir without flow	Constructed wetland without any water

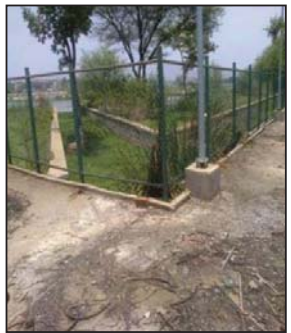
- ❖ Restoration works carried out without removal of encroachments.
- ❖ BDA had formed a residential layout in the lake area. It also irregularly diverted 11 acres of lake for formation of park as part of rejuvenation works in violation of rules.
- ❖ Fencing was breached and left open in many stretches to provide access roads to the nearby residential areas.
- ❖ The level of pollution was not assessed by any agency. BWSSB laid UGD network very close to the water spread area with the approval of LDA and BDA.
- ❖ The treated water flowing from Jakkur Lake was not entering the lake as the inlet was connected to sewage diversion channel and wetland remained dry.

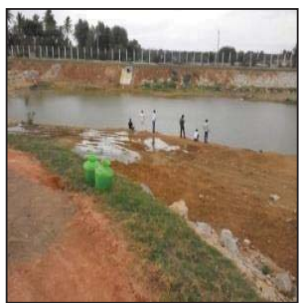
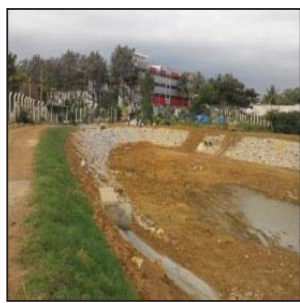
- ❖ The *atchcut* area across the main bund had been demarcated for residential site formation.
- ❖ The lake bund was used as a road to provide connectivity to the nearby areas.
- ❖ During JPV, a graveyard was noticed inside the lake area. Local people were fishing in the lake.
- ❖ The constructed inlet was defective as the opening of inlet was below the existing waste weir. The inlet provided with silt trap, screen barrier *etc.*, was clogged and the excess water was not flowing into the lake.
- ❖ The pollution level was not being monitored by any of the agencies.

Fishing in the lake	Graveyard inside the lake	Inlets opening to the lake below the level of waste weir

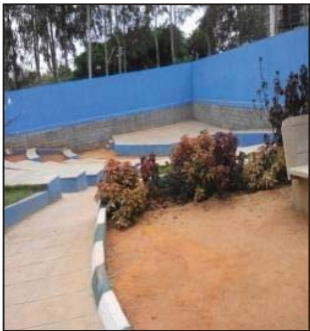
Amphitheatre inside the lake	Diversion pipeline laid inside lake	Loss of foreshore area due to formation of ring bund in the lake

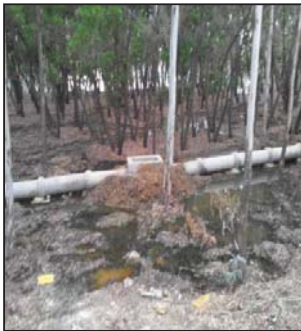
- ❖ The Sarjapura main road is passing through the lake bund, thereby reducing the lake area.
- ❖ Natural flow of rain water/storm water had been restricted to flow through pipeline due to the formation of ring bund.
- ❖ Sewage diversion line was laid inside the water spread area by cutting trees.
- ❖ The foreshore area on the southern part of the lake was being developed into residential complex, breaching the buffer zone.
- ❖ An open amphitheatre was constructed in the lake bed, reducing the lake area.
- ❖ KSPCB (November 2013) classified the quality of water of lake as “E” category, which was below the prescribed standard “B” for outdoor bathing in developed lakes.
- ❖ An NGO (MPSMAS) had taken up the responsibility to maintain the lake.

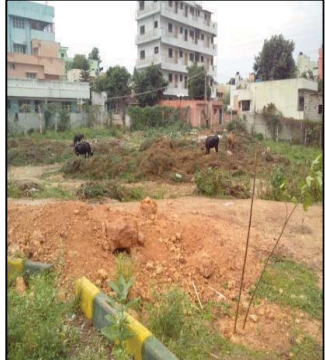
- ❖ The natural wetland was encroached by the ITI factory and a road was formed in the centre as a connecting route to K.R. Puram.
- ❖ The lake is spread over 55 acres 5 guntas and half of the lake area had been encroached upon by a college, slum, residential layouts, road, market, *etc.* The conservation and restoration works were, therefore, carried out only in the remaining area of 20 acres and 35 guntas.
- ❖ The lake was full of weeds which was removed and dumped alongside the pathway.

<p>Removed weeds dumped alongside the pathway</p>	<p><i>Raja Kaluve</i> with sewage and solid waste</p>	<p>Blocked silt traps/sedimentation tanks without water entering the lake</p>

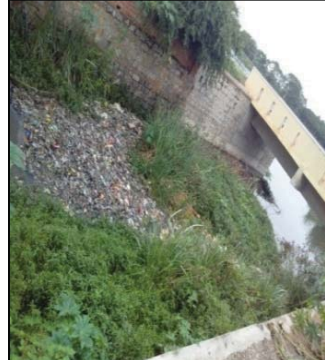
- ❖ The silt traps/sedimentation tanks were blocked, thus disallowing any inflow into the lake and instead the *Raja Kaluve* (SWD) with sewage and solid waste was flowing from the surrounding settlements into the lakes, thereby polluting the lake.
- ❖ The pollution level was not being monitored by any of the agencies.

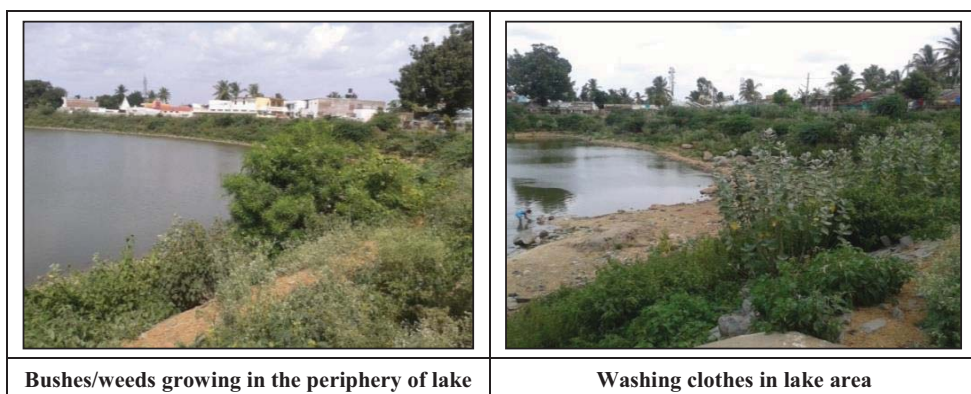
- ❖ Due to non-maintenance, the lake periphery and the bund were full of bushes/weeds as shown in the photograph below.
- ❖ Open defecation was prevalent and clothes were being washed in the lake polluting the lake. This was shown in the photograph below.
- ❖ KSPCB categorised the water quality as “D” which did not conform to the required standard of “B” class.
