CHAPTER – II (SECTION A): COMPLIANCE AUDIT

RURAL DEVELOPMENT DEPARTMENT (RURAL WORKS AFFAIRS)

2.1 Implementation of *Mukhya Mantri Gram Setu Yojana* in Jharkhand

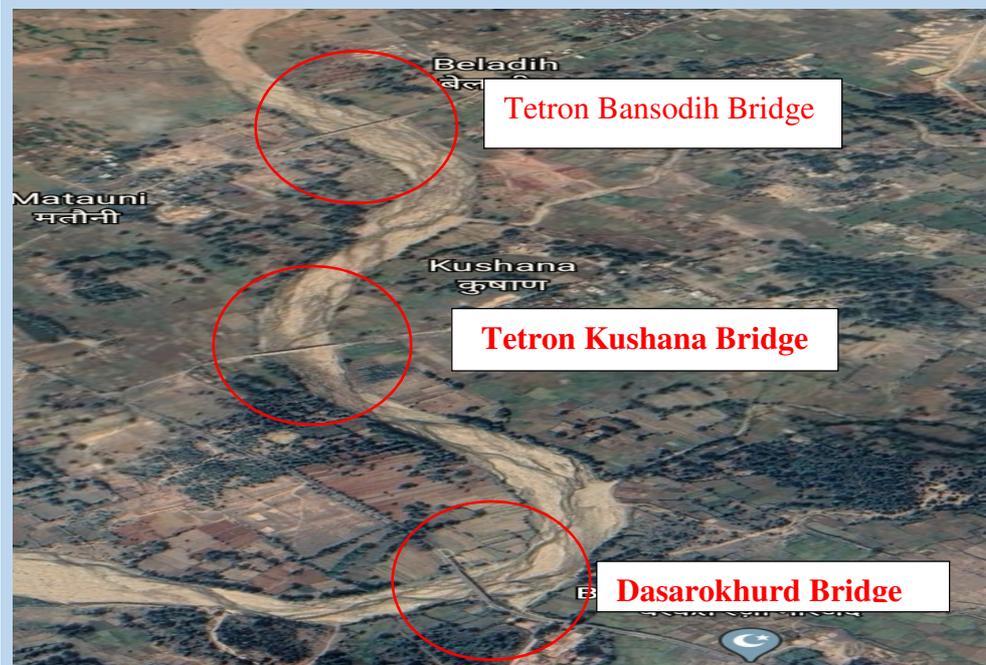
During joint physical verification (28 February 2020), Audit noticed that the distance between the first two bridges (*Tetron-Bansodih* and *Tetron-Kushana*) was one km and the last two bridges (*Tetron-Kushana* and *Dasharokhurd- Parsabad* railway station) was 500 metres. These three completed bridges were providing connectivity to the same habitats of nearby locations. The following satellite picture taken by Audit from *Google Earth* using coordinates of the bridges clearly shows the adjacent bridges.

Picture 2.1: Google Earth image of Tetron-Kushana and adjoining bridges (Joint physical verification done on 28 February 2020)

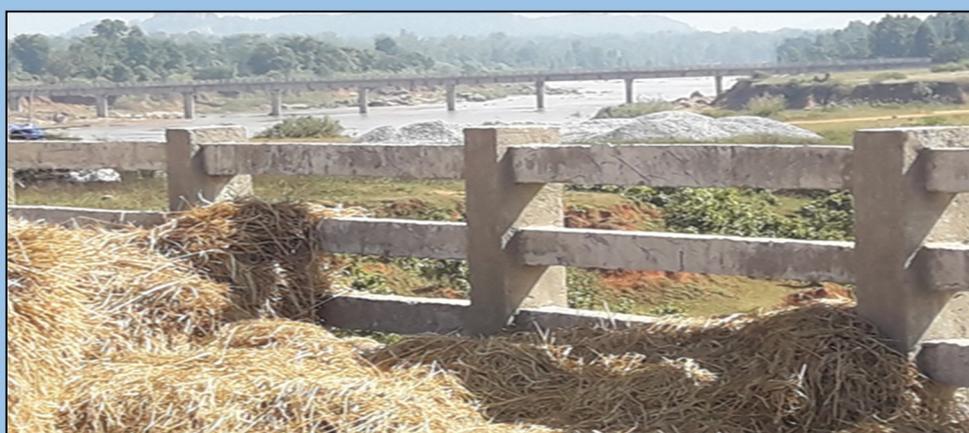
In a span of four years (2011-14), the Department sanctioned two bridges on *Shankh* river in Raidih block of Gumla district for connecting habitats of same location under MMGSY (March 2011 at a cost of ₹ 4.14 crore) and PMGSY (June 2014 at a cost of ₹ 6.71 crore). During joint physical verification (19 November 2019), Audit noticed that the PMGSY bridge was under the DRRP, and was being utilised. The MMGSY bridge on the other hand was not under DRRP and had remained incomplete (November 2019). The distance between the two bridges is only 500 metres. The Department had incurred an expenditure of ₹ 2.20 crore on the bridge which could not be completed in more than nine years and proved unfruitful.

Picture 2.2: Incomplete MMGSY bridge and complete PMGSY bridge at a distance of about 500 m at *Khursurta* and *Bardih* in Gumla district (Joint physical verification done on 19 November 2019)

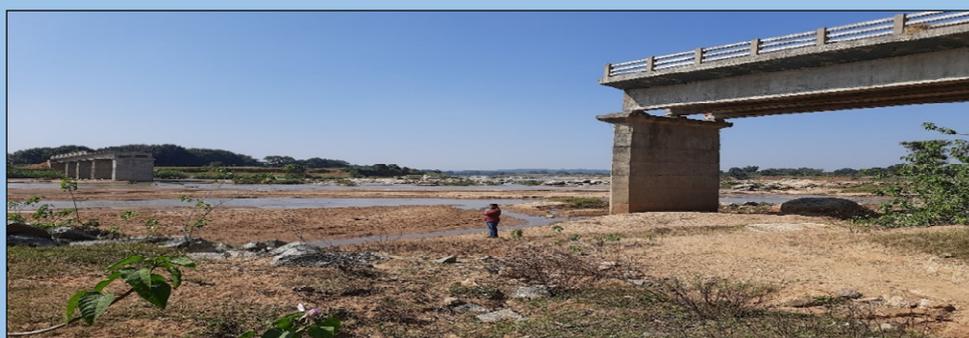
Picture 2.3 : Incomplete MMGSY bridge at *Khursurta* and *Bardih* in Gumla district from a different angle

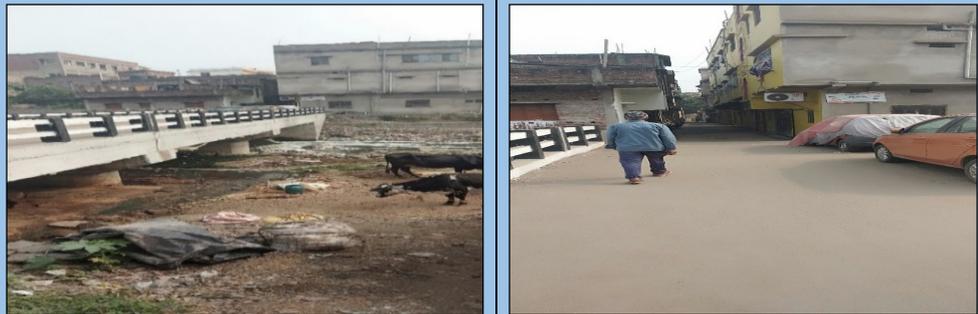
The Department sanctioned (July 2018 at a cost of ₹ 1.13 crore) a bridge under MMGSY over an urban river in *Matkuria*, Dhanbad on the recommendation of the local MLA. During joint physical verification (27 November 2019), Audit noticed the carriage way of the bridge was obstructed (1.5 metres out of total carriage width of 5.5 metres) by pre-existing buildings in the alignment of the bridge. Thus, the bridge was not suitable for heavy vehicles and was being mainly utilised for parking purposes and as cattle sheds as shown in photographs below:

Picture 2.4: MMGSY bridge in urban area of Dhanbad city and existence of buildings in the alignment of bridge (Joint physical verification done on 27 November 2019)

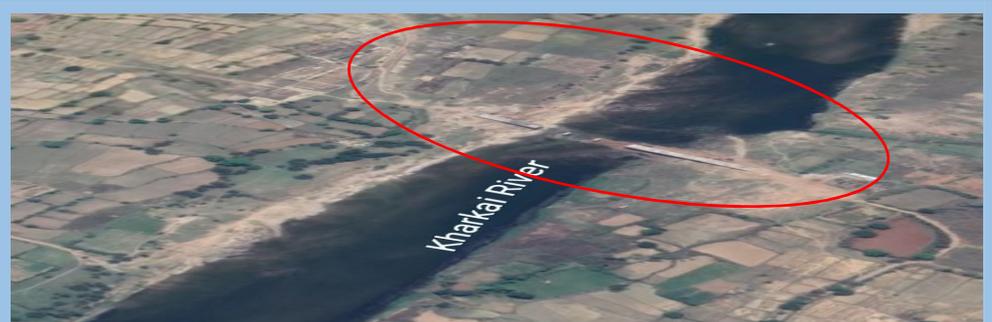
A bridge under MMGSY over *Kharkai* river between *Hudgangada* and *Dharmadiha* village in Saraikela- Kharsawan district was sanctioned (December, 2016) by the Department at a cost of ₹ 4.88 crore. The location of the bridge was not found on DRRP. Audit verified the geographical coordinates of the bridge site (22°38'14.4" N, 85°52'52.8" E) on *Google Earth* and found no connecting roads ahead of the approach roads of the bridge. This fact was confirmed during joint physical verification (7 January 2020) with the departmental engineers.

Picture 2.6: *Google Earth* image (Coordinates-22°38'14.4" N, 85°52'52.8" E)

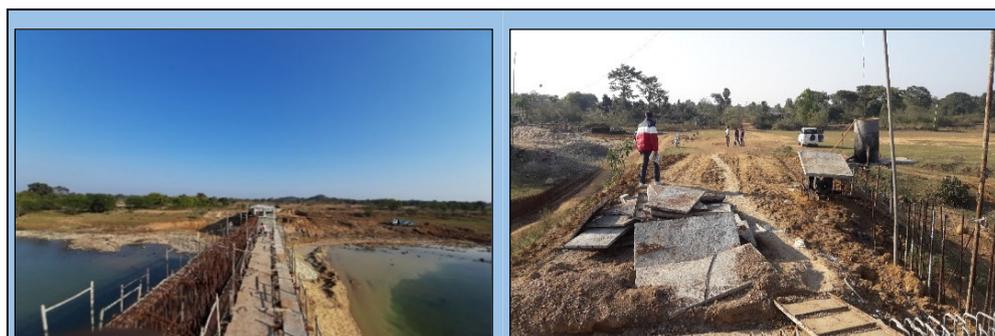
Picture 2.7: Photograph taken during joint physical verification on 7 January 2020

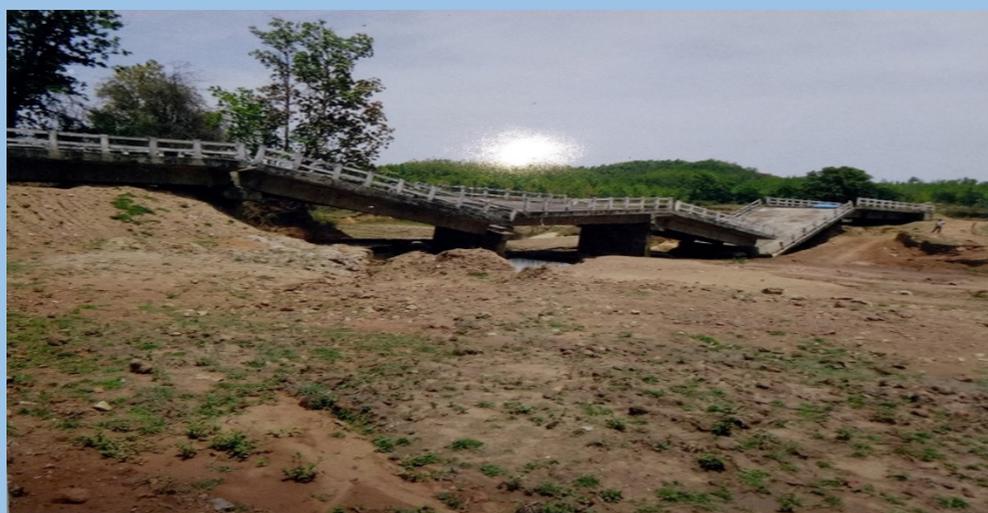
In Gumla district, a bridge under MMGSY over *Charki* river between *Natwal-Dina Road*, completed in May 2012 at a cost of ₹ 1.16 crore, collapsed in February 2017. Audit noticed that in the DPR of the bridge, open foundation was provided for two abutments and five piers of the bridge on the basis of soil investigation of only four boreholes against the requirement of nine. The depth of these boreholes which ranged between 0.95 metres and 1.38 metres were also short. After collapse of the bridge, the enquiry committee noticed (August 2017) that the river bed was sandy and river water was flowing below the four foundations. As a result, soil below the foundation scoured and the bridge collapsed. Thus, at the time of designing the bridge, nature of soil was not properly investigated and provision of open foundation which was not suitable for sandy soil was made in the DPR.

Picture 2.8: Photograph of collapsed bridge over *Charki* river between *Natwal-Dina Road*.)

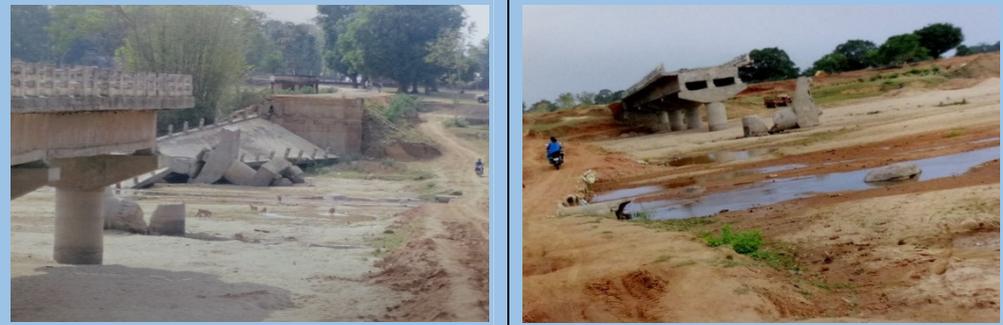
A bridge under MMGSY over *South Koel* river between *Balkhatanga-Lorengo road* in Sisai block of Gumla district was completed in September 2010 at a cost of ₹ 2.95 crore. The bridge collapsed in July 2017 as four piers and five deck slabs were completely washed away due to heavy flow of water in the river. The enquiry committee reported (August 2017) excessive flow

of water as the *prima facie* cause of the damage. Audit noticed that in the DPR of the bridge, open foundations were provided for two abutments and nine piers of the bridge on the basis of soil investigation done in only three boreholes against the requirement of 13. Thus, designing of foundation type was done without conducting soil investigation as required.

Picture 2.9: Photograph of collapsed bridge over *South Koel* river between *Balkhatanga-Lorengo* road in Sisai block

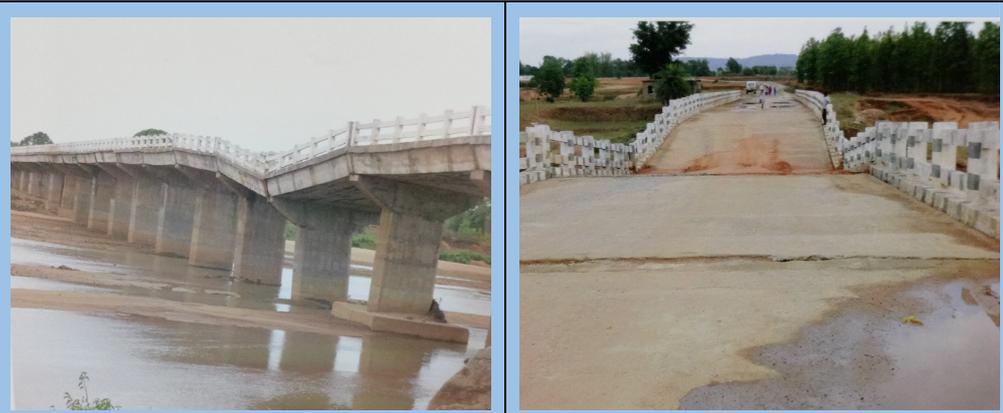
In Gumla district, a bridge under MMGSY over *Sankh* river between *Mariyam toli-Sarnatoli* in Raidih block was completed in March 2015 at a cost of ₹ 3.89 crore. The bridge was damaged in July 2017 as two piers sank and three slabs tilted. The enquiry committee reported (August 2017) that the *prima facie* cause of the damage was excessive sand excavation. Audit noticed that in the DPR of the bridge, open foundations were provided for two abutments and 19 piers of the bridge on the basis of soil investigation done in only four boreholes against the requirement of 23. Thus, designing of foundations were not backed by required soil investigation as stipulated by MORTH.

Picture 2.10: Photograph of damaged bridge over *Sankh* river between *Mariyam toli-Sarnatoli* in Raidih block

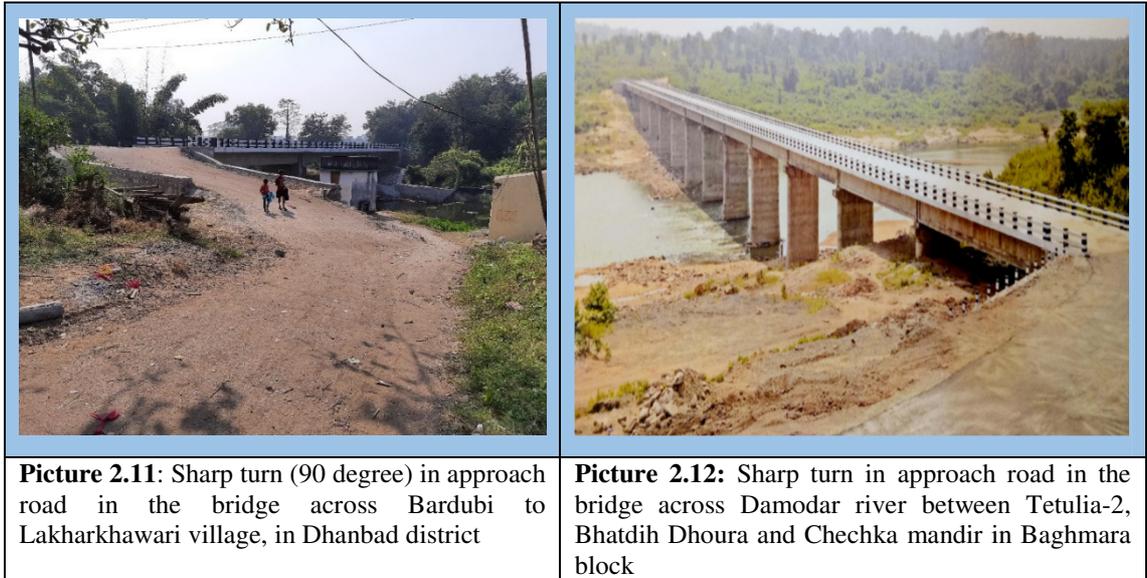
In six test checked districts, sharp curves (up to 90 degree) at the entry/exit point of 16 bridges and shorter width (3.75 metres to 4.1 metres) of approaches in comparison to width of bridges in 28 bridge works were found. These design faults made the areas accident prone in the absence of clear vision and also slowdown in traffic while entering and exiting the bridges.

In reply, the Department stated (February 2021) that due to involvement of private land in approaches it was not possible to give straight approach roads and these limitations were mitigated through moderate curve and curve protection works. The reply was not factually correct as the approach roads were almost at right angles as could be seen in the photographs above taken during joint physical verification with the auditees in violation to IRC provisions of road safety. Further, availability of required land was not ensured before taking up the work as per rule.

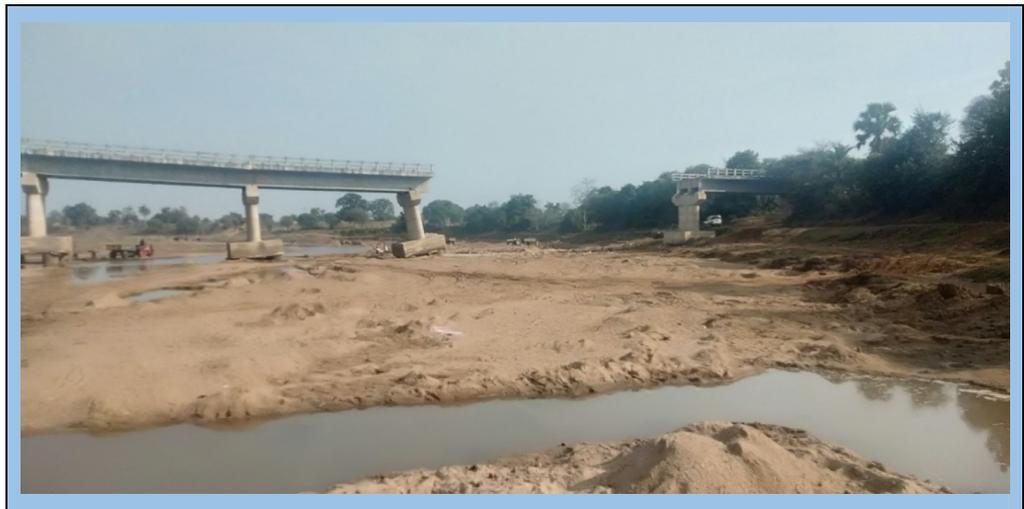
In Pakur, a 13 span bridge across *Bansloi river*, constructed (June 2015) at a cost of ₹ 5.98 crore for connecting *Chandalmara and Ghatchhora* collapsed on 30 September 2019. The Committee headed by CE reported (December 2019) that pier P10 along with two slabs (between P9-P10 and P10-P11) had dislodged and fallen down (shown in photograph below) due to execution of shorter depth of pile foundation than actually envisaged in the DPR, inferior reinforcement in pile and sand excavation near bridge.

Picture 2.13: Damaged spans of bridge over Bansloi river in Chandalmara in Pakur district

- a) Length of one of the exposed piles of P10 was only 4.7 metres but the length recorded in the MB for this pile was 10.96 metres.
- b) As per bridge design, the pile cap¹⁰ and pile shall be below the river bed. However, the piles (1-1.5 metres) of other standing piers were visible below the pile cap. The committee attributed this fault to sand excavation.
- c) Instead of 25 numbers of vertical reinforcement (recorded in MB), only 24 numbers of vertical reinforcement was found in the exposed pile of P10.

- Utilisation of unapproved specifications of steel¹¹ in bridge foundation and brick soling under exposed pile cap of P9.
- The bridge was designed for socketing of pile (by 1.4 metres) in hard rock layer and bridge structure was protected against the scour in upper layer. The Committee had reported that length of pile was shorter than the design depth. As a result, socketing of pile in hard rock was not done by the contractor. Thus, failure of the EE to ensure socketing of piles to the desired depth by the contractor was instrumental in the damage of the bridge.

Thus, the fundamental reasons for damage of the bridge were non-socketing of pile in rock layer due to shorter depth of pile foundation, construction of shorter length of shaft and utilisation of inferior quality steel. This resulted in sub-standard execution and expenditure of ₹ 5.98 crore proved wasteful.

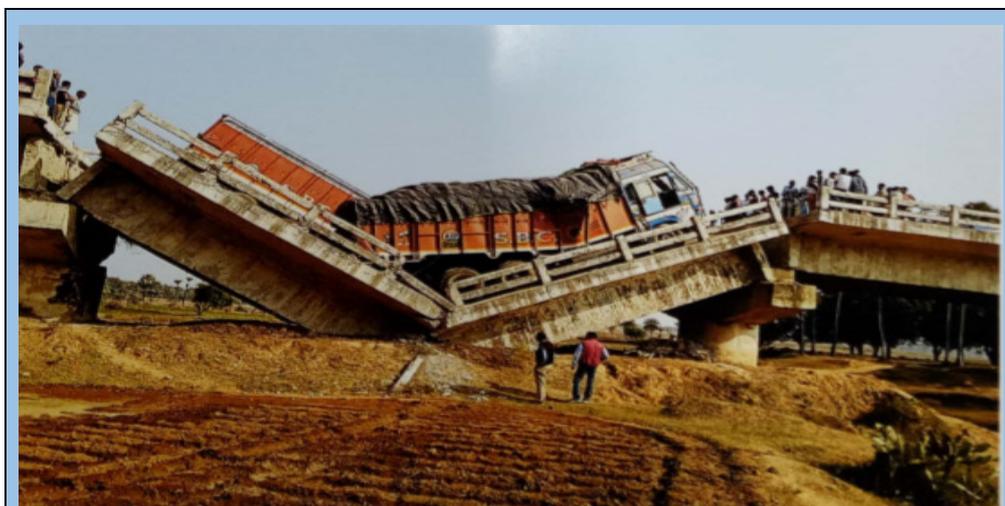
In Godda, a six span bridge across *Khatti river* costing ₹ 4.40 crore was constructed (March 2016) for connecting *Kanhai Pakaria* village and *Karra* village. Audit noticed that a span of the bridge was damaged (December 2018) when two loaded trucks were passing over it.

Picture 2.14: Damaged span of bridge over Korka to Pakaria road in Pathargama block of Godda district (Photo taken from files of the division)

Scrutiny of image taken (8 August 2019) from *Google Earth* and report of the Superintendent Engineer revealed that the broken portion of the bridge (deck slab and girder) was actually located between Pier 4 and Pier 5 but the Committee headed by CE reported (December 2018) that the broken portion of

bridge was between Pier 1 and Pier 2 (the other end). The Committee stated that the damage was due to inferior quality of concrete work in the girder.

Audit noticed design fault in the DPR. As per the DPR, the Pier piles were designed for socketing to 0.6 metres inside the rock layers for resistance. However, the pile foundation of Pier 5 was designed to terminate in soil layer which was 1.973 metres above rock level while the other piers were to be socketed to the desired depth.

Instead of examining and reporting the real cause of damage to the bridge, the CE reported damage to the girder over pier P1 and pier P2 as the main cause of collapse of the bridge. The main aim of misreporting was to conceal the fact that the pile of Pier 5 was not designed to be socketed to the desired depth which might have been instrumental in the sinking of Pier 5 and collapse of the bridge and needs further investigation.

The Department stated (February 2021) that the damaged portion of the bridge have now been reconstructed by the contractor and that the EE, AE and JE were suspended and the contractor blacklisted.

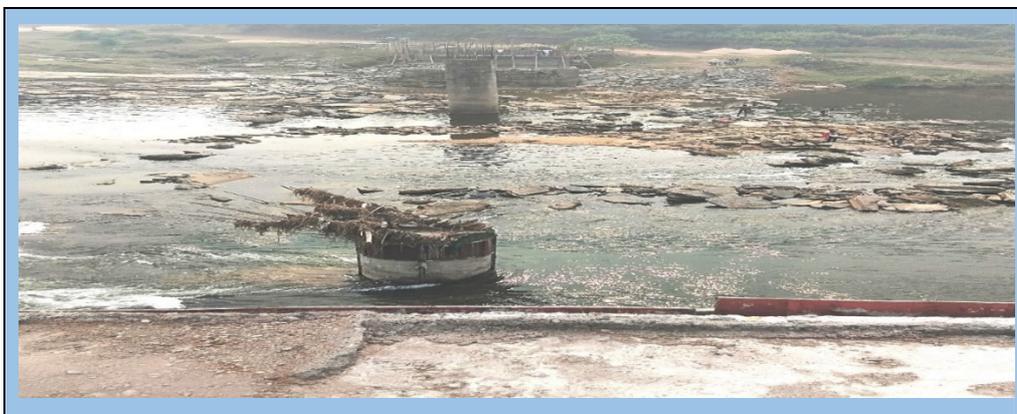
Upon fresh tendering (February 2017), the Department allotted (May 2017) the balance bridge work at ₹ 4.89 crore to the same contractor who had executed substandard works earlier. The work was to be completed by November 2018. Scrutiny of MB revealed that the contractor again executed substandard works in the superstructure where four deck slabs over piers- P4 to P8 was constructed without dismantling 2.5 metres from the upper side of the shafts. Till date of audit (March 2020), the work was incomplete as shown in the photograph below:

Picture 2.15: Partly constructed substructure P9, P11, old A2 (to be dismantled) and under construction A2 in bridge over Damodar river between *Gansadih-Suyiadih* road in Dhanbad

Thus, the Department failed to provide connectivity through the bridge after more than 11 years of commencement of work due to change in work site, execution of substandard works, delayed resumption of stalled works etc. This also led to cost escalation of ₹ 2.12 crore besides compromising the structural stability of the bridge.

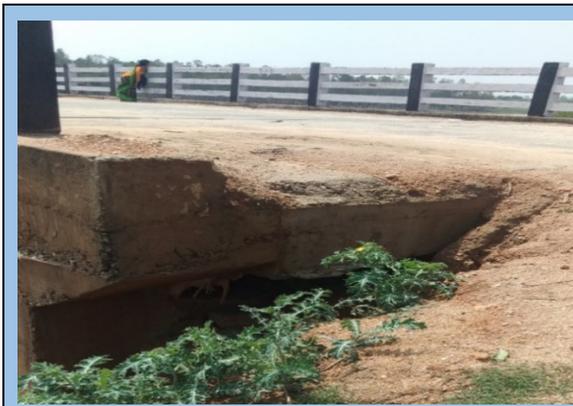
- six bridges required urgent repair and maintenance due to scouring in foundation;
- in four bridges, wear and tear in expansion joints and wearing coat were noticed;
- in two bridges, cracks in RCC works of approach slab were found;
- elastomeric bearing of one bridge was damaged;
- eight bridges have damaged approach roads or flanks at the entry/exit points which makes them accidents prone.

Picture 2.16: Washed away approach in the flank near approach slab in bridge across Amanat river between Saraiya-Jhalkhandi, block Panki of Palamu district

- The Department should conduct a Safety Audit of all the bridges in the State and carry out necessary repair and maintenance work. Bridge registers should be maintained and schedule of repairs should be recorded. The load bearing capacity of each bridge should be clearly displayed at its entry/exit point.

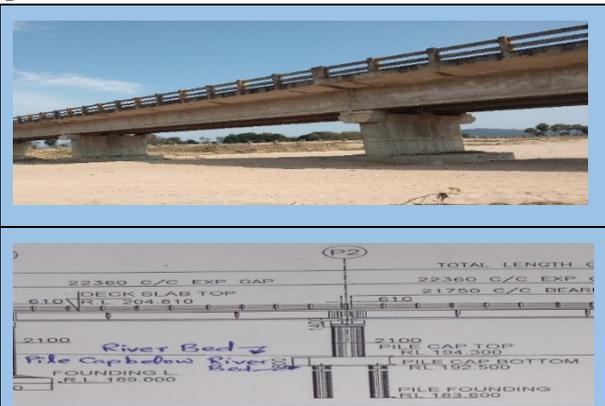
Picture 2.17: Pile cap visible due to scouring in bridge foundation in bridge across Sakri river between Marchoi and Basodih, block Satgawan of Koderma district

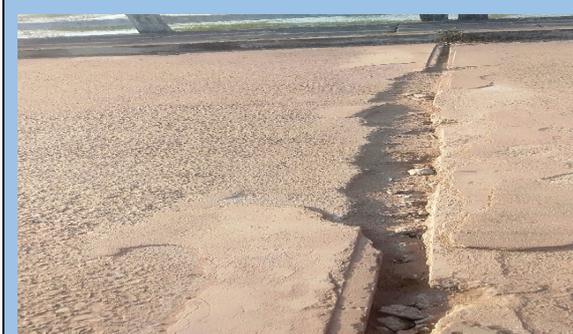
Picture 2.18: Absence of expansion joints in bridge across Swarnrekha river between Khokro-Karkidih road in Ichagarh block of Saraikela district

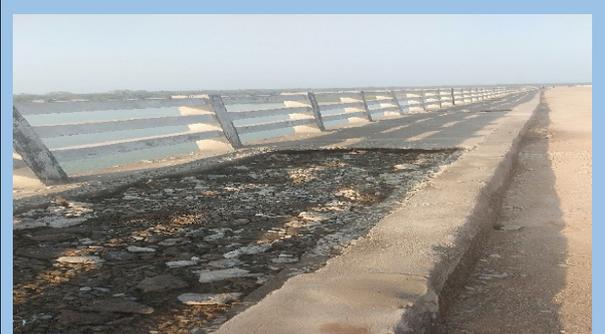
Picture 2.19: Broken slab in footpath in bridge across Swarnrekha river between Khokro-Karkidih road in Ichagarh block of Saraikela district
