## Chapter 4: Post clearance monitoring and enforcement of CRZ Notifications

## **4.2 Enforcement of CRZ provisions**

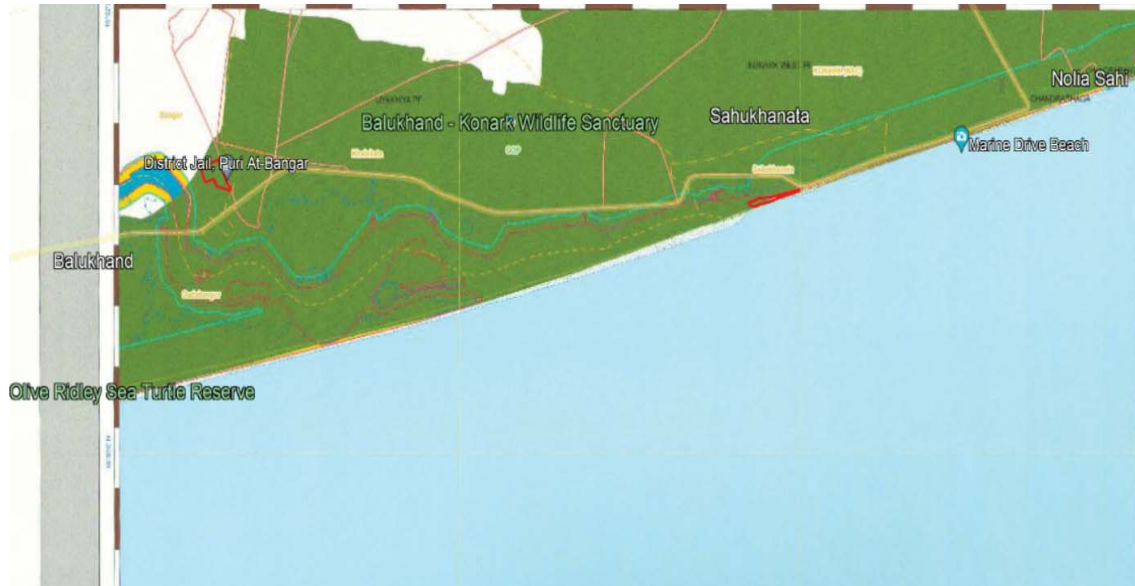
Audit observed irregular construction of a jail complex in CRZ 1A area located at Bangar in Puri district, Odisha. The construction was inside Balukhand-Konark Wildlife Sanctuary, which

also has Olive Ridley Turtle nesting sites on the beaches. The figures below indicate the approved CZMP for the area and the satellite images obtained by audit for the area in December 2020.

Fig. 4: CZMP for the coast around Balukhand sanctuary and Turtle reserve, indicating CRZ 1A zone in green shade and irregular construction is marked in red

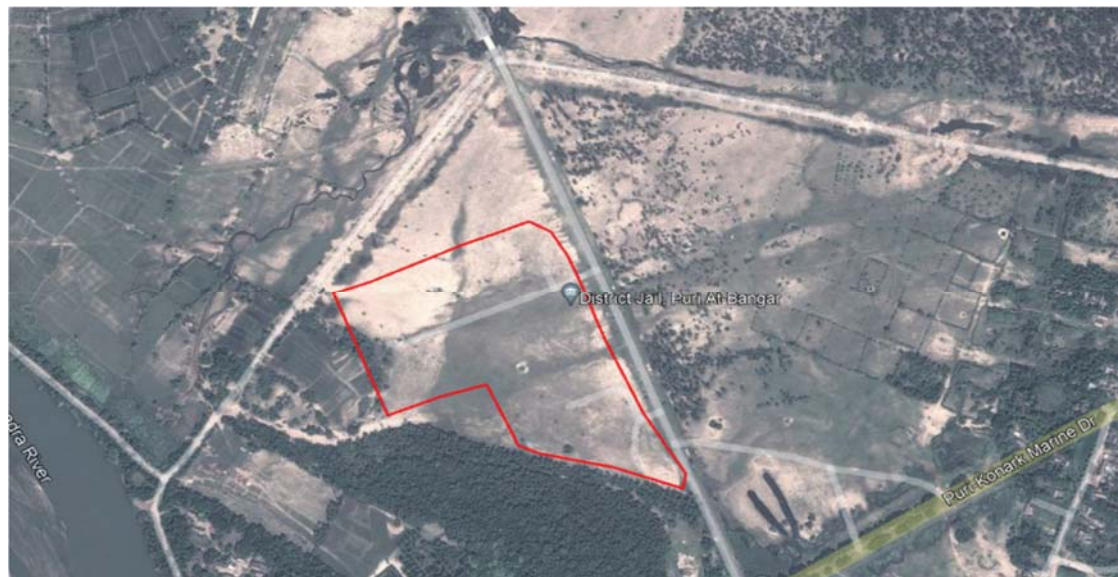
Further, satellite images obtained by audit below indicates that there was no construction in the area in 2011.

Fig. 5: Satellite Image (October 2011) of area before construction of jail complex showing empty land within the red marked area

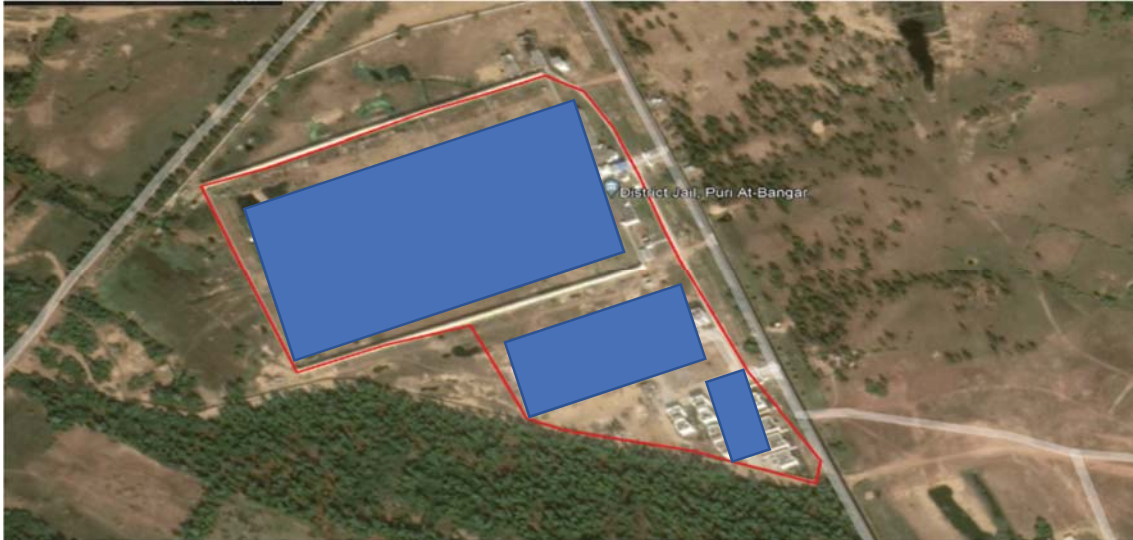
Fig. 6: Satellite Image (December 2020) of jail complex at Bangar within the red marked area

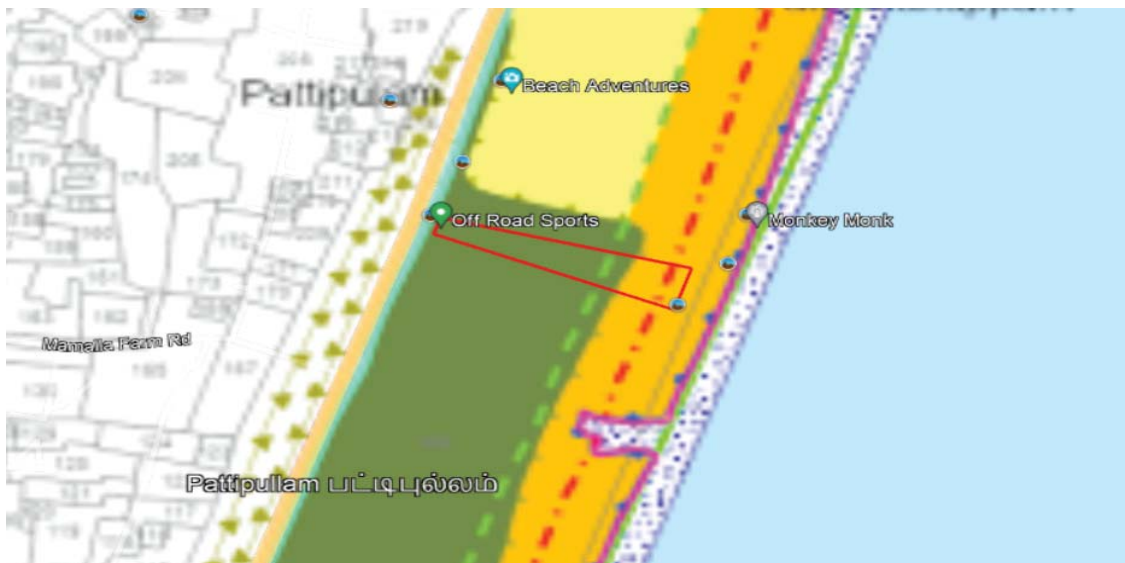
Audit observed that a racetrack was constructed at Pattipulam, Chennai in CRZ 1 area. The figures below indicate the approved CZMP for the area and the satellite images obtained by audit for the area in March 2021. As per the approved CZMP, the area where racetrack is constructed (marked in red) falls partly in CRZ 1A area and partly in No Development Zone (NDZ). The satellite images obtained by audit from March 2021 indicates the presence of irregular construction of the racetrack in the restricted area.

Fig. 7: Approved CZMP of Pattipulam area indicating CRZ 1A zone in green shade and NDZ in yellow shade

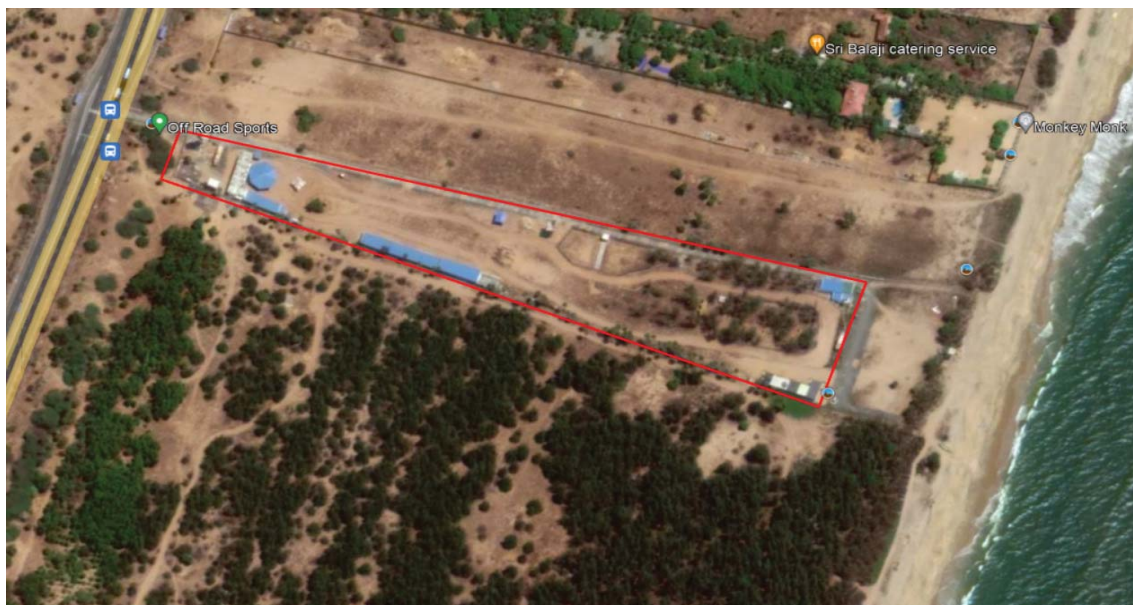
Fig. 8: Satellite image (March 2021) of racetrack constructed in CRZ 1A and NDZ area

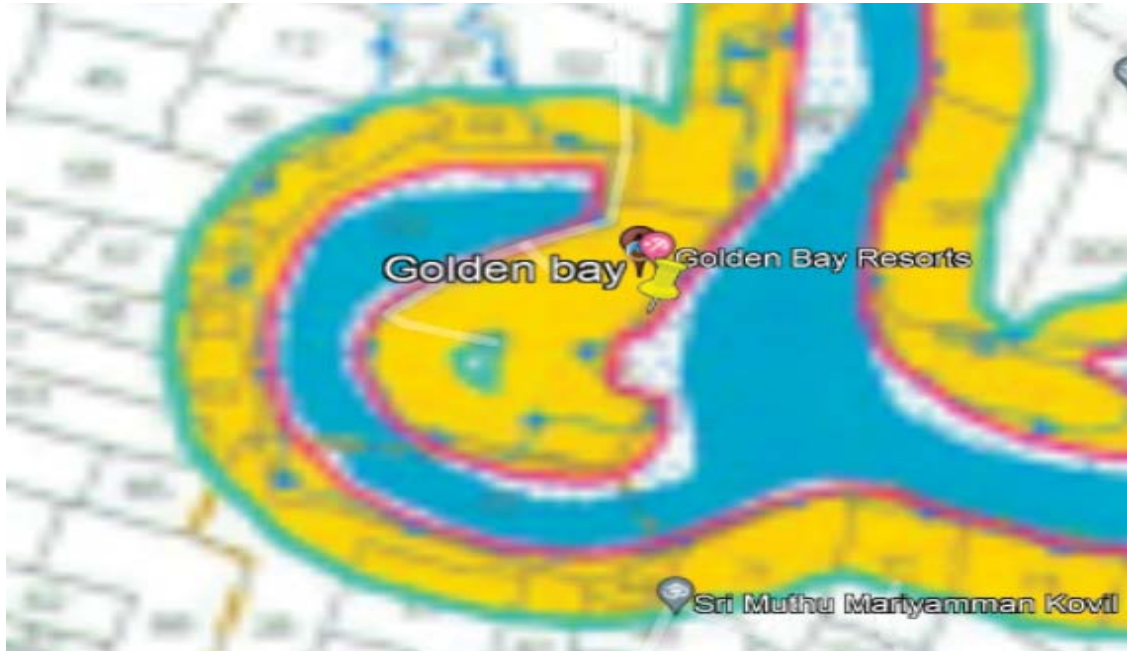
A complaint was received at TN SCZMA about the construction of a resort (Golden Bay Resorts) in No Development Zone in Kuvathur area of Kanchipuram district. The CZMPs approved as per CRZ notification 2011 defines No Development Zone as area upto 200 metres<sup>32</sup> from HTL on the landward side in case of seafront and 100 metres along tidal influenced water bodies or width of the creek whichever is less. Audit assessed the follow up action of TN SCZMA and found that DLC, Kanchipuram district visited the resort and reported to TN SCZMA that the resort has been in operation since 2013 without a valid Consent to Establish Certificate. It was also reported that the resort had been discharging untreated sewage to the sea. TN SCZMA issued show cause notice to the resort in 2017. It was noted that no further follow up action was taken by TN SCZMA as on March 2021. Audit obtained satellite images of the area and compared it with the approved CZMP, as shown below.

Fig. 9: Approved CZMP for the area with NDZ indicated in yellow shade

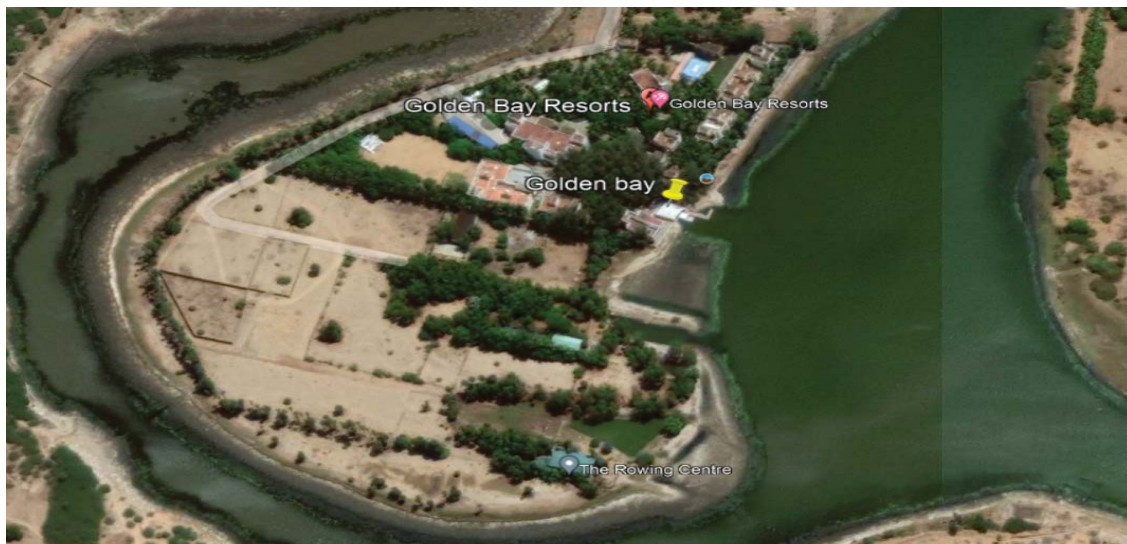
Fig. 10: Satellite Image (October 2021) of the resort in No Development Zone

During JPV by the audit team and relevant officials from the State in March 2021, the presence of the resort as well as a boat jetty was confirmed.

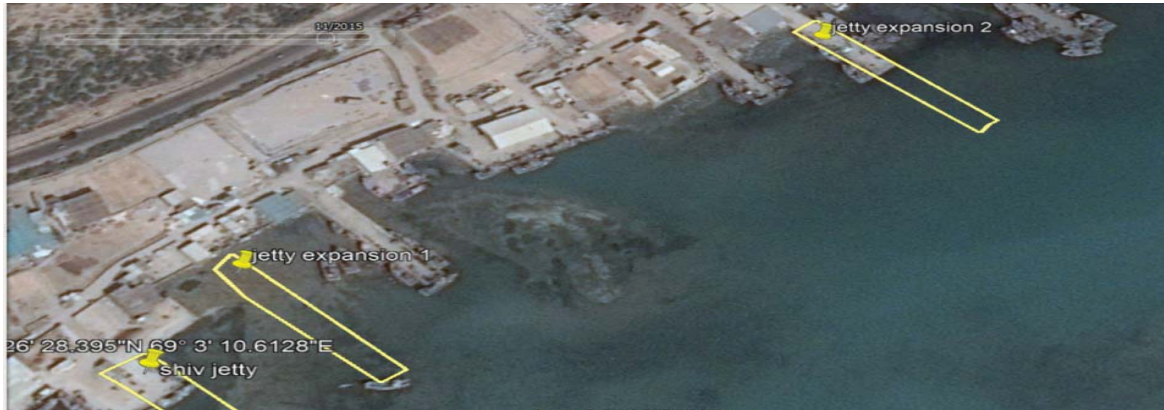
Gujarat SCZMA received a complaint in June 2018 about an irregular construction in Devbhumi, Dwarka and instructed the Gujarat SPCB for site inspection. Gujarat SPCB confirmed the illegal construction of a 30-meter-long jetty and instructed the violators to remove the construction. Audit obtained satellite images of the area as shown below:

Fig. 11: Satellite image (November 2015) of area without jetty extensions in yellow marked region

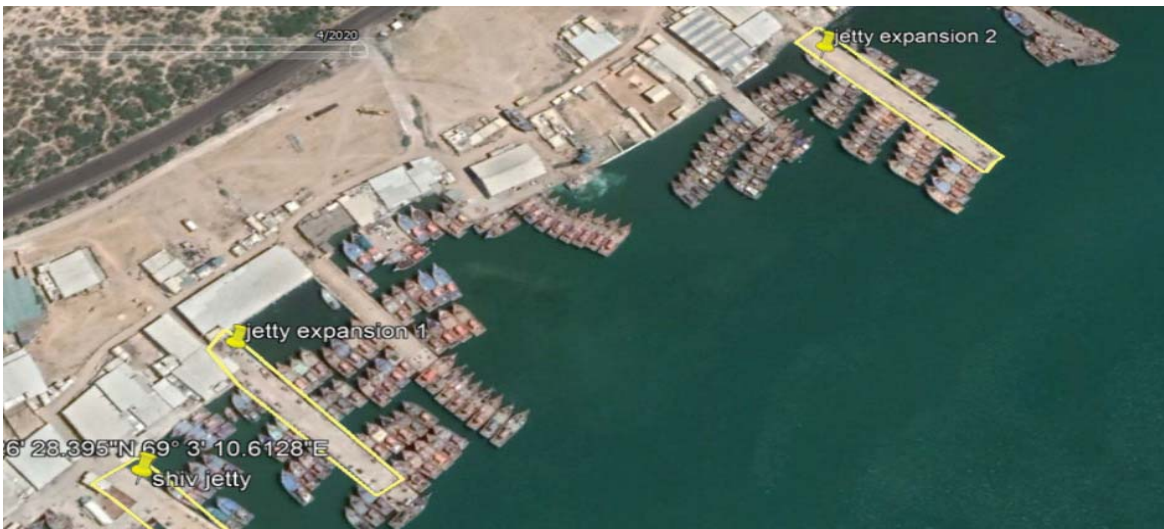
Fig. 12: Satellite image (September 2021) of the jetty extensions

From the images above, it is observed that even though the Gujarat SPCB instructed the violators to remove the construction in 2018, the structure still remains even as of 2021, indicating ineffective follow up on part of concerned authorities.

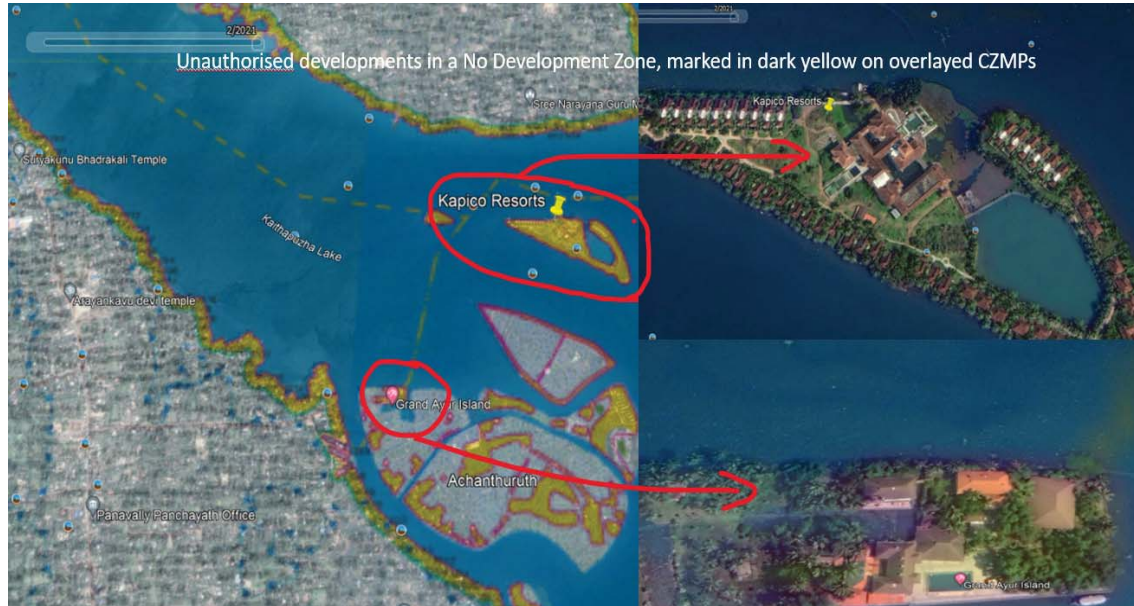
the project area, audit identified another resort, Grand Ayur Island in Anjuthuruthu island in Panavally panchayat, Alleppey district. These islands formed a part of No Development Zone in the lake region under CRZ notification. The figures below indicate the approved CZMP for the island area (NDZ indicated in yellow shade) and satellite images obtained by audit for the area indicating irregular construction in No Development Zone.

**Fig. 13: Approved CZMP of the area on left and satellite image from 2021 for the area on right**

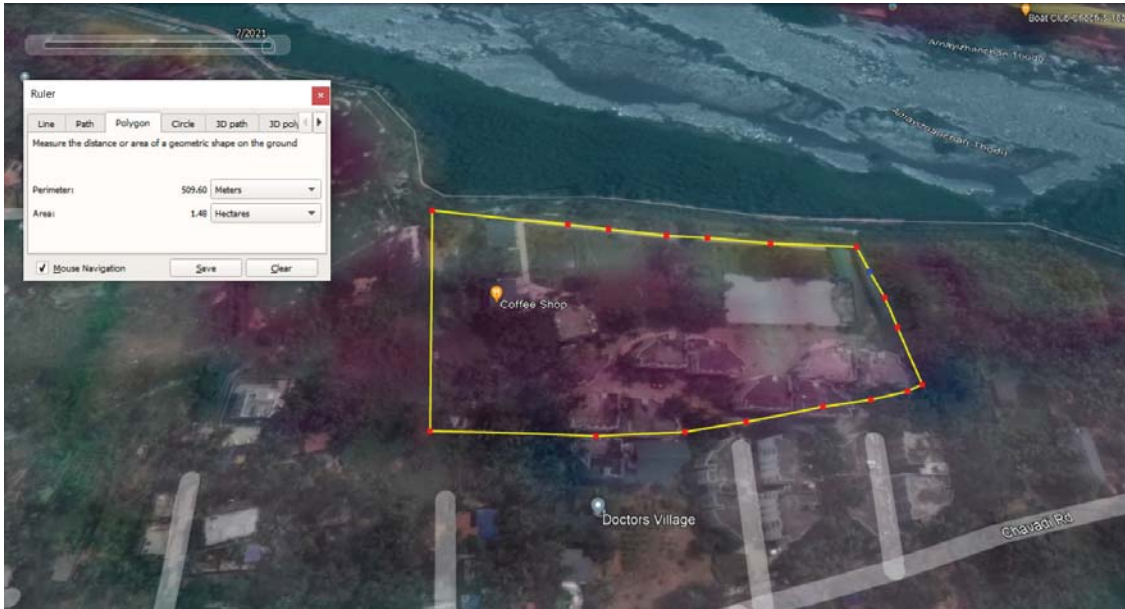
Akkulam lake in Trivandrum is a wetland ecosystem in Thiruvananthapuram, that has continuously been threatened by reclamations and construction activities<sup>34</sup> in the lake region. Audit observed that based on a complaint received by Kerala SCZMA about illegal constructions and reclamation in the Akkulam lake region, Kerala SCZMA directed Municipal Corporation of Thiruvananthapuram to furnish an Action Taken Report (ATR), to which response is still awaited. DLC conducted a site verification September 2020 and found irregular construction in the region. While analysing the satellite imagery of the region, audit found irregular construction of a residential building on the HTL. We observed that the residential complex is constructed around the HTL and an approximate area of 1.48 Hectares falls in the intertidal zone (seaside from HTL). The images for the same are given below:

Fig. 14: Site image in 2021 indicating approx. 1.48 hectares construction in intertidal zone (HTL in purple shade)

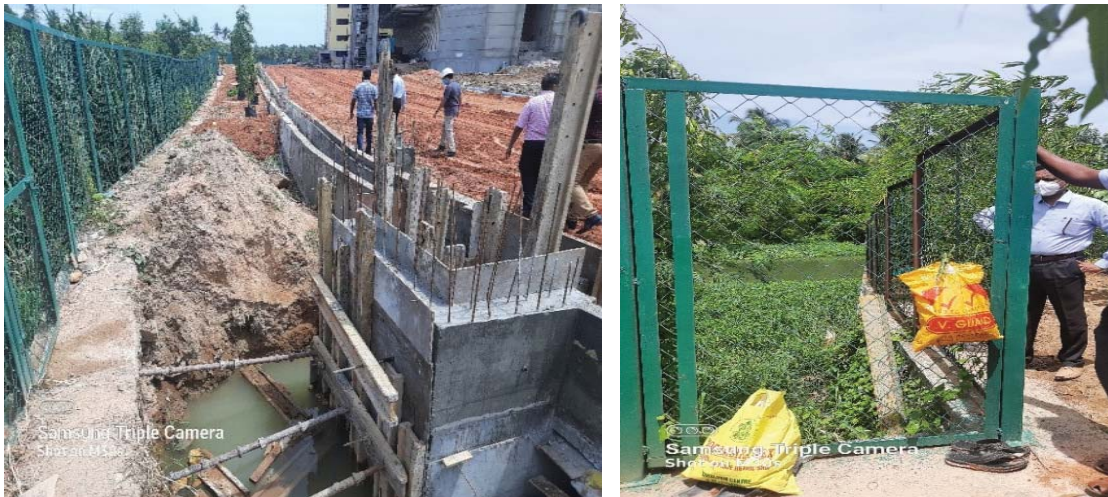
M/s Lulu International Shopping Mall is constructed in the NH Bypass Road near Aakkulam in Thiruvananthapuram. JPV conducted by the audit revealed that the portion of land adjacent to the boundary line with nearby TS Canal falling under NDZ area has been reclaimed and concrete beams and basins for fixing high mast lights were constructed. A stone wall with an average height of three metres with a wire mesh fencing on the top of it was constructed in the CRZ area adjacent to TS canal, as shown in the following photos:

Fig. 15: Images indicating reclamation and construction of stone wall in No Development Zone

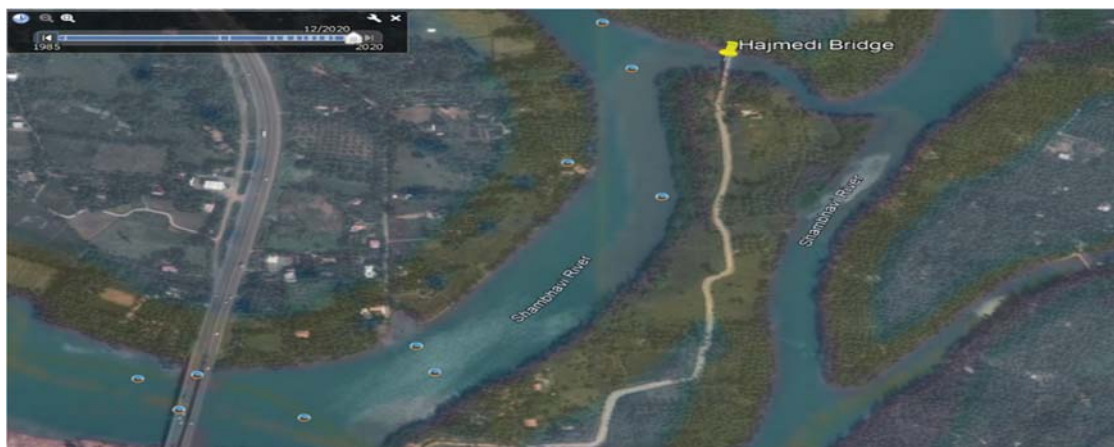
A complaint was received by Karnataka SCZMA about illegal construction of a road in the islands of Shambhavi River. During the site inspection, it was observed that a road and two bridges were constructed without obtaining CRZ clearance. Further, it was reported that

mangrove plantations were destroyed for construction of the road. Though show cause notice was issued to the state works department, no follow up action has been taken by Karnataka SCZMA. The presence of the road was verified by the audit team during JPV. Audit obtained satellite images of the site which clearly show the road as depicted below:

**Fig. 16: Satellite image of the road constructed in the middle of the island (No Development Zone)**

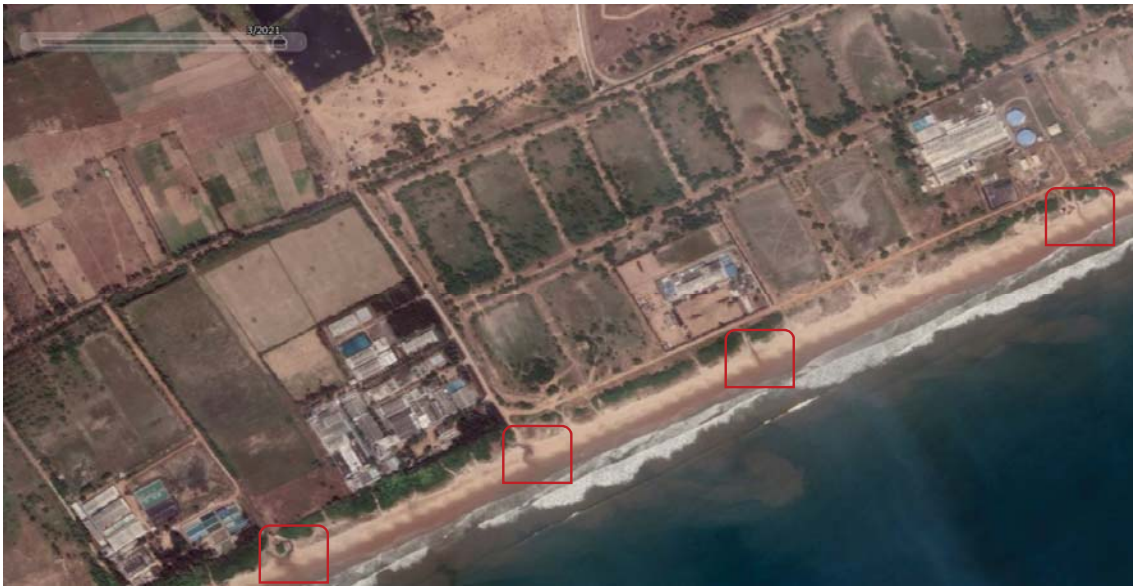
We further observed that APPCB issued show cause notices (March 2018) and closure orders (May 2018) as they did not obtain/renew consent. The firms applied (May/June 2018) for CTOs by claiming ignorance of law and the APPCB granted/renewed consents revoking (May/June 2018) the closure orders subject to condition that they shall not discharge untreated effluents outside the industry premises under any circumstances. Audit obtained satellite images of the area which showed the existence of many hatcheries which were releasing their effluents into the sea.

**Fig. 17: Surrounding area of Gayatri Hatchery on Kothapeta Rural Beach side in East Godavari district, indicating direct release of effluents in the sea by many other hatcheries**

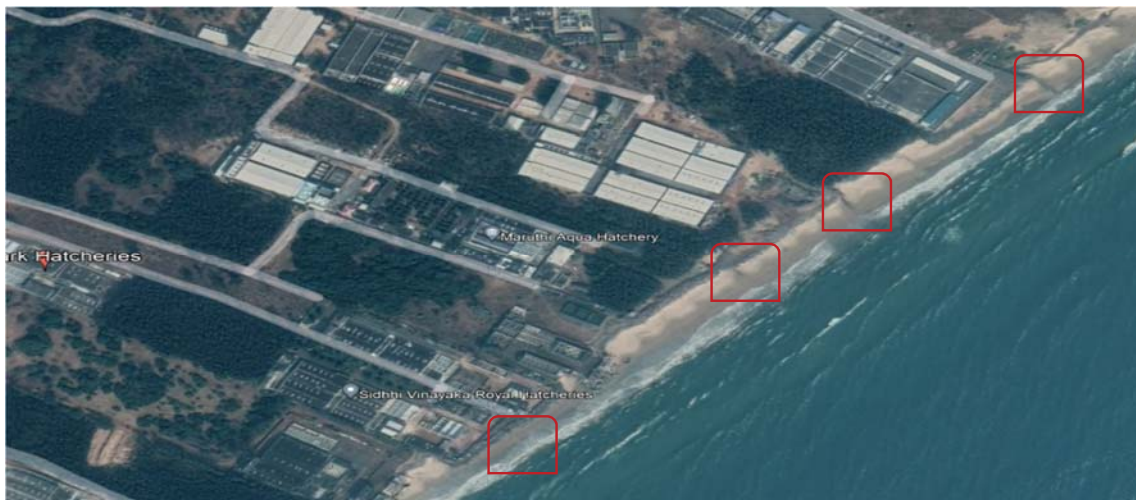
We further examined the aerial imagery of the Konapapapeta beaches in East Godavari district and observed that Konapapapeta beach also has clusters of hatcheries and shrimp farms that release effluents directly into sea as seen in the satellite image from March 2021 below:

**Fig. 18: Presence of many hatcheries on coastline and open discharge of the effluent into sea by hatcheries on Konapapapeta beach, East Godavari district.**

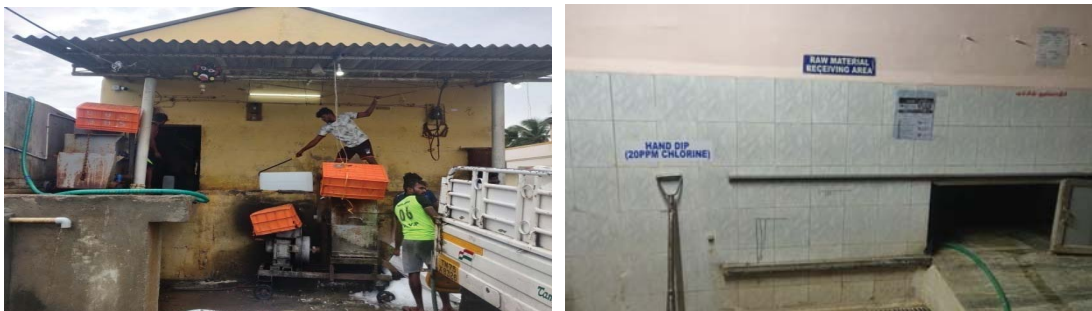
Setting up and operation of ice plants in CRZ areas require CRZ clearance. We noted cases of ice plants operating in Kanyakumari district without obtaining CRZ clearances. During JPV, it was observed that a fish packing unit was operating within the premises of an ice plant. The activities were irregularly granted clearance by DLC, Kanyakumari. TN SCZMA in August 2020 directed DLC, Kanyakumari to take penal action against the violation and report on the same. It was noted that DLC is yet to take any action in this regard till March 2021.

Fig. 19: Pictures taken during JPV for unauthorised operation of Ice plant and Fish Packing unit

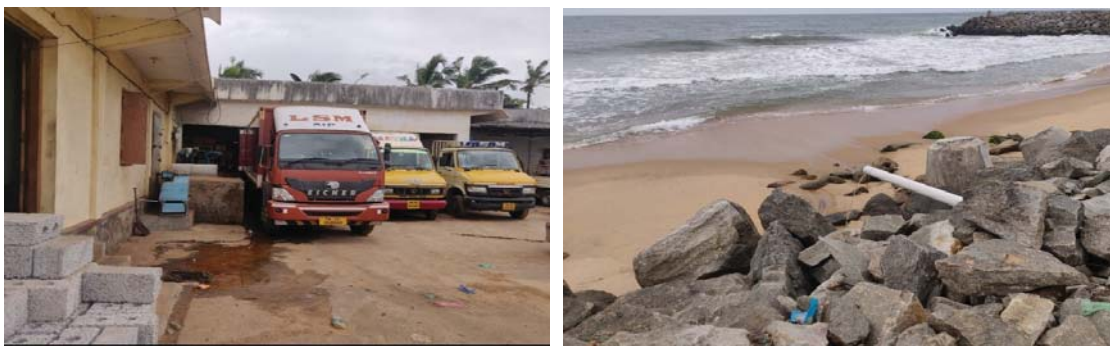
Another instance of irregular operation of an ice plant was noted in Kanyakumari district, where the plant discharged wastewater directly to the sea. It was also found that the ice plant was drawing ground water, violating provisions of CRZ notification. Though TN SCZMA directed DLC to take penal action, DLC was yet to take any action in this regard.

Fig. 20: Pictures taken during JPV for open discharge of wastewater to sea by the Ice plant
