## Chapter III : Use of Technology

### **3.1 Non-utilisation of satellite images to detect and prevent illegal mining activities**

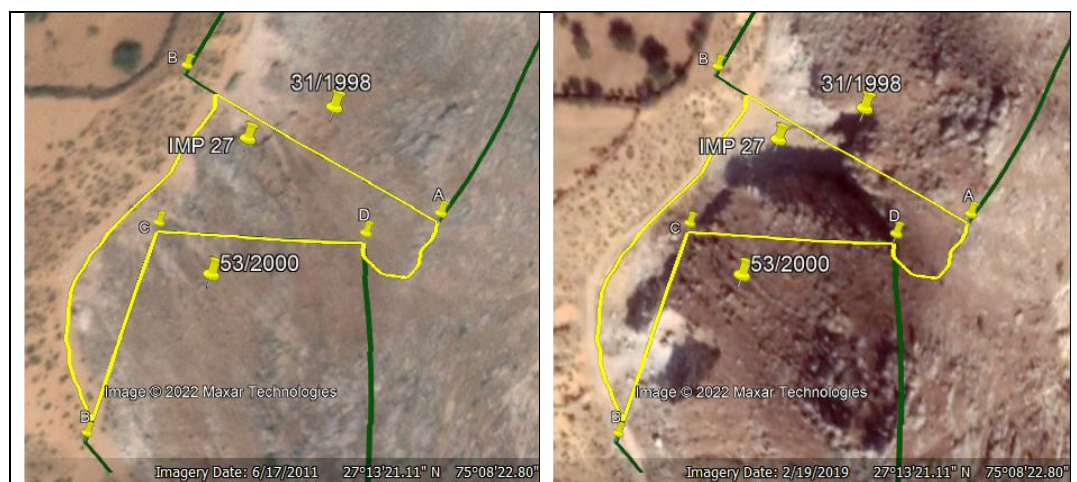
**Figure 1:** Comparison of Satellite Imagery taken on 17.06.2011 and 19.02.2019 showed the illegal mining in 0.44 hectare of land outside the lease area (lease number 53/2000 and 31/1998, ME Sikar).

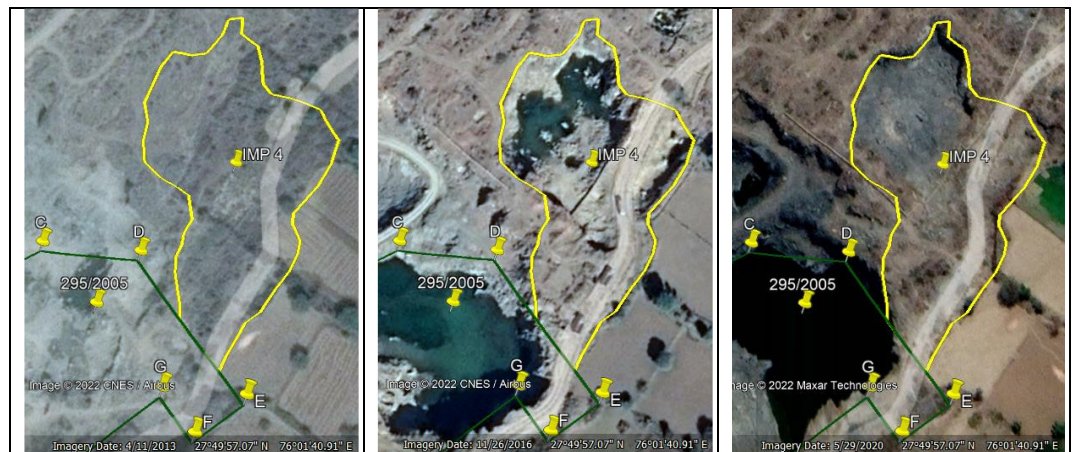
**Figure 2:** Analysis of Satellite Imagery taken on 11.04.2013, 26.11.2016 and 29.05.2020 revealed continuous illegal mining in 0.92 hectare adjoining the lease number 295/2005 (AME Neem ka Thana).

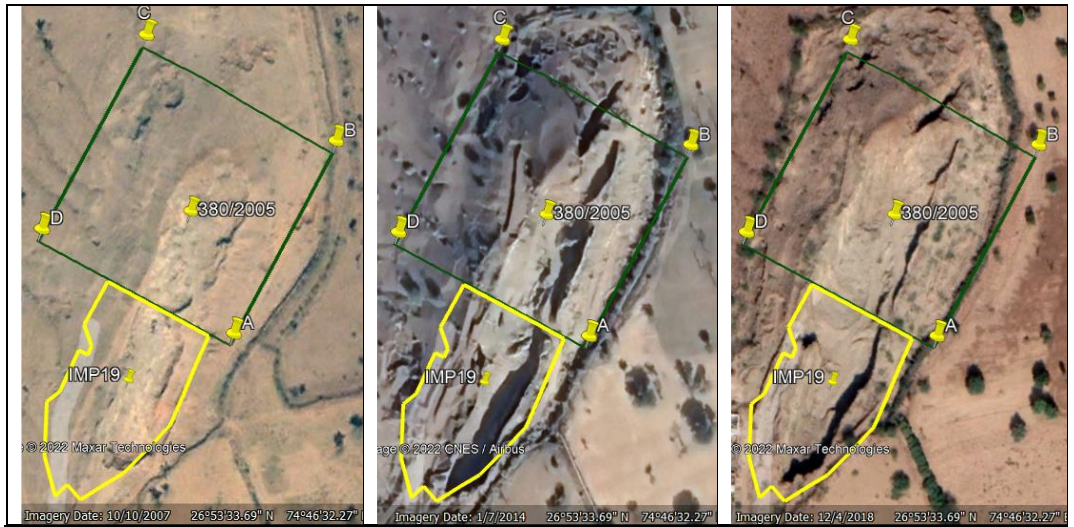
**Figure 3:** Analysis of Satellite Imagery taken on 10.10.2007, 07.01.2014 and 04.12.2018 revealed illegal mining in 0.43 hectare area adjoining lease number 380/2005 (ME Makrana).

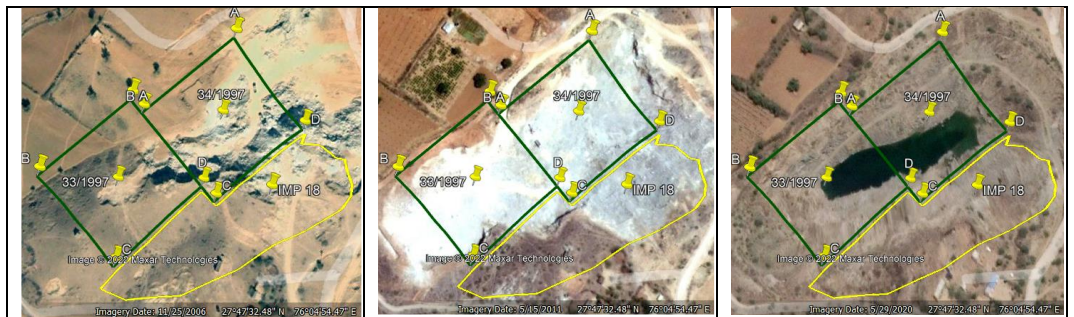
**Figure 4:** Analysis of Satellite Imagery taken on 25.11.2006, 15.05.2011 and 29.05.2020 revealed continuous illegal mining in an area of 1.13 hectare adjoining lease number 33/1997 and 34/1997 (AME Kotputli).

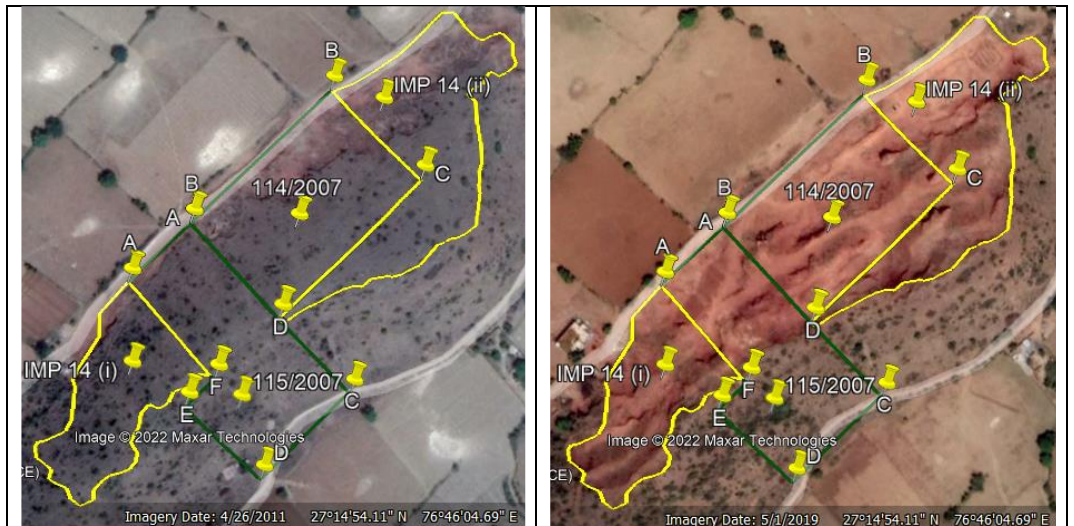
**Figure 5:** Analysis of Satellite Imagery taken on 26.04.2011 and 01.05.2019 revealed illegal mining in an area of 1.63 hectare adjoining lease number 114/2007 and 115/2007 (ME Alwar).

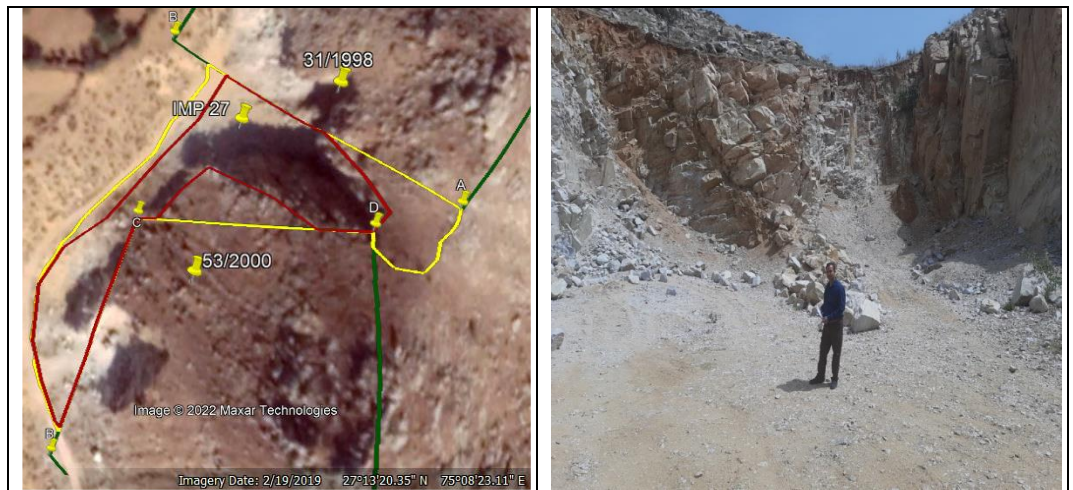
**Figure 8**

**Lease number 53/2000 and 31/1998 (ME Sikar), Photograph taken on 24-03-2021.**

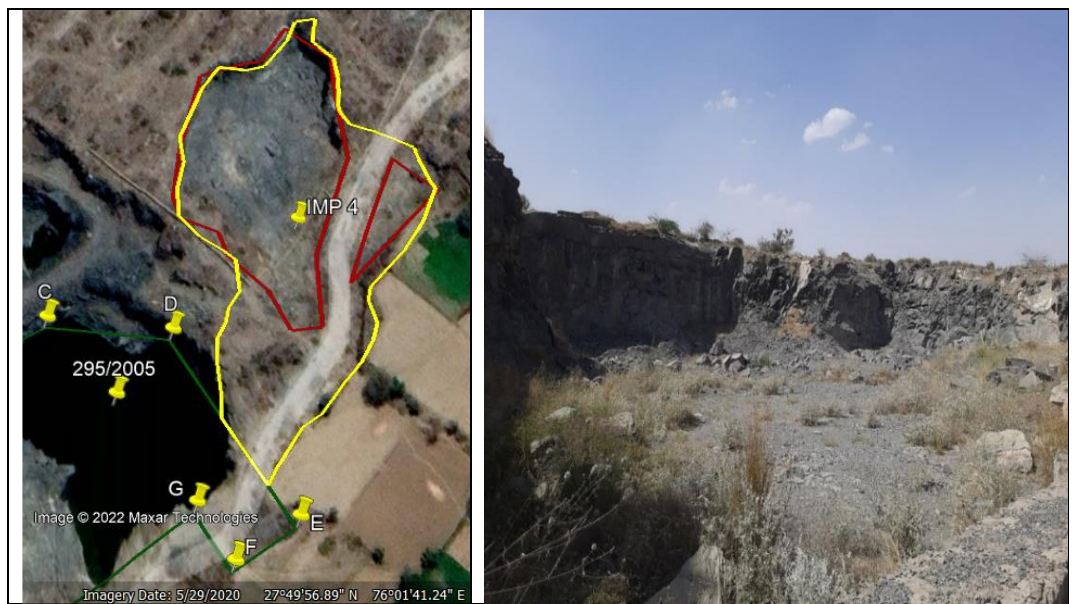
**Figure 9**

**Lease number 295/2005 (AME Neem ka Thana), Photograph taken on 06-04-2021.**

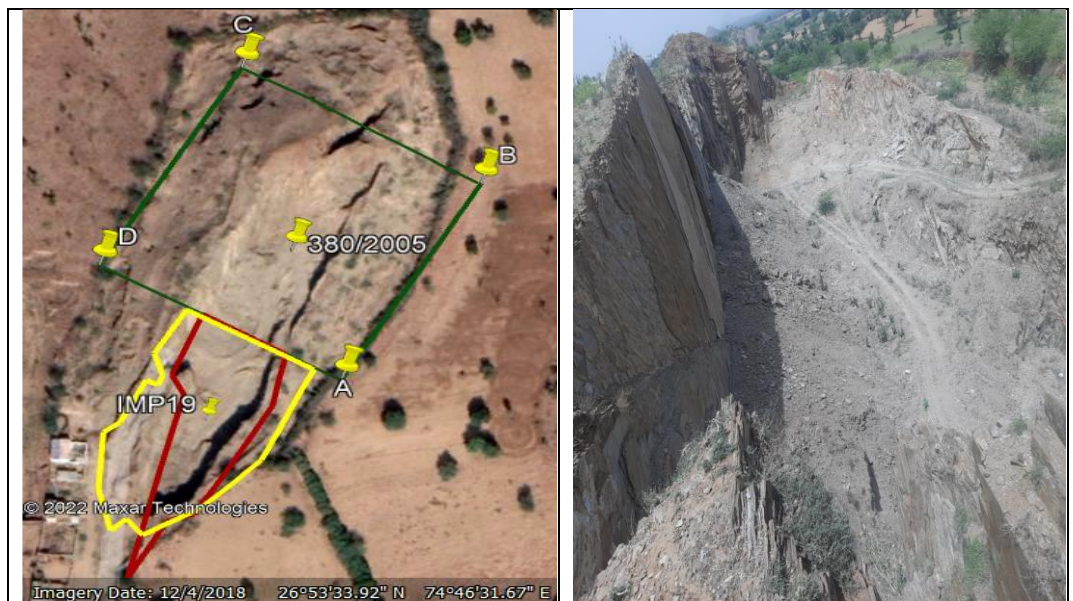
**Figure 10**

**Lease number 380/2005 (ME Makrana), Photograph taken on 24-06-2021.**

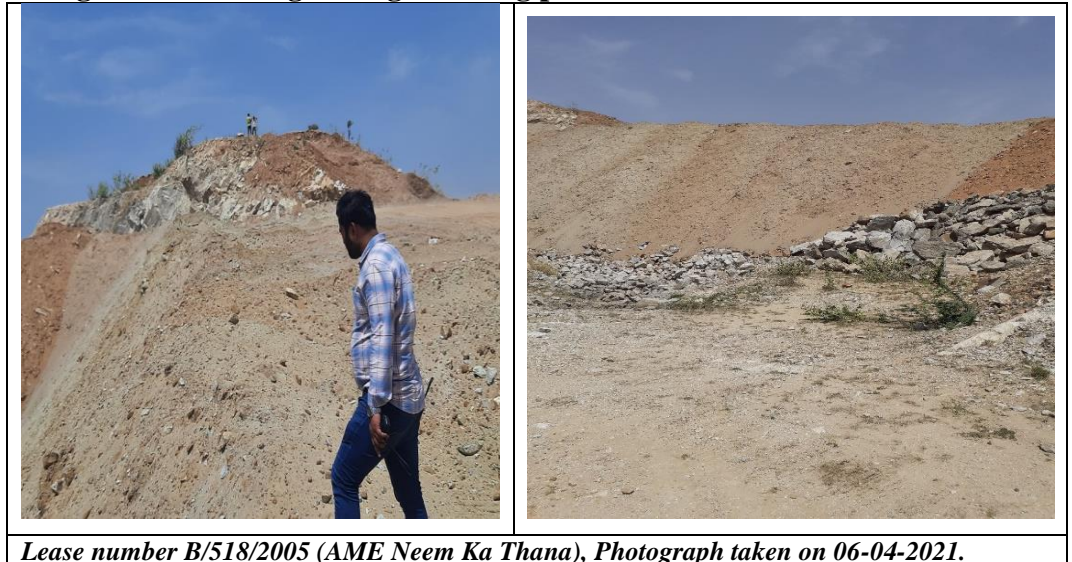
*Figure 11*

During JPV, audit also noticed that at two IMPs (Sikar and Neem ka Thana), huge pits of illegal excavation were being back filled with the mix of sand, dust or overburden material.

### **Image of back filling of illegal mining pit**

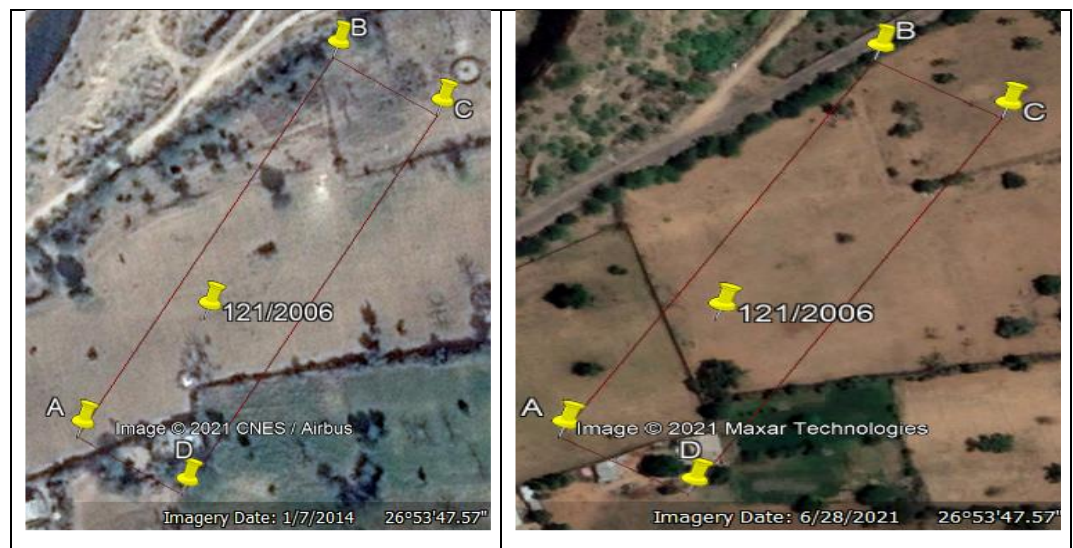
Figure 12

The analysis of Satellite images revealed that there was no mining activity at ML number 121/2006 (ME Makrana) during the period July 2014 to June 2021. However, the lessee dispatched 57,568.43 MT mineral through 2,317 *e-rawanna* from this lease from 30 August 2018 to 25 November 2019.

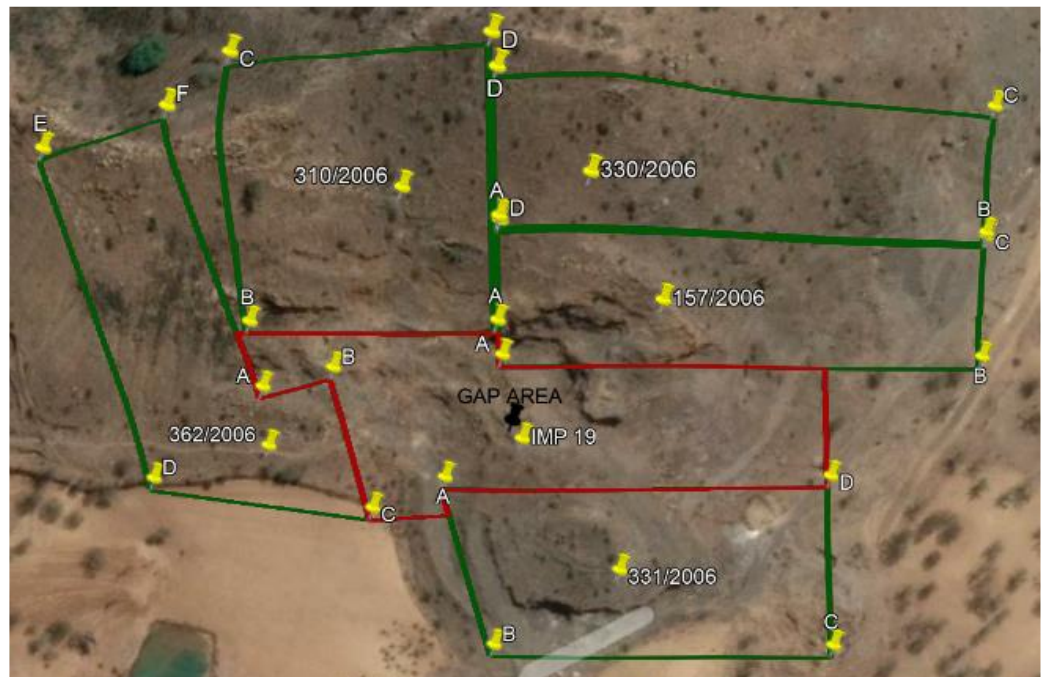
Figure 14

**Image of illegal mining in gap area under the jurisdiction of ME Sikar**

● Green line depicts Lease area. ● Red line depicts Gap area.

The Government replied (February 2022) that suitable gap areas would be auctioned and intimated to Audit.
