CHAPTER III

Adoption of advanced technologies to curb illegal mining

3.1 Introduction to advanced technologies

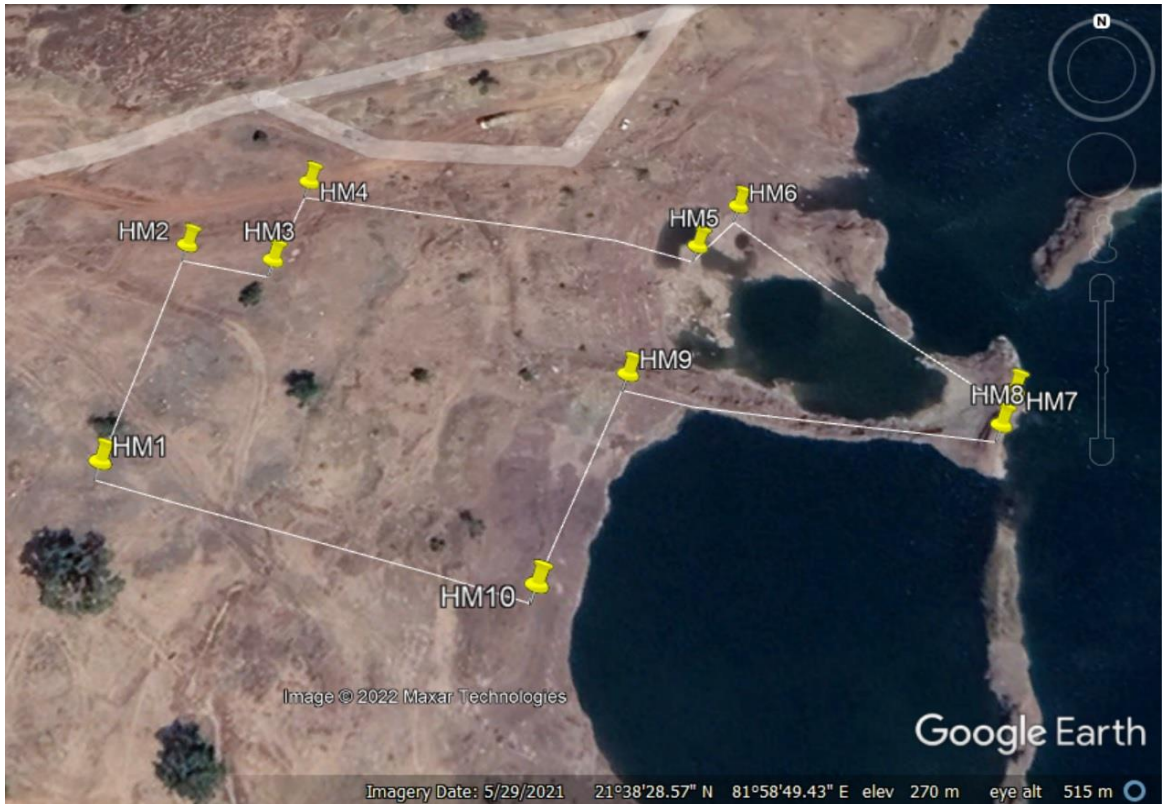
As per the conditions stipulated in the EC/ Mining Plans, the leaseholders are required to undertake plantations in the barrier zone. Plantation work was not carried out as per norms given in EC and Mining Plans in 40 cases. Out of these, 33 leases were granted before 2015 and eight leases were granted after 2015.

Joint physical verification of 10 out of above mentioned 40 cases revealed that in seven cases, no plantation was carried out, while in other three cases, the plantation was carried out partially.

In the instant case, it can be seen that plantation work was not carried out as per EC and Mining Plan. The Department could not ensure compliance of the conditions of EC and Mining Plans even in the case of leases which were granted after 2015.

Figure-3.1 (a): Satellite image of mine at Village Ranijaraud, Balodabazar 1.172 Ha, where no plantation work was carried out. (Photo dated: May 2021), Source: Google Earth Pro

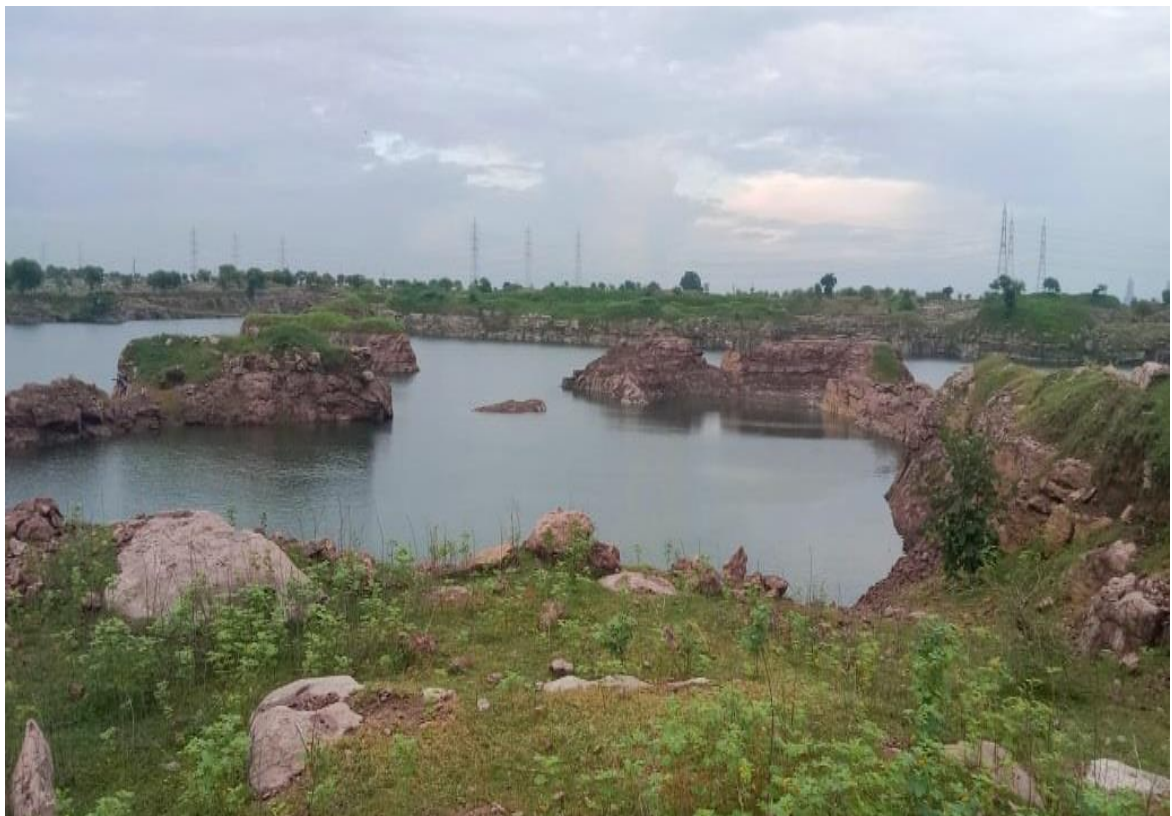
Figure-3.1 (b): Image of the above mine (figure 3.1 (a)) taken during joint physical verification (Photo dated: September 2022)

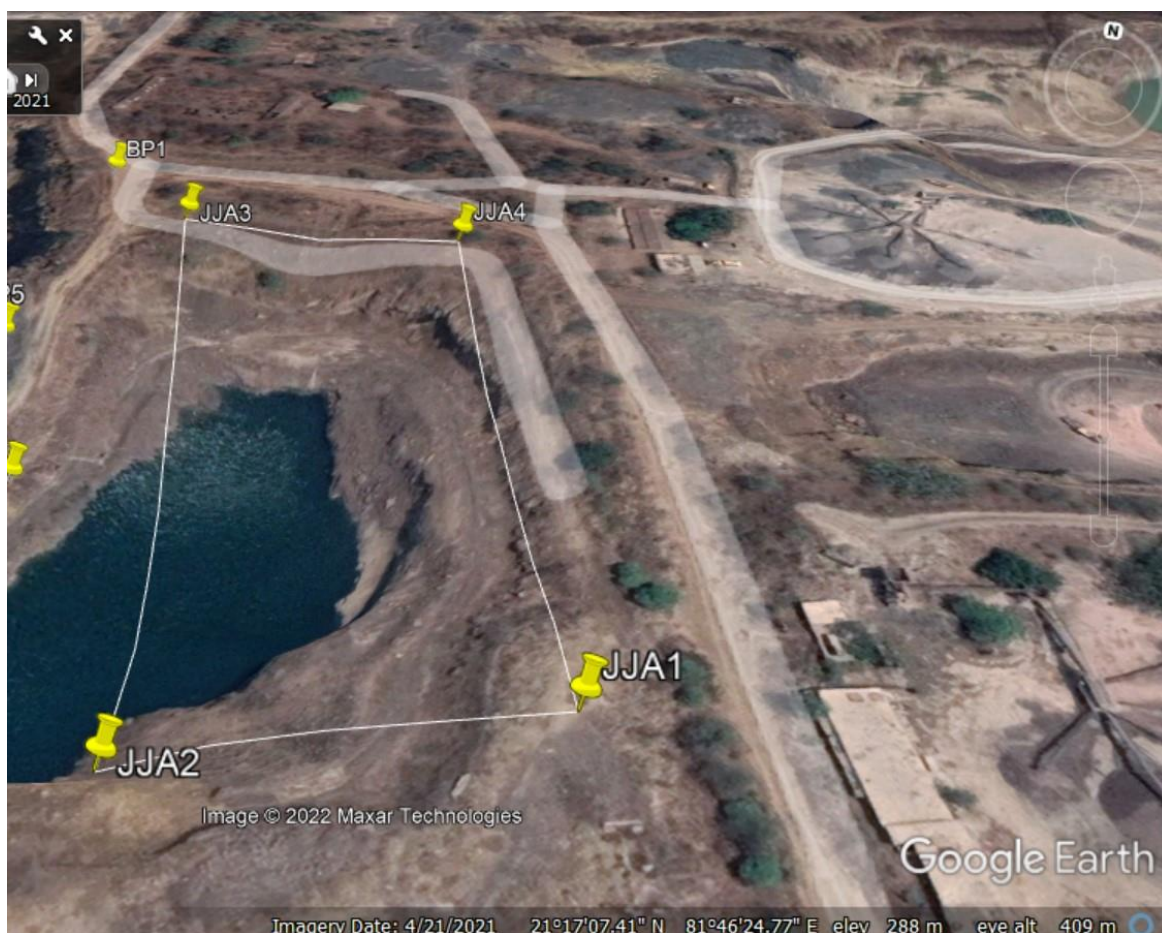
Out of the 202 quarry leases for which the Audit plotted the co-ordinates given in the respective approved plans, it was observed that in eight cases under four districts, pits were observed in the areas adjacent to the quarry leases beyond the approved co-ordinates.

In the instant case, it can be seen that the pit created due to the mining activity by the lessee was extended beyond the co-ordinates given in the approved Quarry Plan (as shown in **Figure- 3.2 (a), (b) & (c)**). During the joint physical verification of the quarry lease, the pit was found to be extended beyond the approved coordinates covering adjacent areas.

Figure-3.2 (a): Satellite image showing pit outside the approved co-ordinates (*khasra no. 1960, area- 0.971 hectare, village-Nardaha, Tahsil- Arang, District- Raipur, lease period- 25.09.2002 to 24.09.2032*) Photo dated: April 2021, Source: *Google Earth Pro*

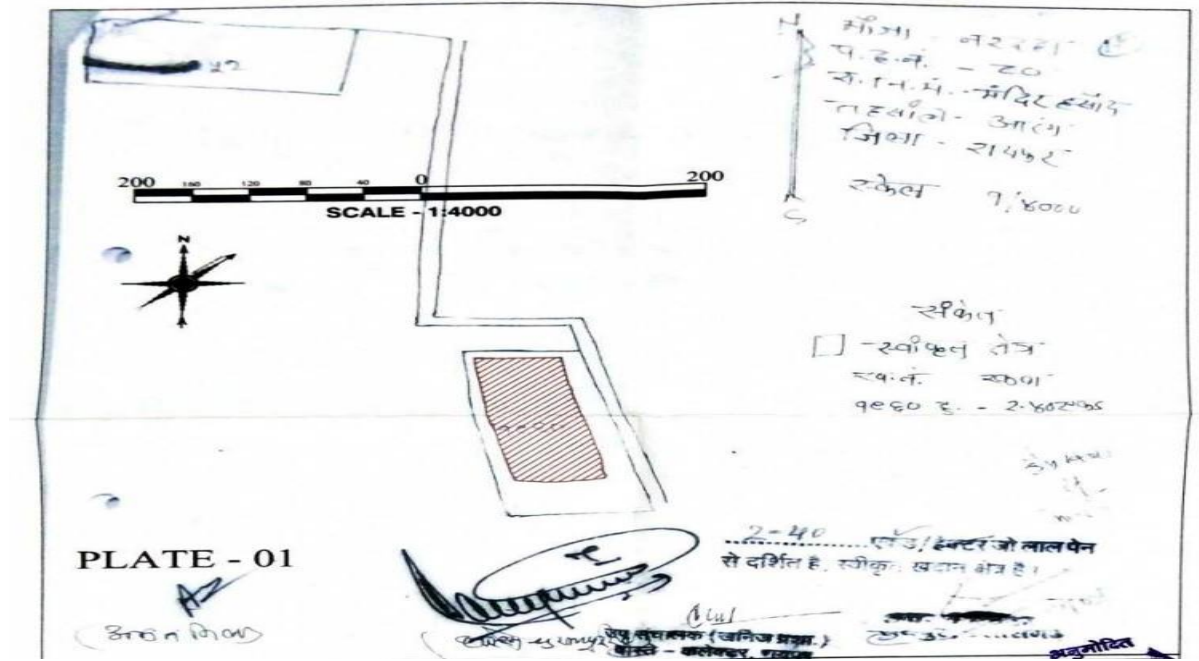
Figure-3.2 (b): Khasra map of Figure-3.2 (a)

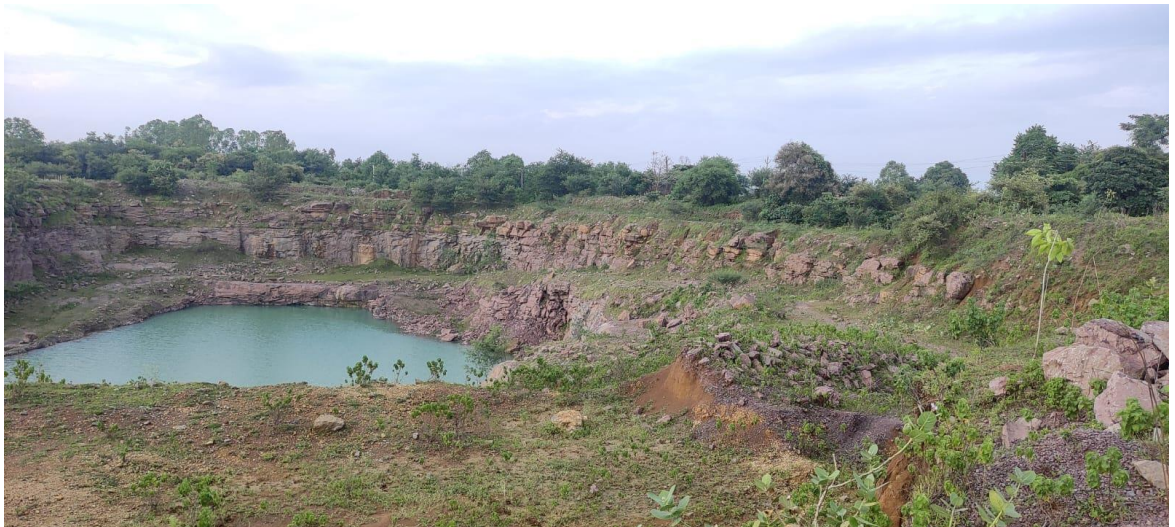
Figure-3.2 (c): Image of the above mine (Figure-3.2 (a)) taken during joint physical verification (Photo dated: September 2022)

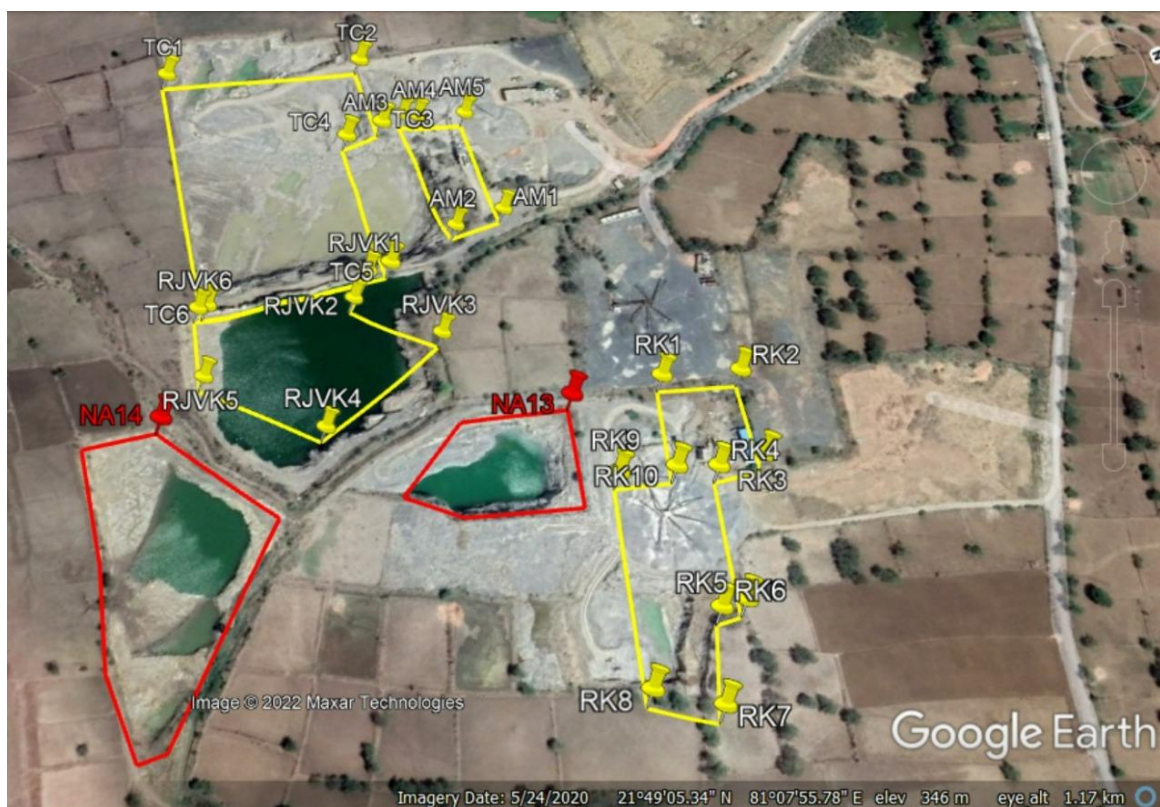
To verify the genuineness of co-ordinates and examine whether unauthorised mining activities were being carried out beyond the approved coordinates, Audit requisitioned co-ordinates of all the sanctioned leases in one of the selected districts i.e. Kawardha district. DMO, Kawardha furnished the coordinates of 28 leases (including major mineral leases). Audit plotted all the co-ordinates of these sanctioned leases through satellite imagery on “Google Earth Pro”. After plotting these co-ordinates, Audit identified 15 sites in the district, where pits were observed in the areas other than the sanctioned leases (as shown

in **Figure- 3.3 (a) & (b)**). This indicates sign of unauthorised mining activities outside the sanctioned lease areas.

- Yellow – sanctioned leases
- Red - unauthorised pits

Figure-3.3 (a): Satellite image of sanctioned and unauthorised pits (Photo dated: May 2020), *Source: Google Earth Pro*

Figure-3.3 (b): Satellite image of sanctioned and unauthorised pits (Photo dated: May 2020), *Source: Google Earth Pro*

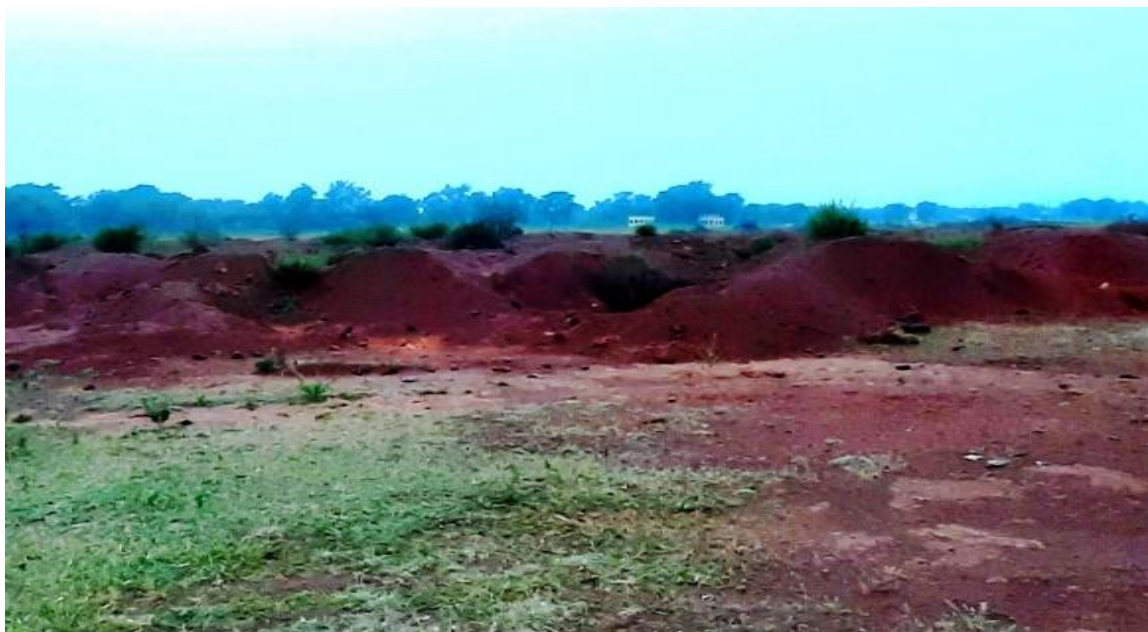
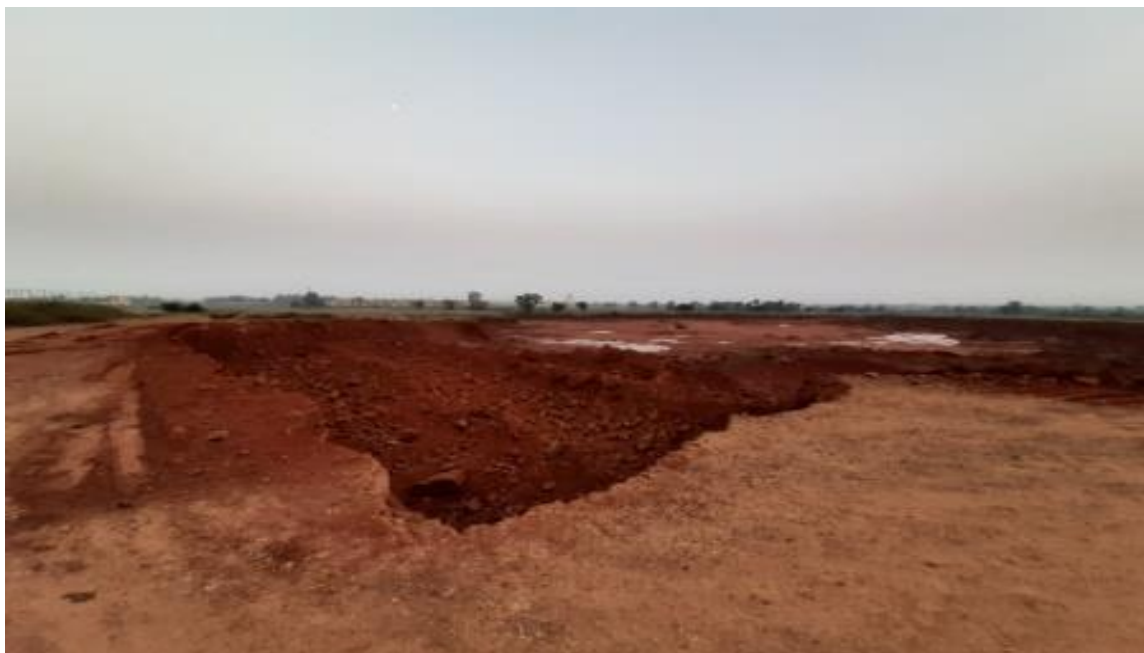
During the joint physical verification of mines along with the officials/ staff of DMOs (between October 2020 and August 2021), Audit observed extraction and dumping of huge quantity of *murrum* near Reco village, Nava Raipur and Mura-Tilda area (DMO, Raipur) without obtaining valid permits (**Figure- 3.4 (a) & (b)**).

Figure-3.4 (a): Unauthorised *murrum* excavation near village Reco, Nava Raipur (date of image: October 2020).

Figure-3.4 (b): Unauthorised *murrum* excavation near village Reco, Nava Raipur (date of image: October 2020).

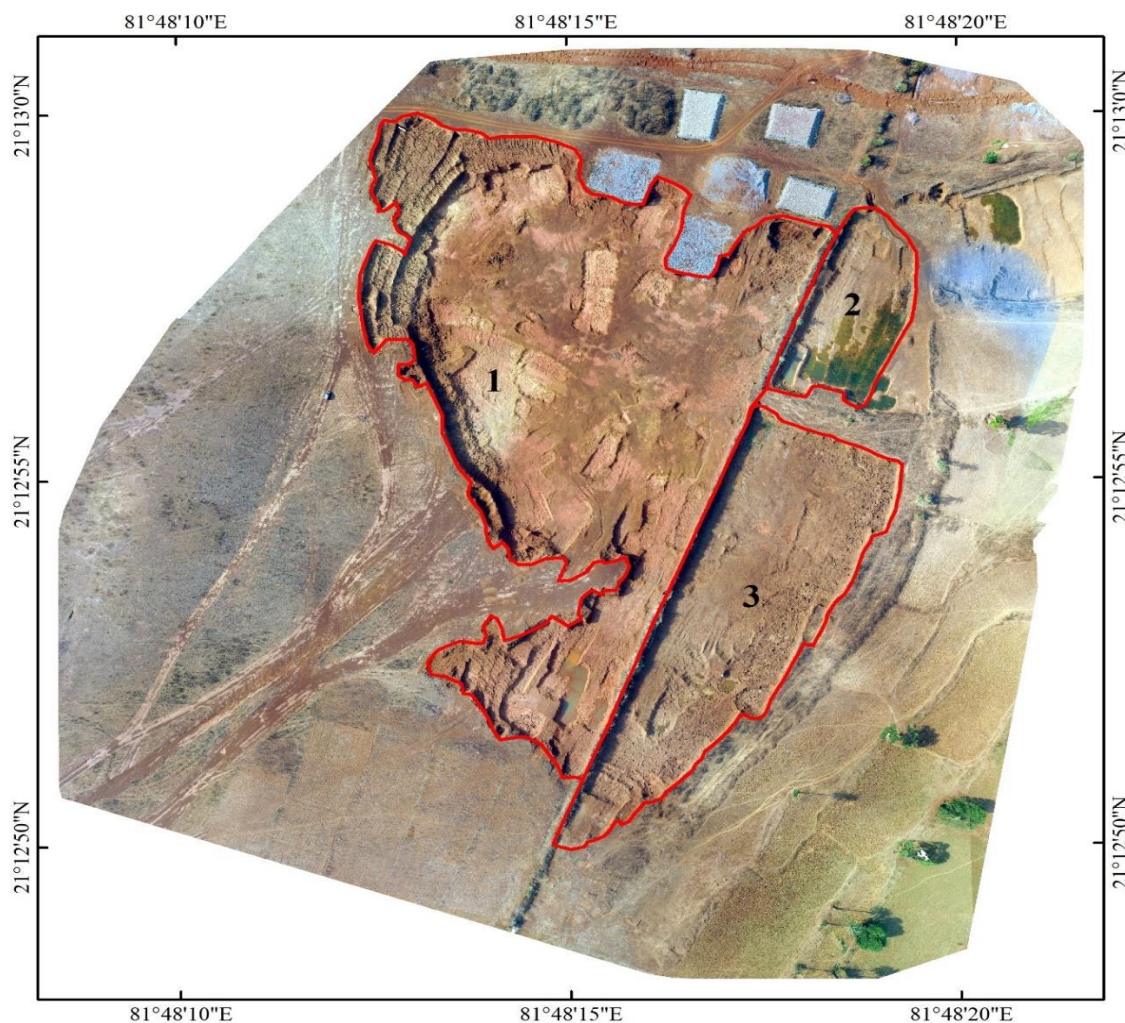
Audit conducted drone survey of the illegal *murrum* excavation site at Nava Raipur with the help of the technical consultant. As per the reply of DMO, Raipur it was noticed that, during the period 2015-16 to 2020-21 only three quarry permits for quarrying of *murrum* were sanctioned⁵, for use in the road construction work (NH 200), for a period of two years (06.12.2016 to 05.12.2018). The sanctioned areas of the quarry permits were situated in village- Naktikhapri, Tahsil – Tilda (District – Raipur). The technical consultant's report revealed that total area of illegal excavation was 38,867.2 square meter (shown as 1, 2 and 3 in the **Figure-3.5**) wherein approximately 99,528.78 cum of *murrum* was excavated without obtaining valid quarry permit. This resulted in loss of revenue to the tune of ₹ 49.76 lakh⁶ to the Government, being the value of applicable royalty.

⁶ Royalty = ₹ 50 x 99528.78 cum = ₹ 49,76,439

Figure- 3.5: Drone image of illegal *murrum* excavation (shown as 1, 2 and 3 in the Fig. above) at RECO Village, Nava Raipur (date of image: May 2022)

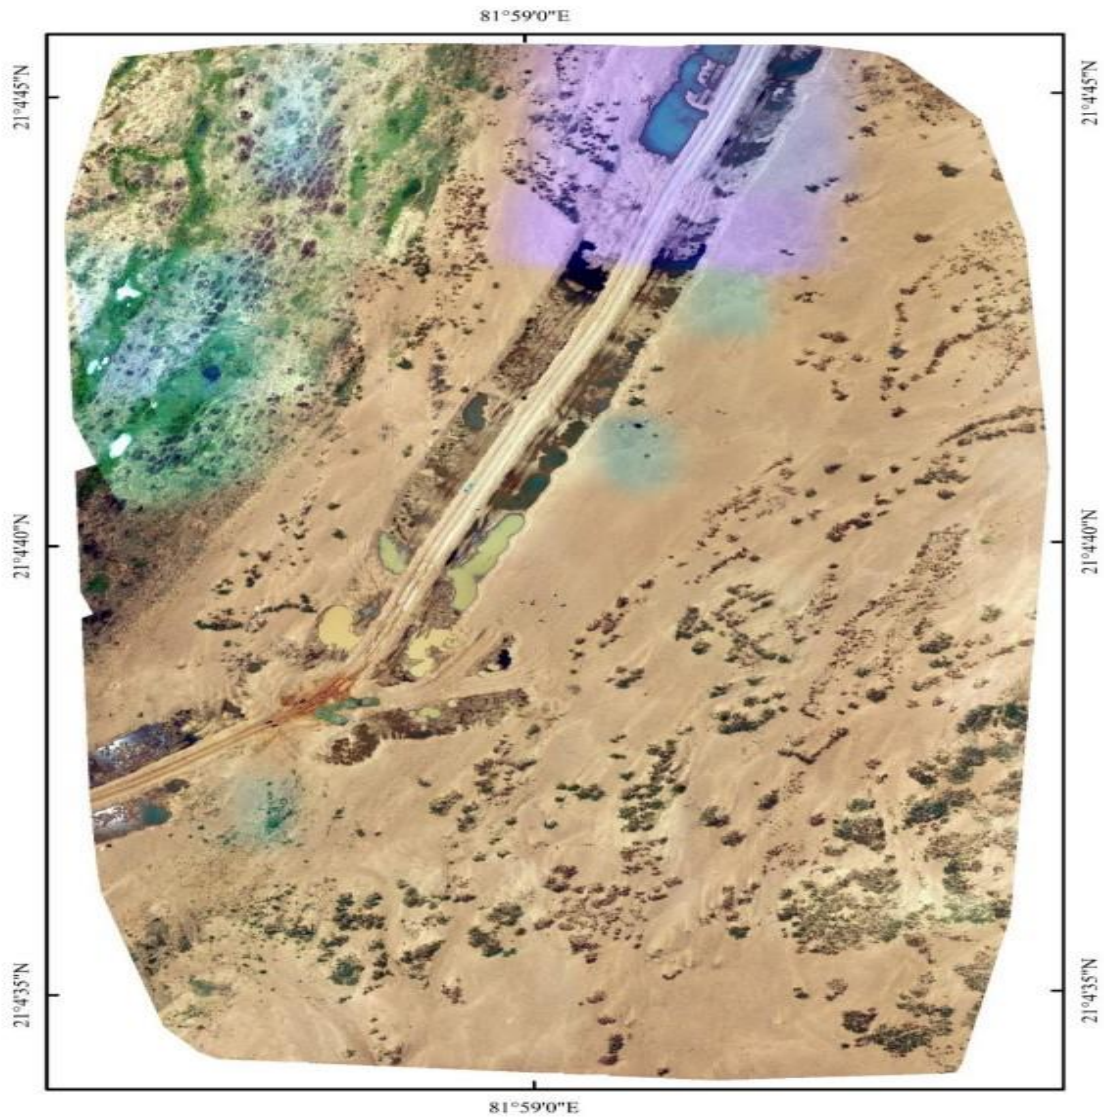
Audit conducted drone survey of sand mine at Kumhari under the jurisdiction of DMO, Raipur. As per information provided by the Department, only one sand lease was sanctioned by the DMO at Kumhari during 2019-21 after the commencement of Chhattisgarh Minor Mineral Ordinary Sand (Quarrying and Trade) Rules, 2019. Drone Survey was conducted using the approved coordinates of the sanctioned sand lease in the mining plan. As per report of the technical consultant, illegal excavation was carried out in a huge area beyond the sanctioned lease area. Out of that, an area of 5,759.45 square meter was captured through drone camera for volume calculation which showed that approximately 2,958.04 cum of sand was illegally excavated as shown in the

Figure- 3.6 and 3.7. This resulted in loss of revenue to the tune of ₹ 1.48 lakh⁷ to the Government, being the value of applicable royalty.

Figure- 3.6: Drone image showing illegal excavation of sand beyond the allotted lease area (Kumhari, khasra no. 1882, date of image: May 2022)

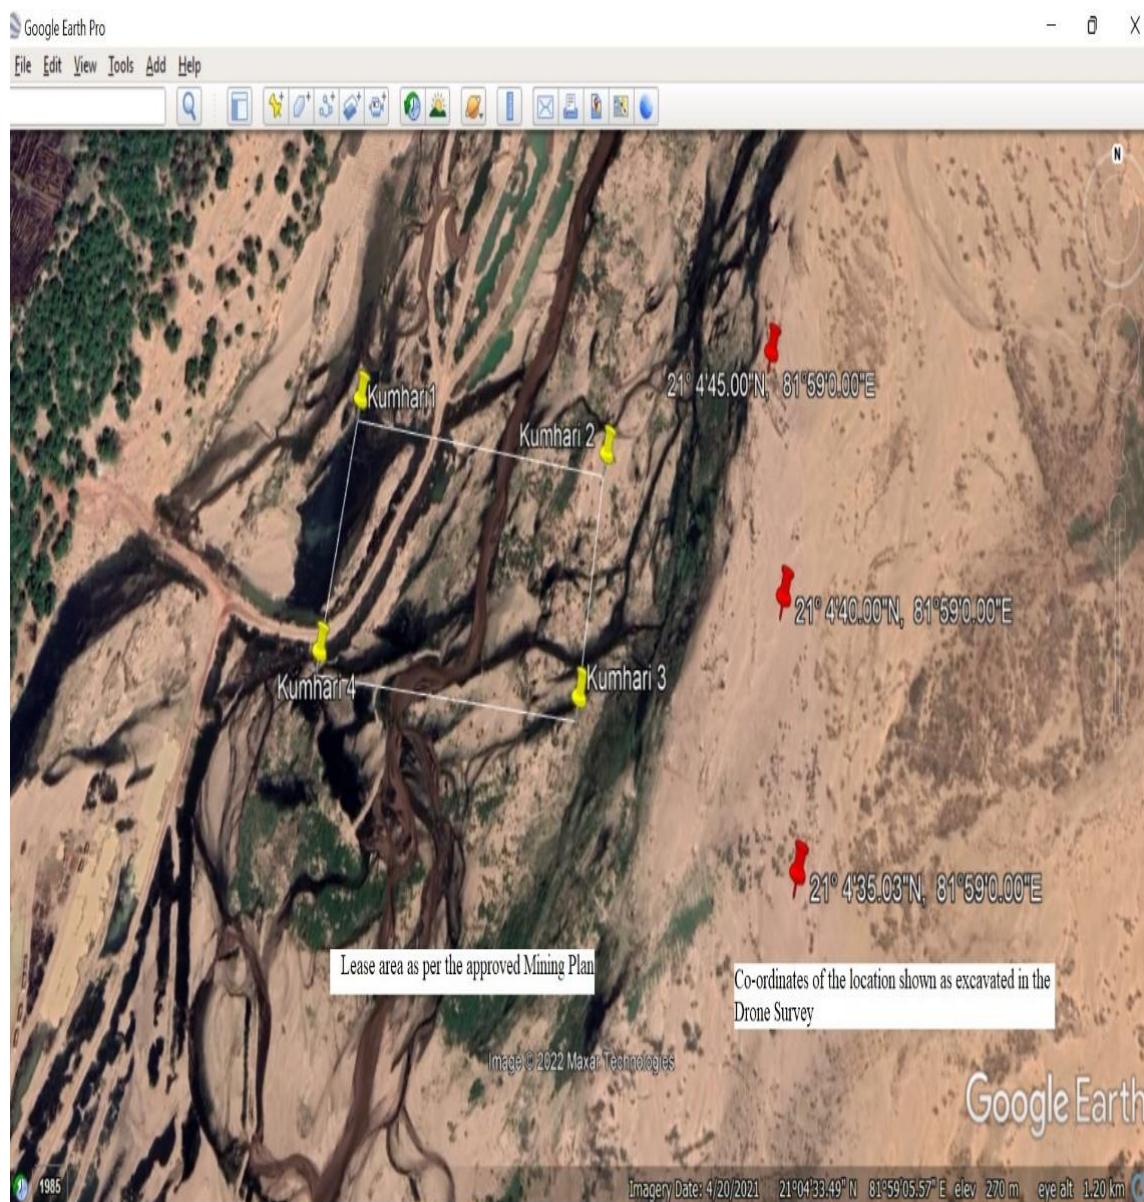
Figure- 3.7: Image showing approved lease area of sand mine and illegal excavation outside the lease area at Kumhari, Raipur, khasra no. 1882, area- 4 hectare, period of lease- 30.12.2019 to 29.12.2021.

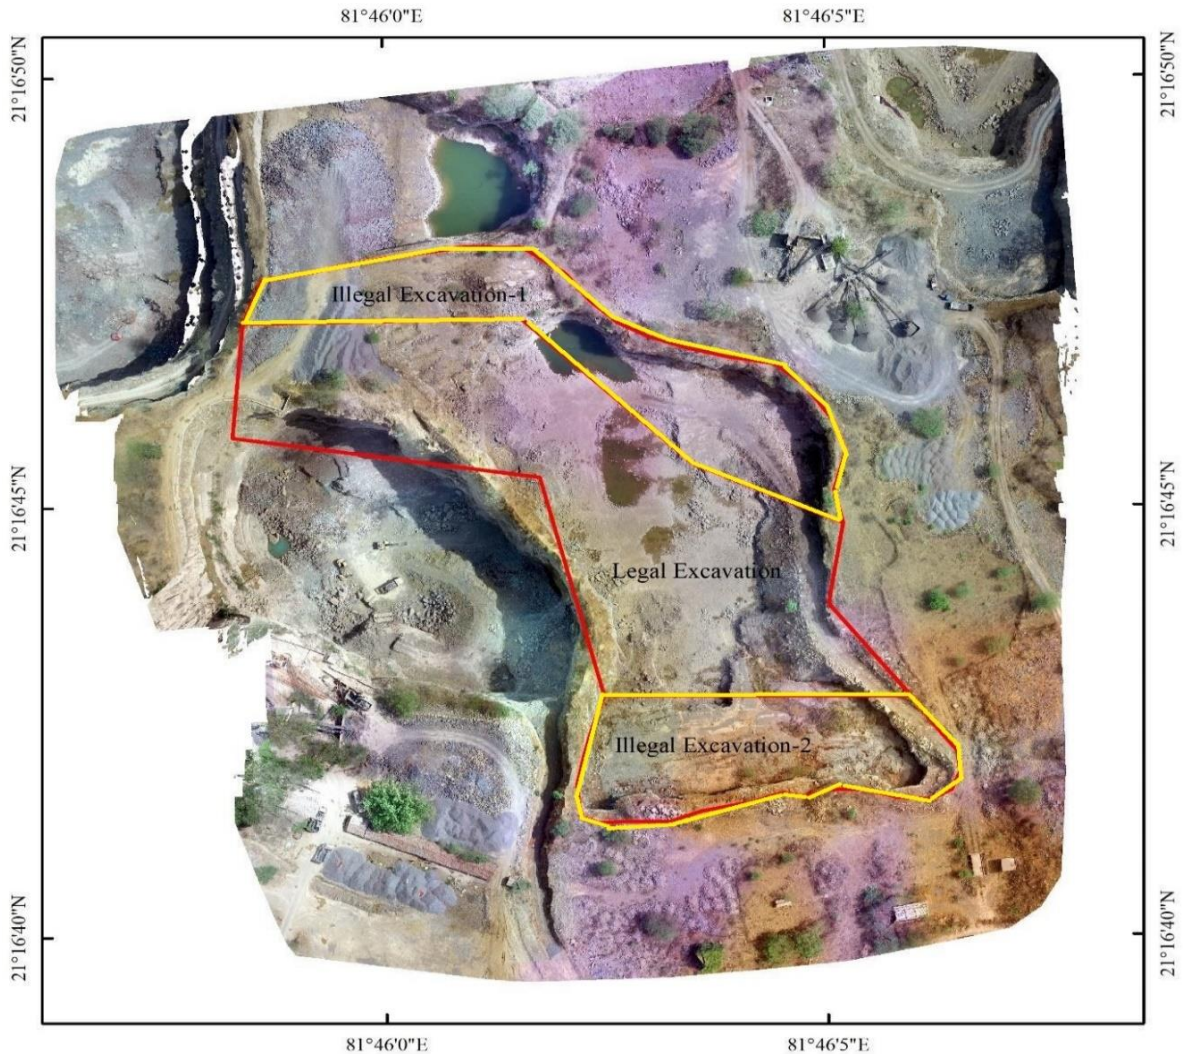
- In the case of quarry lease at Dhansuli, the lessee was allotted quarry lease at *khasra* No. 818, 870 and 871 (new 913, 926, 927) in 1.19 hectares⁸, (red boundary in the middle, mentioned as Legal Excavation in **Fig 3.8**). However, it was observed that illegal excavation of approximately 57,750.27 cum of limestone from an area of 15,831 square meters (1.583 Ha) beyond the approved co-ordinates (marked in yellow colours) was carried out, resulting in loss of revenue amounting to ₹ 68.96 lakh⁹ to the Government, being the value of applicable royalty.

Figure- 3.8: Drone image showing quarry lease boundary and illegal excavation beyond the lease area (village- Dhansuli, Tahsil- Arang, date of image: May 2022)

⁹ 0.67 cum = 1 Tonne; 57,750.27 cum = 86,194 Tonne; Royalty = ₹80 x 86,194 Tonne = ₹68,95,520.

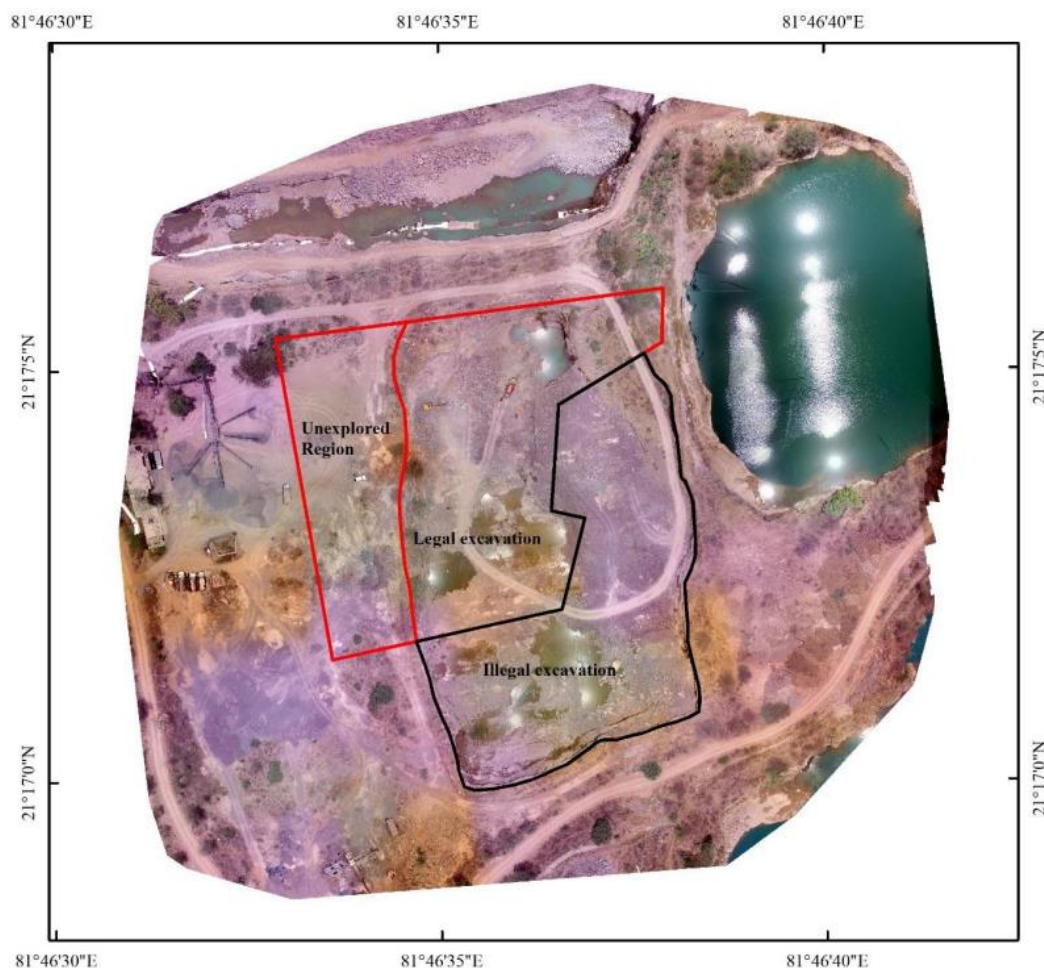
- In the case of quarry lease at Nardaha, the lessee was allotted quarry lease at *khasra* No. 1997 (part), in 1.214 hectares¹⁰, out of which approximately 0.37 hectare was unexplored¹¹. However, it was observed that illegal excavation

(marked in black colour) of approximately 76,076.14 cum of limestone from an area of 13,892 square meters (1.389 Ha) beyond the approved co-ordinates was carried out as shown in the **Figure- 3.9**, resulting in loss of revenue amounting to ₹ 90.84 lakh¹² to the Government, being the value of applicable royalty.

Figure- 3.9: Drone image showing quarry lease boundary and illegal excavation beyond the lease area (Nardaha, Tahsil- Arang, District- Raipur, date of image: May 2022)

¹² 0.67 cum = 1 Tonne; 76076.14 cum = 1,13,546 Tonne; Royalty = ₹ 80 x 1,13,546 Tonne= ₹ 90,83,680.

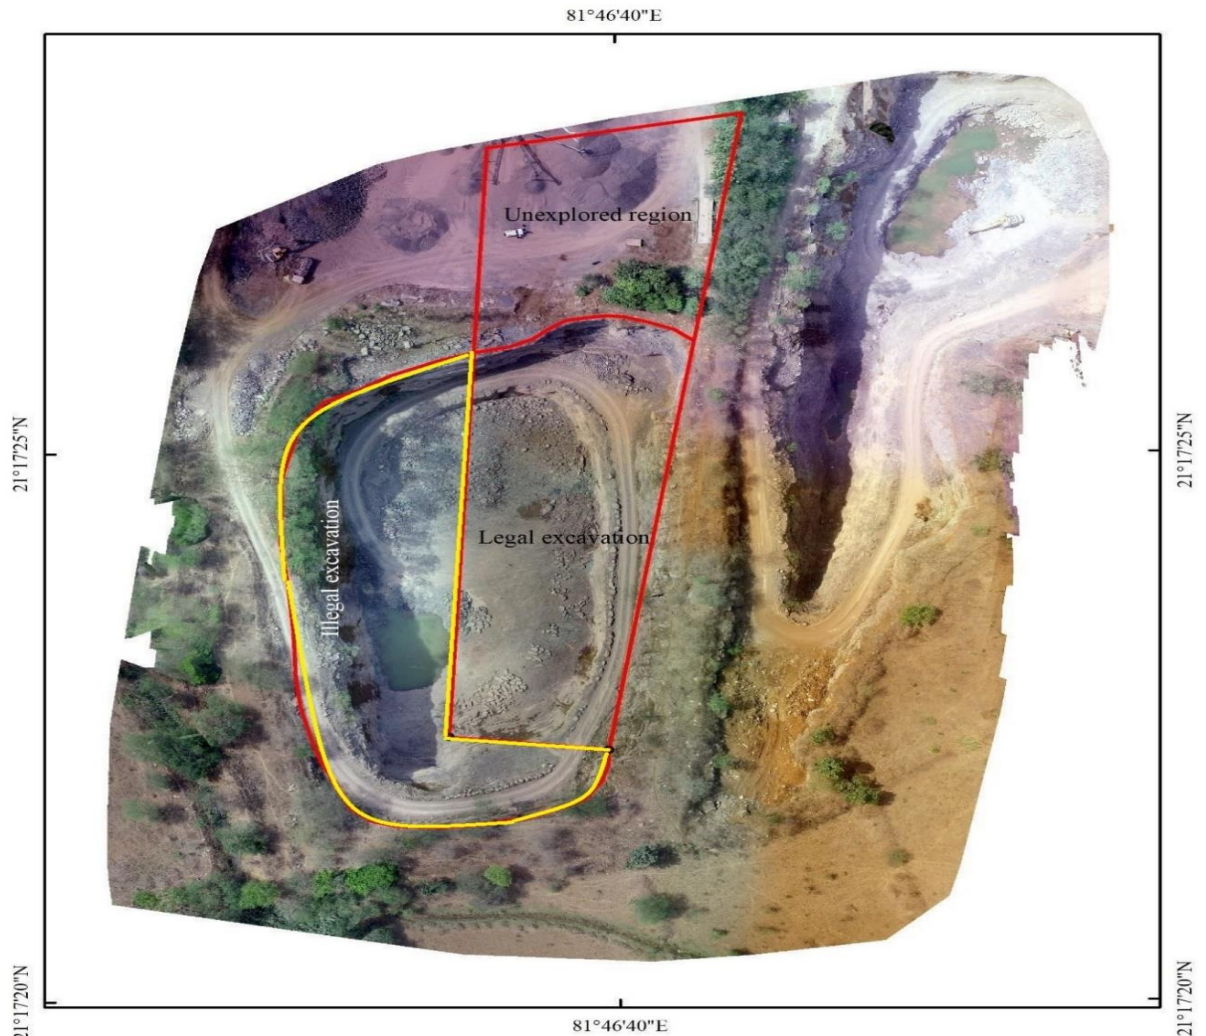
- In the case of quarry lease at Akoldih-Khapri, Tehsil- Arang, the lessee was allotted quarry lease at *khasra* No. 553/ 1 (part) in 1.052 hectares¹³, out of which approximately 0.5 hectare was unexplored¹⁴. However, illegal excavation (marked in yellow colour) of

approximately 46,748.71 cum of limestone from an area of 11,195 square meters (1.120 Ha) beyond the approved co-ordinates was observed, as shown in the **Figure- 3.10**, resulting in loss of revenue amounting to ₹ 55.82 lakh¹⁵ to the Government, being the value of applicable royalty.

Figure- 3.10: Drone image showing quarry lease boundary and illegal excavation beyond the lease area (Akoldih-Khapri, Tahsil- Arang, date of image: May 2022)

¹⁵ 0.67 cum = 1 Tonne; 46748.71 cum = 69,774 Tonne; Royalty = ₹ 80 x 69,774 Tonne = ₹ 55,81,920.

- The Department should examine the feasibility and use of GIS/ Drone Survey to detect illegal mining activities till the implementation of Mining Surveillance System.*
