CHAPTER-VI
PROCESSING AND DISPOSAL OF
MUNICIPAL SOLID WASTE

Processing and Disposal of Municipal Solid Waste

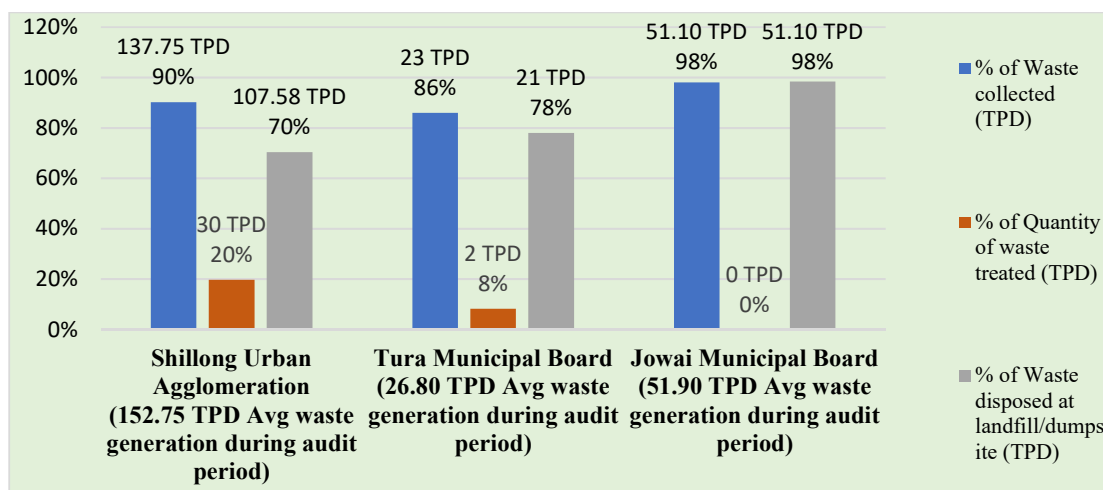
Chart 6.2 – Comparison of Waste processing and disposal in selected Urban Areas (Period from 2017-18 to 2021-22)

From the information available as shown in the Chart above, it can be seen that the waste processing capacity of the major urban areas like Shillong and Tura were grossly insufficient. In Shillong, only 20 *per cent* of the total collected waste, *i.e.* 30 tonnes was being processed, while in Tura the percentage of waste processing was abysmal eight *per cent*. Although the collection of waste from selected urban areas were 90 *per cent* for Shillong Urban Agglomeration, 86 *per cent* for Tura MB and 98 *per cent* for Jowai MB, 70 to 98 *per cent* of unprocessed solid waste ended up in landfills.

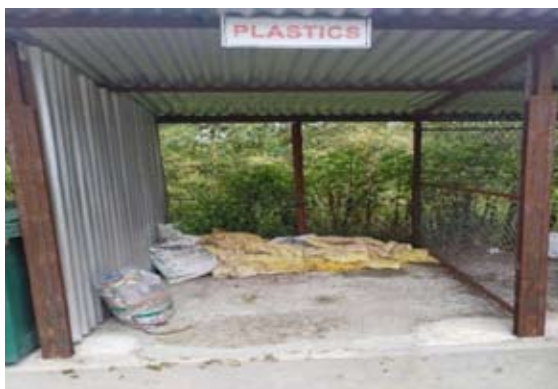
- A Waste Recovery Centre (WRC) Shillong, to reduce waste transportation cost by recovering recyclable waste to be sold as scrap, was set up at Umpling, a census town within SUA, which was being operated by two people (unregistered as SHG till the date of JPV). The WRC was set up with space for composting and storing of waste. During JPV (September 2022), it was however seen that all the sheds to segregate and store valuable materials from the waste were empty except glass bottle shed. The person in-charge admitted that the WRC was not yet fully functional and there were no earnings from the WRC. It was also stated that due to improper segregation, the entire waste goes to landfill. The SMB in collaboration with the Dorbar Shnong of Umpling should take steps to fully operationalise this WRC in order to reduce the waste generated from the locality which will ultimately reduce the burden in the sanitary landfill at Marten.

Exhibit 6.1: Storage shed used not as intended

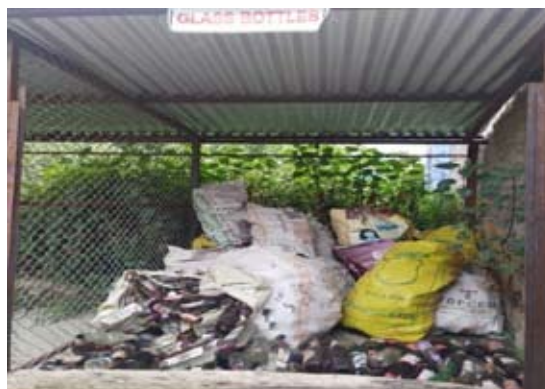
Exhibit 6.2: Glass bottle storage

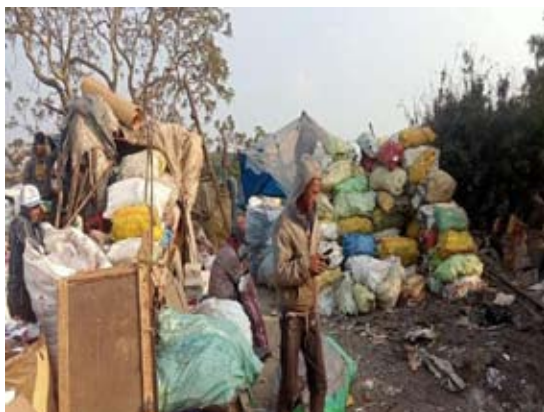
- Eleven recyclers were operating in Marten landfill site to collect, sort and transport various types of recyclable materials segregated from the collected waste. However, there were no records to indicate that these recyclers have been formally integrated into the SWM system.

Exhibit 6.3: Recyclers operating at Marten, Shillong

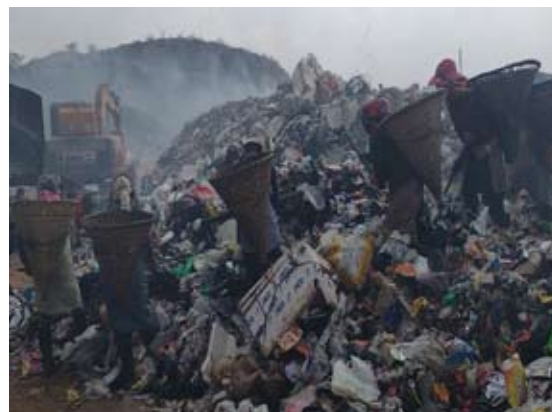
Exhibit 6.4: Manual workers sorting recyclables from dumped waste

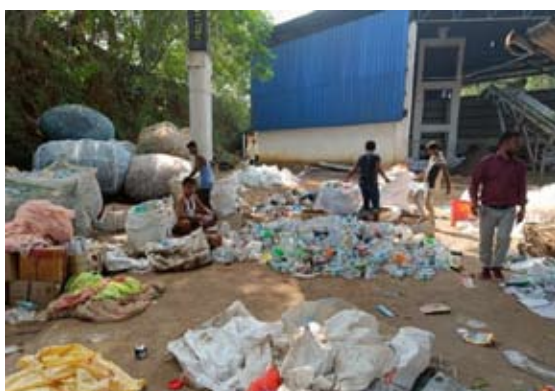
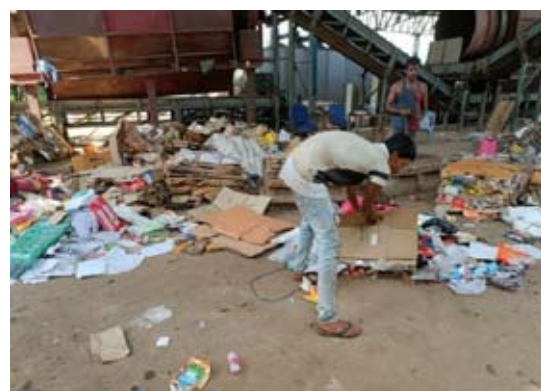
- In Tura, some workers were seen segregating/sorting the recyclables, valuable materials from the heap of garbage and transferring them to recycling industries. These workers were part of Swapan Industries and they are recycling about one TPD of waste from Rongkhon Songittal, the dumping site of Tura. The proprietor informed that his transporting capacity could be augmented if one plastic baling machine was made available to him.

Exhibit 6.5 & 6.6: Informal Sector workers sorting and packaging recyclables at Tura dumpsite

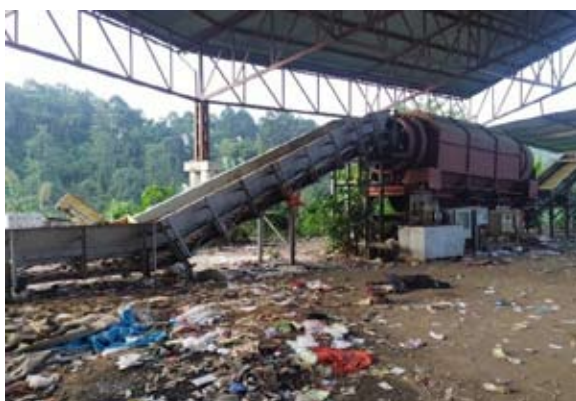
- This facility was yet to be handed over to the Town Committee by MUDA.
- Though the composting plant and windrow platform was available at the site, no composting was being carried out.
- Facilities including the machineries, the windrow platforms, vermi-compost pits, office building, storage rooms, *etc.* was not used as they were originally intended.
- Machineries at Nongpoh could not be started and vegetation could be seen growing out of the machinery. The windrow platform, vermi-compost pits and office building, *etc.* were lying idle and unused since completion.

Exhibit 6.7: Compost Plant Machineries with vegetation coming up at Nongpoh

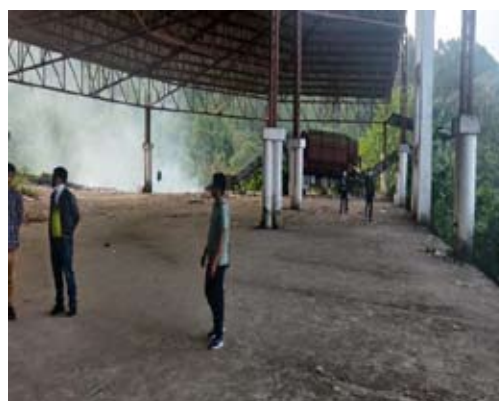
Exhibit 6.8: Unused windrow platform at Nongpoh

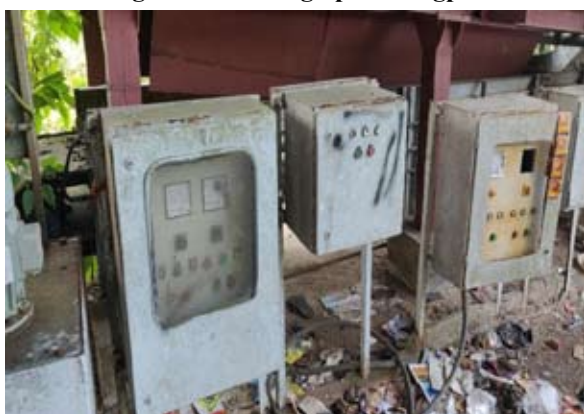
Exhibit 6.9: Damaged panel board of compost plant

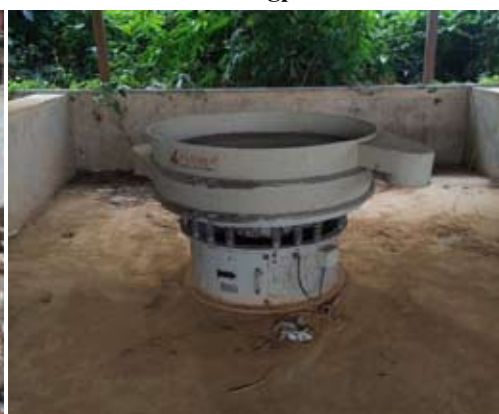
Exhibit 6.10: Parts of the machineries lying separately

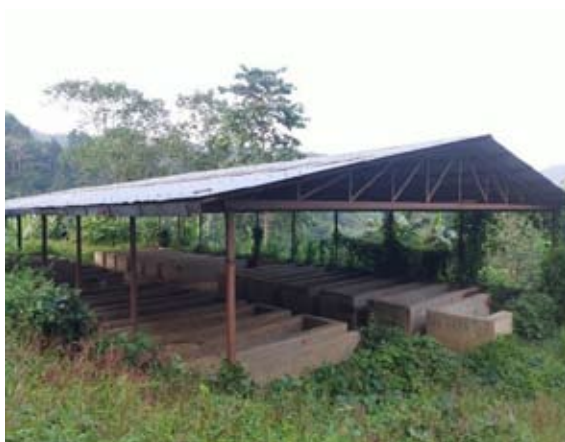
As evident from the photographs taken on site, civil structures for segregation, treatment and storage of waste as well as the compost plants were not used.

Exhibit 6.11: Unused vermi compost pits at Nongpoh

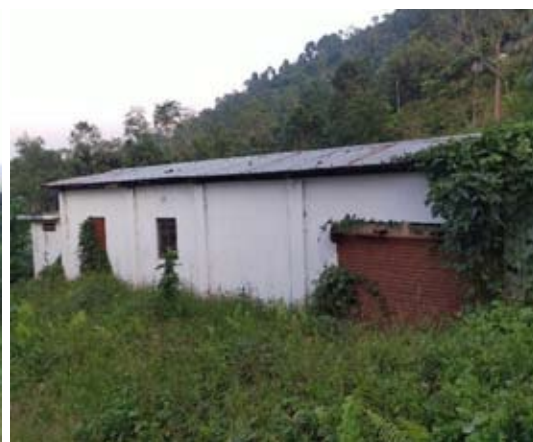
Exhibit 6.12: Unused office room

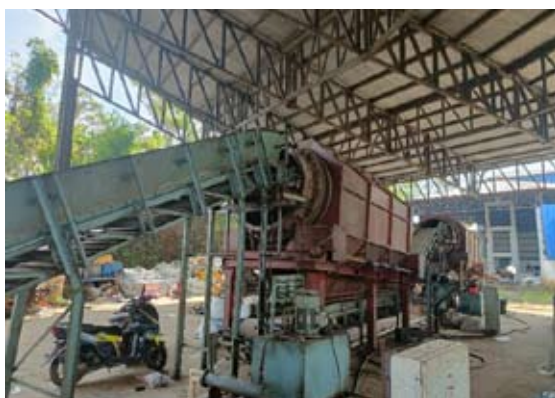
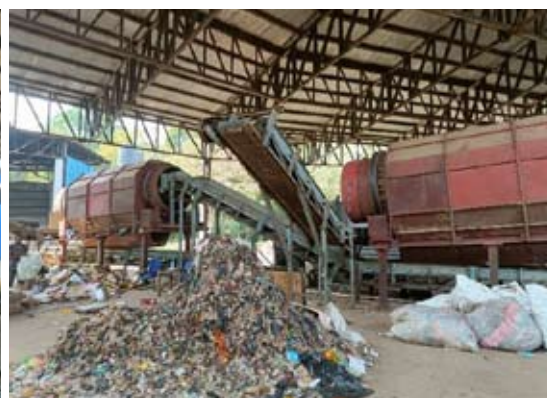
- The facilities were handed over to TMB by the Executive Engineer, Urban Affairs, Tura (July 2019).
- A composting plant was also available at the site but it was observed that no composting was being carried out. Officials from the TMB apprised that the machinery was never used for its intended purpose.
- The road around the plant, drain around the road, leachate drain was not observed. Officials from the TMB apprised that those could not be seen as they were already under the dumped garbage.
- The vermi composting platform was learned to be dismantled and now being used to dump garbage and no traces of the same was visible.

Exhibit 6.13: Unused Compost Plant Machineries **Exhibit 6.14: Dumping of waste near Compost Plant**

During the Exit Conference (May 2023), the Director, Urban Affairs Department stated that the Department would take steps to hand hold the Municipal Board to ensure that the Compost Plants become functional.

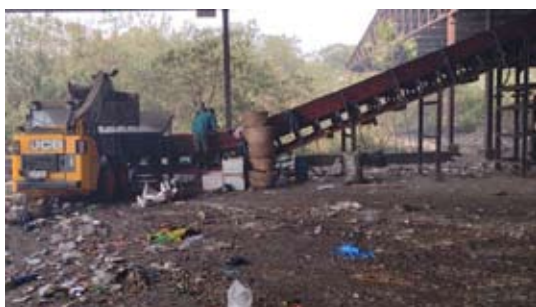
During JPV (September 2022), it was seen that the compost plant was functioning but was not utilised at full capacity due to poor source segregation of waste. This was apparent from the fact that even though the compost plant started functioning since March 2022, presently, SMB processed only 30 TPD of segregated waste collected against the capacity of 170 TPD during the year 2022. Audit noticed that the reasons for under performance was as under:

Exhibit 6.15: Mixed waste put into first input section of the compost plant

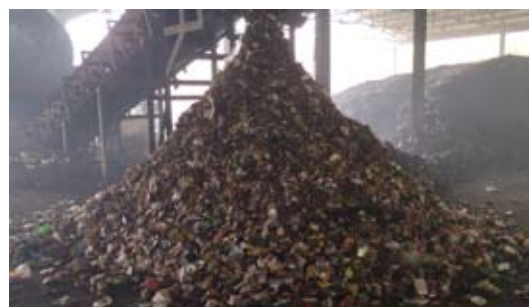
Exhibit 6.16: Output from the first section not properly segregated

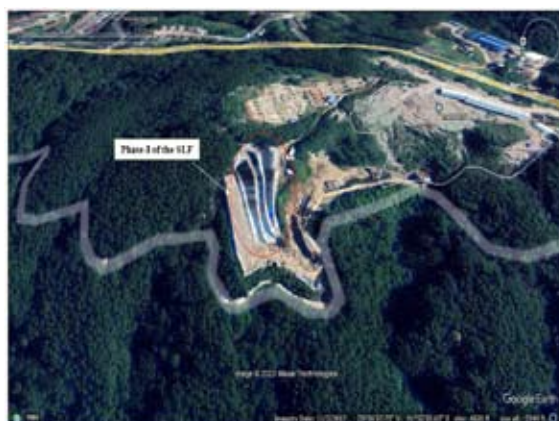
November 2017 image of Marten Landfill extracted from the Google Earth showing fully utilized Phase-I of the SLF

Satellite imagery showed that Phase I of the SLF was already fully utilized and was covered under vegetation. Major portion of the Phase II SLF was already filled with waste. During Joint Physical Verification with the audit team, officials from the Shillong Municipal Board confirmed that the space (Phase II) would last only for three more years up to 2025.

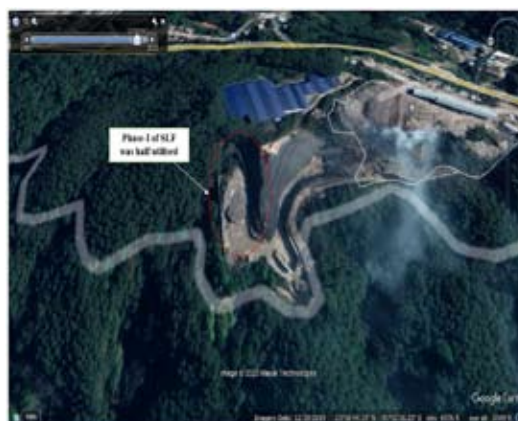
December 2019 image of Marten Landfill extracted from the Google Earth showing Phase I of SLF was half utilized

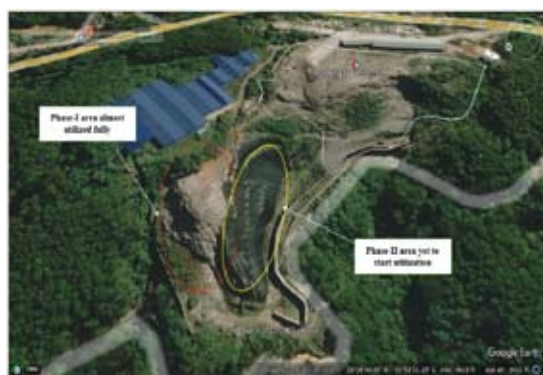
November 2020 image of Marten Landfill extracted from the Google Earth showing the Phase-I area almost utilized fully but Phase-II area was yet to be started utilization (black portion)

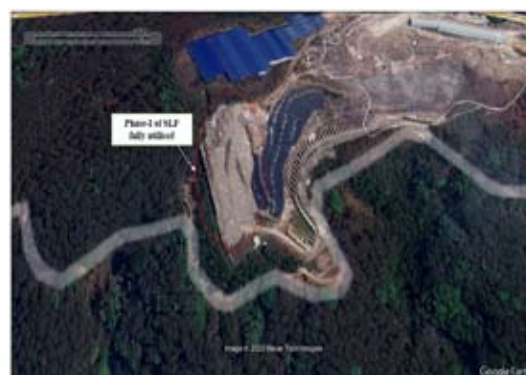
April 2021 image of Marten Landfill extracted from the Google Earth showing Phase-I of SLF was fully utilized

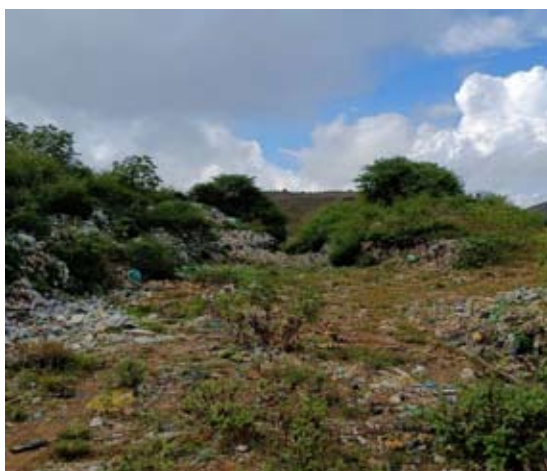
Exhibit 6.17: Traces of Haphazard dumping of waste at Mynkjai dumping ground (October 2022)

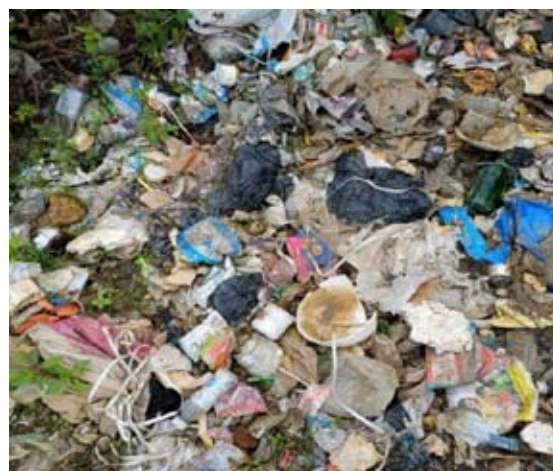
Exhibit 6.18: Traces of Unsegregated waste at Mynkjai dumping ground (October 2022)

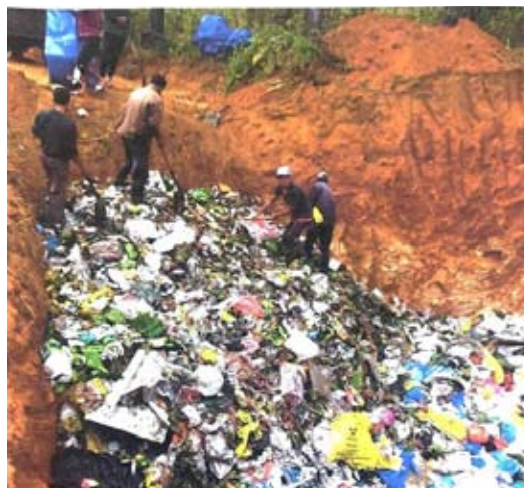
Exhibit 6.19: Mixing of non-biodegradable (plastics) with biodegradable waste in temporary dumping of waste at Mookabeng

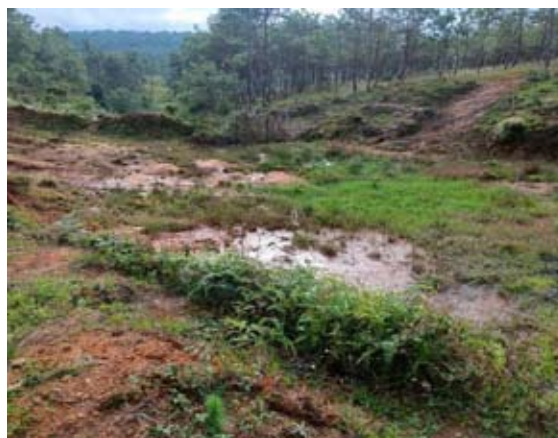
Exhibit 6.20: Temporary dumping site at Mukhla where waste was filled with loose soil

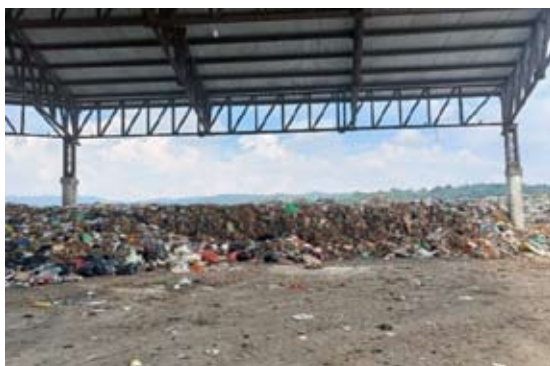
Tura Municipal Board was constituted in 1979 and a small plot of land measuring only about 3.99 acres at Rongkhon Songittal was acquired for use as dumping site. At the time of acquisition, the site was uninhabited. As time passed, the surrounding of the dumpsite was occupied by residential buildings, graveyard, roads and public amenities. Continuous dumping resulted in spillage of garbage outside the compound which affected a public graveyard situated very near to the dumpsite. The Secretary of the Rongkhon Songittal⁶⁵ filed a case against indiscriminate dumping in and around the dumpsite causing encroachment of the graveyard, burning of garbage and violation of SWM Rules 2016. The Meghalaya High Court (December 2018) directed TMB not to use the graveyard as a dumpsite and clean the garbage from the graveyard. During June 2019, the TMB had to dismantle one of its assets vermi-composting pits to make space for dumping of waste.

Exhibit 6.21: Haphazard dumping of waste at Tura

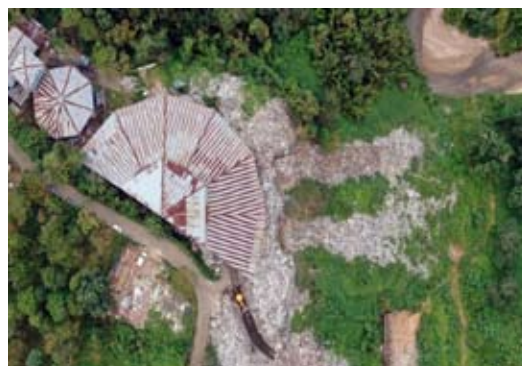
Exhibit 6.22: Spillage of waste at Tura

During the Exit Conference (May 2023), the Department stated that partial payment has recently been made for procurement of 30 acres of additional land for landfill.

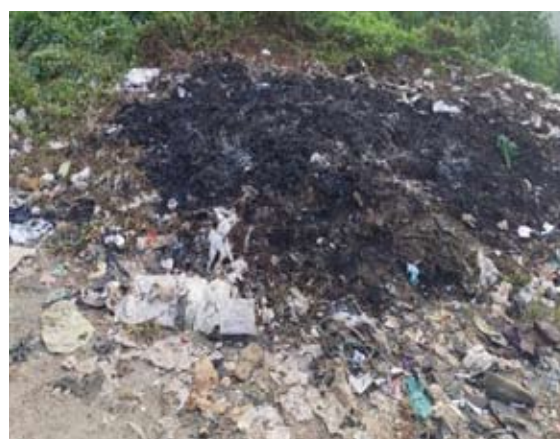
In **Nongpoh**, the waste is disposed at Umshangling dumpsite. During JPV, it was seen that mixed waste was openly dumped in a gorge in the dumpsite. It was also noticed that the waste was being burnt to which the officials from Nongpoh Town Committee stated that waste was burned by miscreants oftentimes as the dumpsite was neither fenced nor gated.

Exhibit 6.23: Traces of burning of wastes at Nongpoh

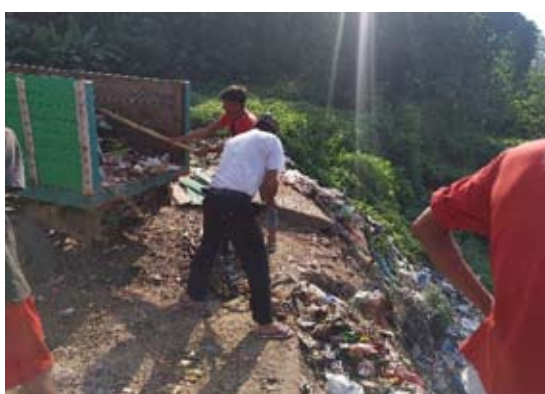
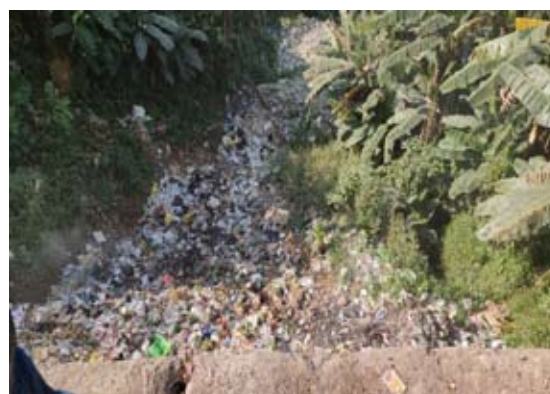
Exhibit 6.24 & 6.25: Unscientific dumping of unsegregated waste into a gorge at Nongpoh

During the Exit Conference (May 2023), the Director, Urban Affairs Department agreed that the Compost Plant must be made functional. He stated that the Department would take steps to decentralise the system of processing of waste so as to reduce the burden on the dumpsite.

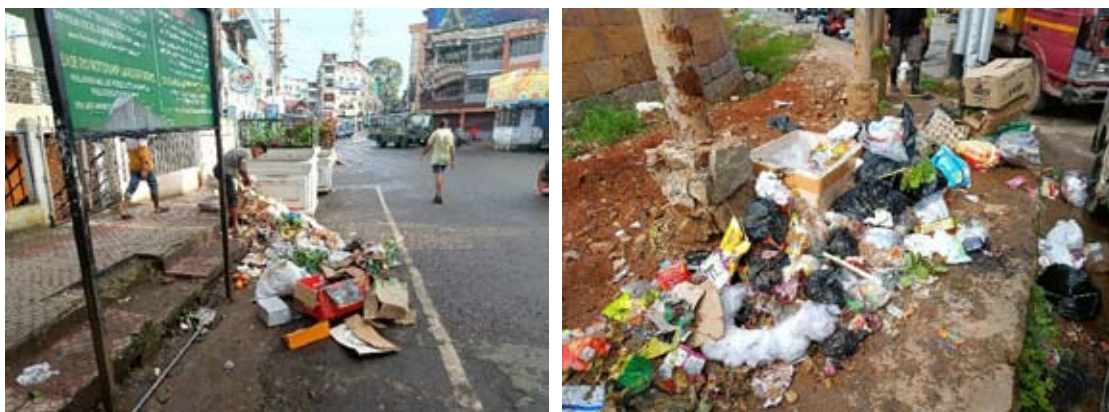
Waste generators in certain areas were observed to be violating Rule 4 (2) of the Solid Waste Management Rules, 2016 by dumping waste in open spaces and water bodies, as seen during Joint Physical Verifications and reported in news articles, causing both environmental degradation and health risks.

Exhibit 6.27 & 6.28: Household waste dumped in open spaces in Shillong (Laitumkhrah & Lower Mawprem)
