Chapter-3
Collection, Segregation, Storage,
Transportation and Disposal of
Municipal Solid Waste

Collection, Segregation, Storage, Transportation and Disposal of Municipal Solid Waste

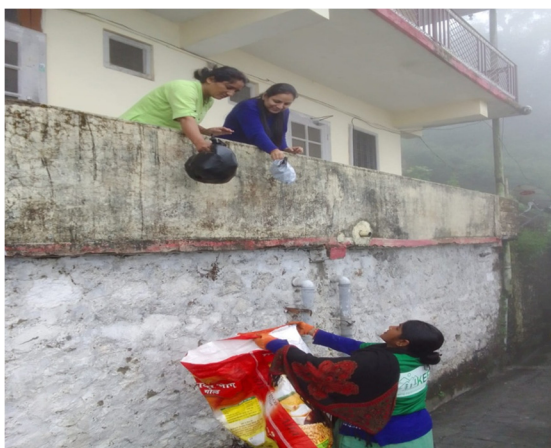
A) Lack of Source Segregation: Across multiple concession agreements, a common issue was the failure to segregate waste at the source into biodegradable and non-biodegradable waste. Instead, mixed solid waste was collected undermining recycling efforts and overall waste management processes. The same was also confirmed during joint physical verification of door-to-door collection of waste in different ULBs. This can be seen in the following photographs-

Photo-3.1: Door-to-door collection of waste in Nagar Palika Parishad Mussoorie (11 October 2022)

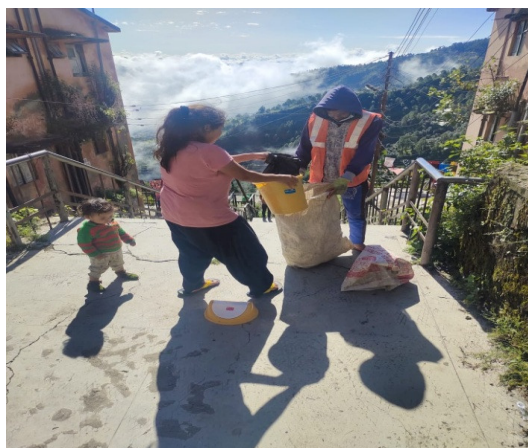
Photo-3.2: Door-to-door collection of waste in Nagar Palika Parishad Tehri Garhwal (03 March 2023)

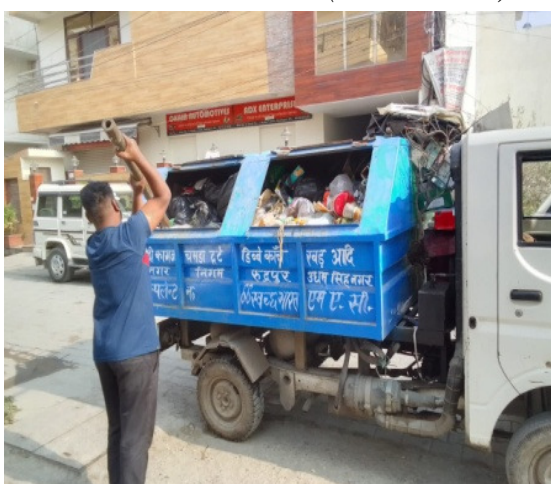
Photo-3.3: Door-to-door collection of Mixed waste in NN Rudrapur, U.S. Nagar (16 January 2023)

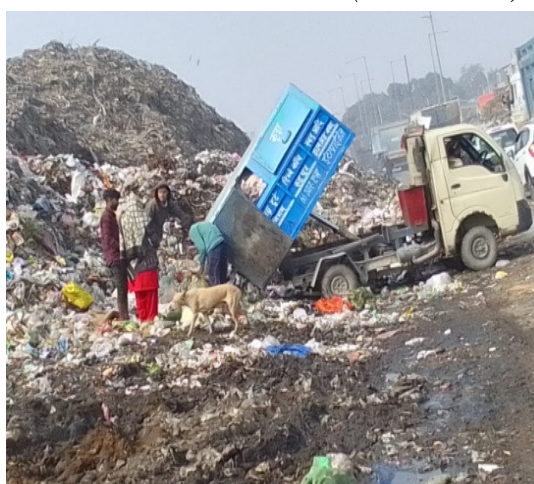
Photo-3.4: Collected door-to-door waste unloaded in dumping ground of NN Rudrapur (16 January 2023)

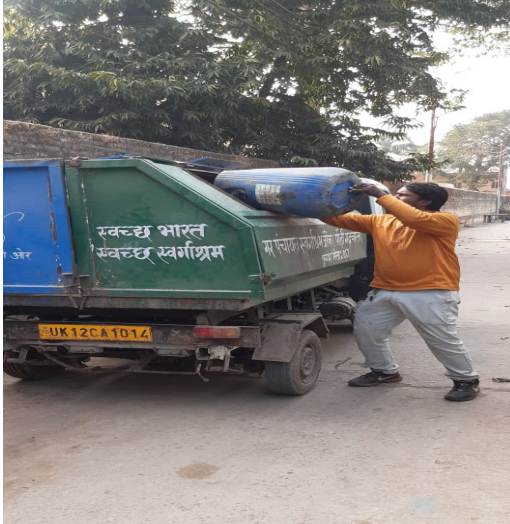
Photo-3.5: Collected door-to-door waste unloaded in vehicle in Nagar Panchayat Swargashram Jonk (11 January 2023)

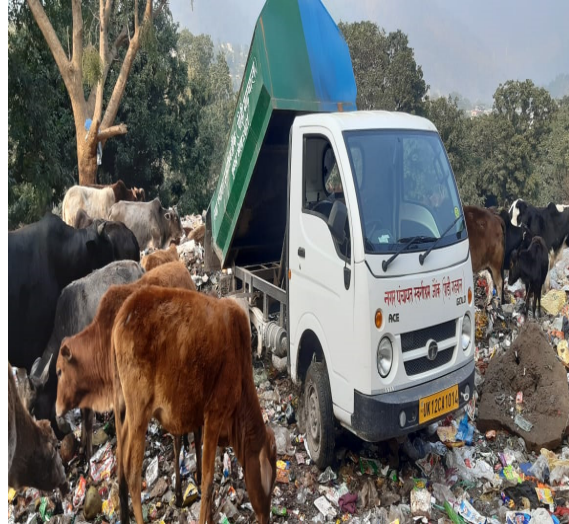
Photo-3.6: Collected door-to-door waste unloaded in dumping ground of Nagar Panchayat Swargashram Jonk (11 January 2023)

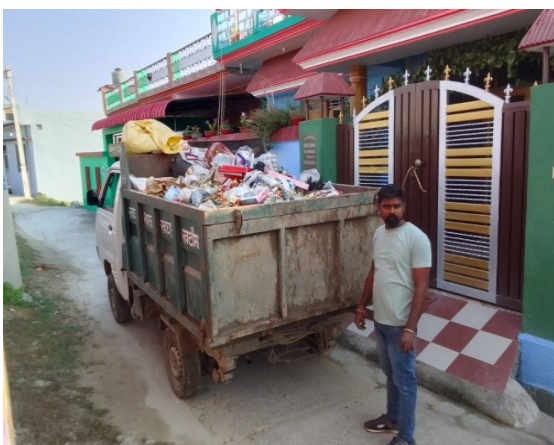
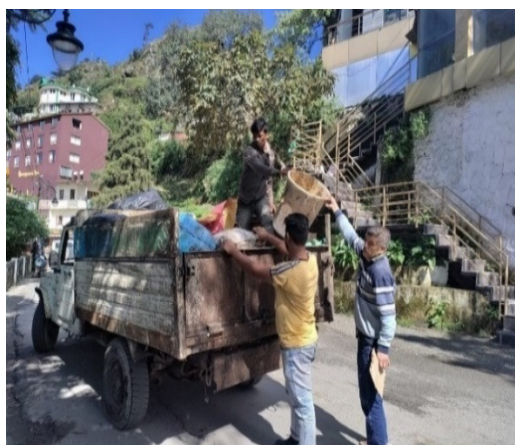
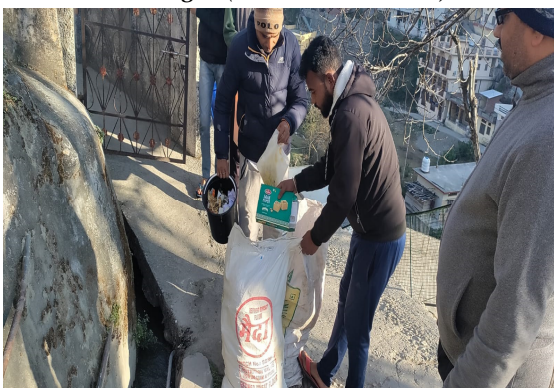
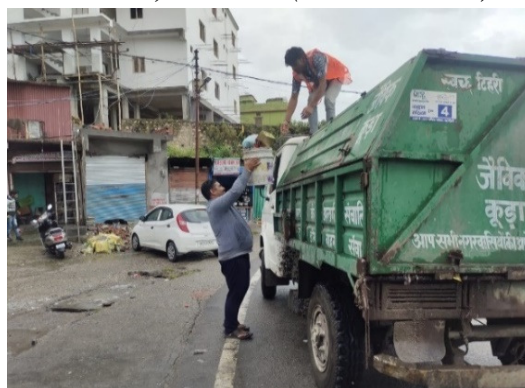
The above findings were corroborated in joint physical verification where workers handling solid waste were found not to be using personal protection equipment except in isolated cases. Results of physical verification can be seen in following photographs:

Photo-3.7: Nagar Palika Parishad Khatima, U. S. Nagar (13 December 2022)

Photo-3.8: Ward No. 08, Nagar Palika Parishad, Mussoorie (13 October 2022)

Photo-3.9: Nagar Palika Parishad-Barkot (02 March 2023)

Photo-3.10: Nagar Palika Parishad Tehri (03 March 2023)

While accepting the facts, the Additional Secretary in the Exit Conference (September 2023) stated that instructions will be issued in this regard. The State Government further replied (December 2023) that it is being ensured that Personal Protection Equipment (PPE) kit will be made available to Paryavaran Mitras of all the ULBs.

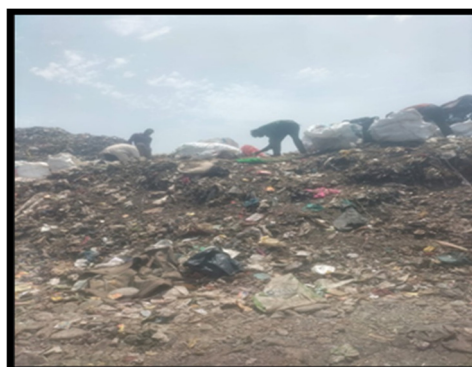
During physical verification of the transfer station/dump site in ULBs where waste pickers were involved, the waste pickers were working without using safety equipment. (Photo 3.11).

Photo-3.11: Rag pickers in dumping site of Nagar Nigam Haldwani (14 December 2022)

While accepting the facts, the Additional Secretary said in the Exit Conference (September 2023) that efforts will be made for inclusion of informal waste workers within a year and instructions will be issued in this regard.

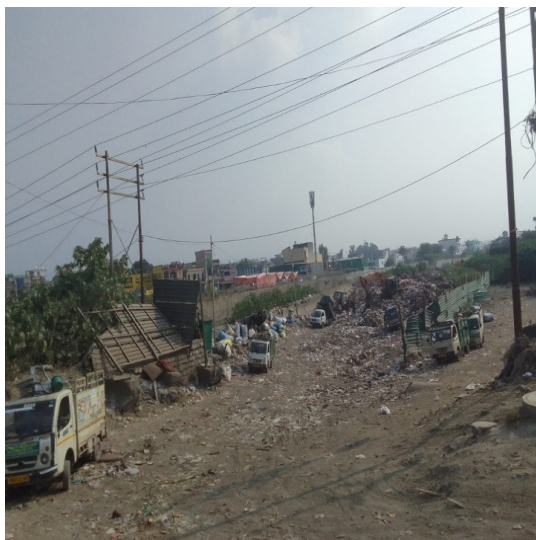
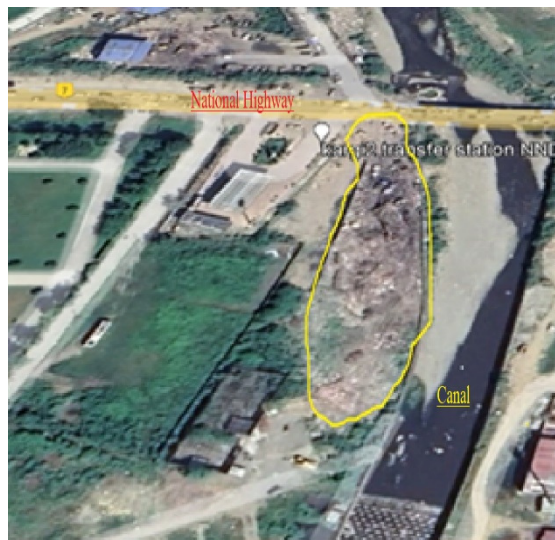
- Transfer stations were set up near the residential areas, National Highways, Canals and in open grounds of the ULBs (Photo 3.12 to 3.19).
- Weigh bridge machine was available only in NN Dehradun for small vehicles.

Photo-3.12 Secondary Storage facility in open place near National Highway at Kargi, Nagar Nigam Dehradun (29 October 2022)

Photo-3.13: Geo tagging of Secondary Storage facility in open place near National Highway in Kargi, NN Dehradun (27 March 2023)

The Geo tagged pictures clearly indicate that the Transfer Stations/Secondary Storage were located near the residential areas, National Highways, Canals and in open grounds of the ULBs.

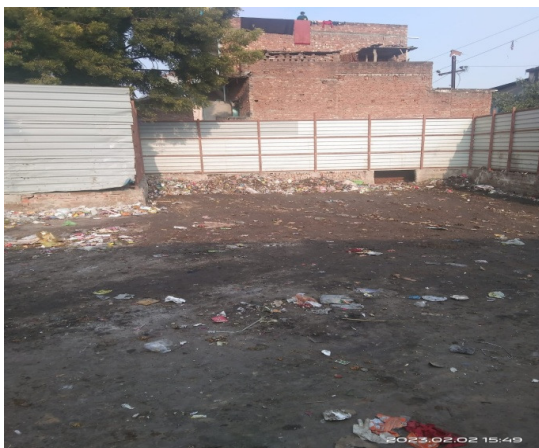
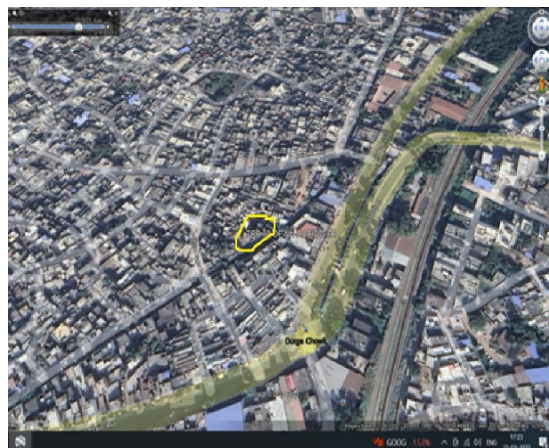
Photo-3.14: Secondary Storage facility in residential area at Shyam Nagar, Haridwar (02 February 2023)

Photo-3.15: Aerial view (Geo tagging) of Secondary Storage facility at Shyam Nagar, Haridwar in residential area (02 February 2023)

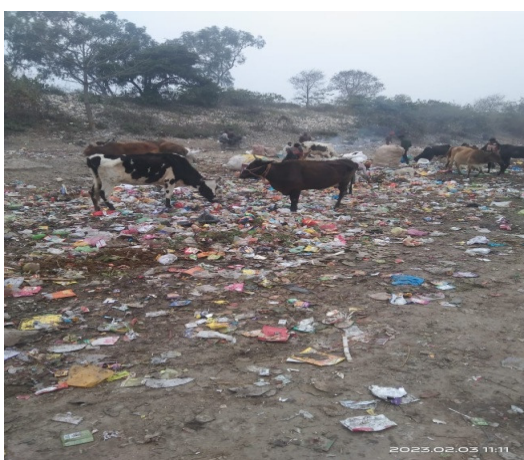
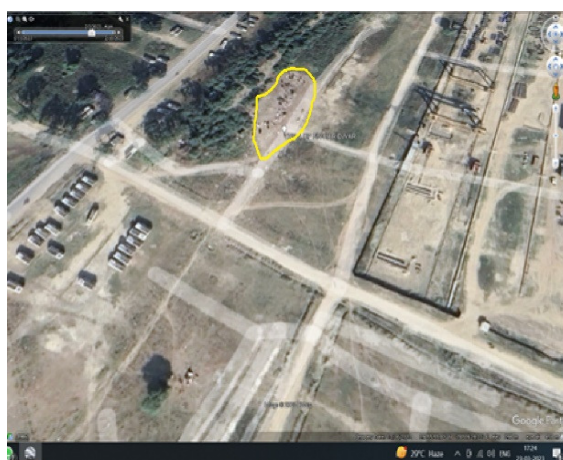
Photo-3.16: Secondary Storage facility in open area near new developing residential colony at Bairagi Camp, Haridwar (03 February 2023)

Photo-3.17: Aerial view (Geo tagging) of Secondary Storage facility in open area near new developing residential colony at Bairagi Camp, Haridwar (03 February 2023)

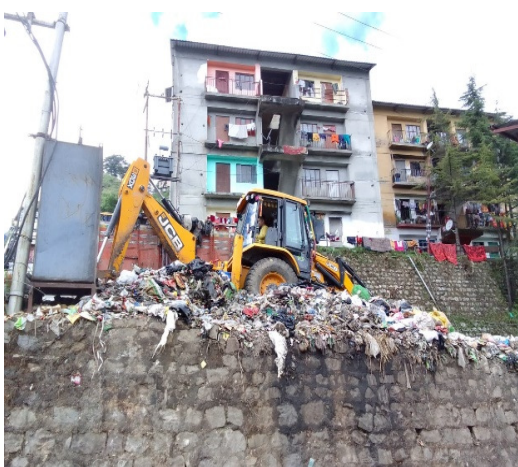
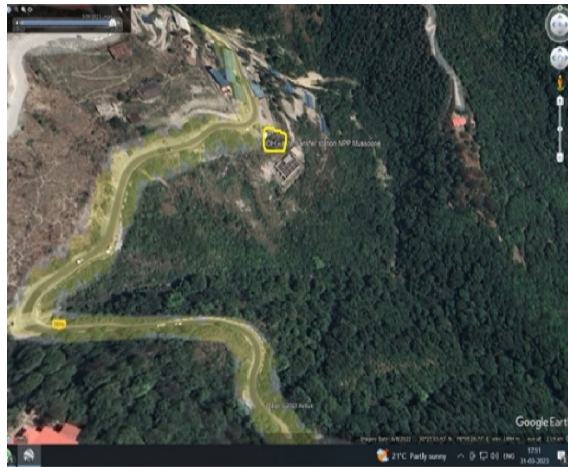
Photo-3.18: Secondary Storage facility NPP, Mussoorie near residential building (10 October 2022)

Photo-3.19: Aerial view of Secondary Storage facility NPP, near residential building Mussoorie (29 March 2023)

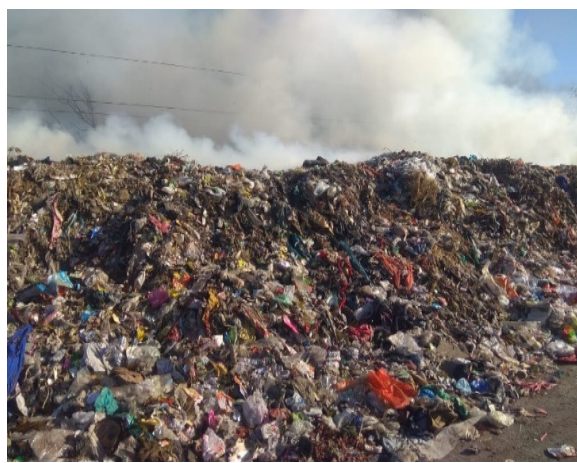
When household waste, like wood and leaves, are burned, they produce smoke, which contains vapours and particulate matter (solid and liquid droplets suspended in the air). Air pollution from smoke can impact human health. Other chemicals released while burning plastic include benzo(a) pyrene (BAP) and polyaromatic hydrocarbons (PAHs), which have both been shown to cause cancer. If agricultural bags or containers are contaminated with pesticides or other harmful substances, those will also be released into the air.

Photo-3.20: Burning of Municipal Solid Waste in Dumping site of Nagar Nigam Haldwani (14 December 2022)

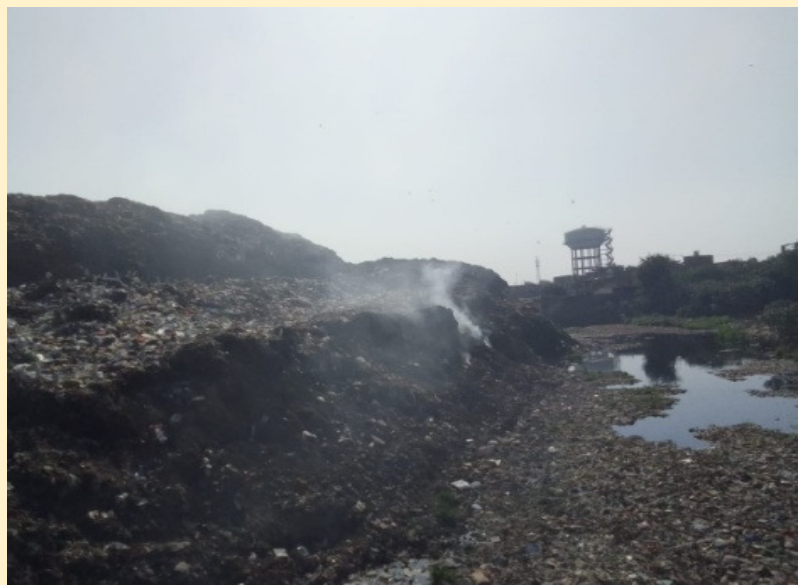
When the garbage is dumped into the rivers or water bodies, they cannot be degraded and get accumulated in the bodies. The degradation of these materials results in the release of toxic compounds which kill the plants and aquatic animals. The water becomes polluted and is not fit for drinking. The inlets of the fresh water and the sources of ground water gets blocked which results in the accumulation of contaminants in the same water body and lack of water resources.

Photo-3.21: Dumpsite near the river at Nagar Nigam Rudrapur (12 January 2023)

Thus, as can be seen from above instances, open dumps were causing soil and water contamination and damaging plant & wildlife habitat.

During Exit Conference (September 2023) the Additional Secretary stated that the matter will be looked into and the Government was trying to prepare Detailed Project Reports of such waste lying in the Open dump sites by treating it as legacy waste.

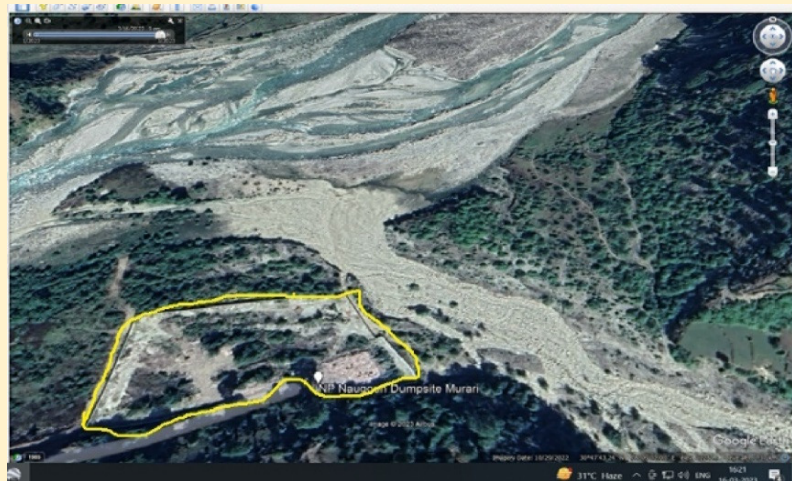
Photo-3.22: Aerial view (Geo tagged) of dumpsite at NP-Naugaon near river (16 March 2023)

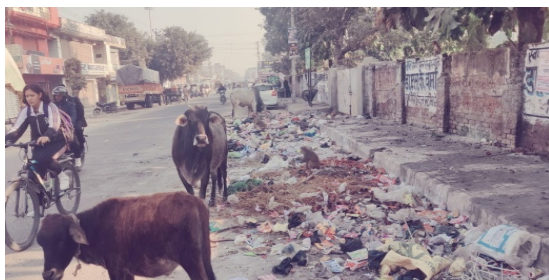
Failure to enforce efficient and effective door-to-door collection resulted in littering/dumping of Municipal Solid Waste/food waste on roadside. Roadside dumping effects the environmental conditions of the area leading to negative effect on health of local people besides attracting the stray animals, as can be seen in the pictures below taken during physical verification:

Photo-3.23: Roadside dumping of waste in Nagar Palika Parishad Khatima (13 December 2022)

During Exit Conference (September 2023), the Additional Secretary stated that a plan is being prepared for 100 *per cent* collection of Municipal Solid Waste. The execution of such plan will be ensured.

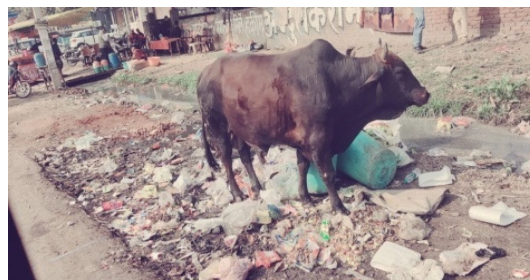
Photo-3.24: Roadside dumping of waste in Nagar Nigam Rudrapur (16 January 2023)

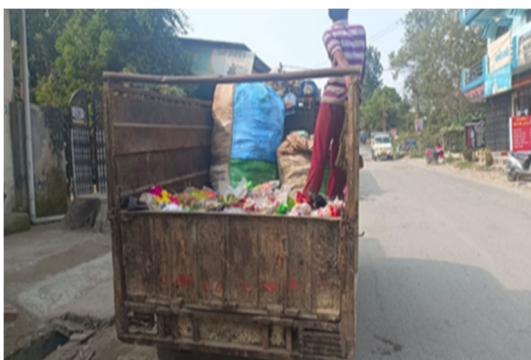
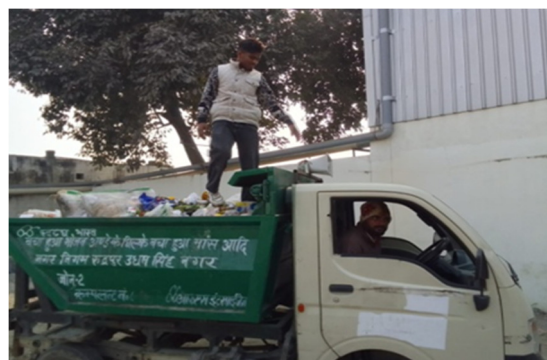
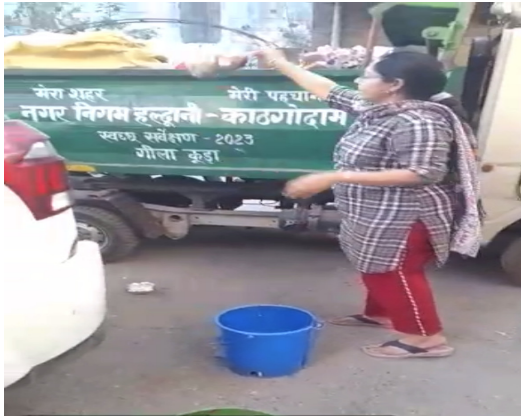
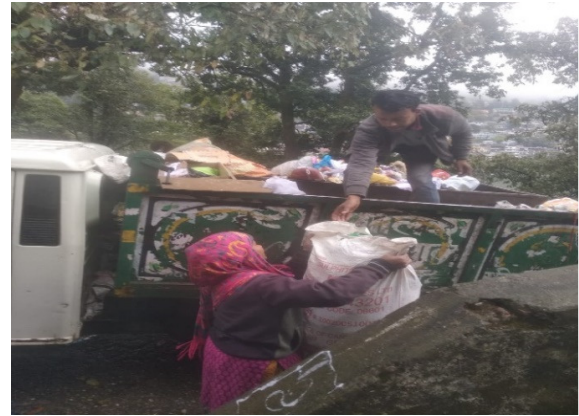
It was noticed in the test checked ULBs that out of 425 vehicles, 272 (64 *per cent*) used for door-to-door collection were uncovered. This confirmed in Joint Physical Verification as well (photos 3.25 to 3.28).

Photo-3.25: Municipal Solid Waste transported by uncovered vehicle in Nagar Nigam Dehradun (29 October 2022)

Photo-3.26: Municipal Solid Waste transported by uncovered vehicle in Nagar Nigam Rudrapur (16 January 2023)

Photo-3.27: Uncovered vehicle used for transportation of Municipal Solid Waste, Nagar Nigam Haldwani (14 December 2022)

Photo-3.28: Uncovered vehicle used for transportation of Municipal Solid Waste, Nagar Palika Parishad, Nainital (30 November 2022)

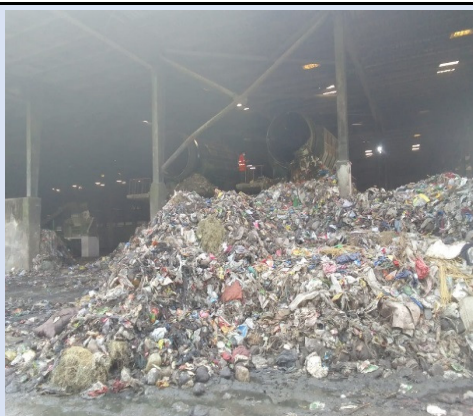
- i. Mixed Municipal Solid Waste was being received at Processing Plant.
- ii. RDF was dumped at Landfill site.
- iii. In landfill site only inert material was allowed to be dumped but RDF, plastic materials were also being dumped which was gross violation of concession agreement terms and MSW Rules, 2016.
- iv. Only four out of installed 21 cameras were functional.
- v. Leachate Water was accumulated around the Processing Shed flooring and near Sanitary Landfill Site area which affects the surrounding environment by creating foul smell in the area.
- vi. It was also seen that Medical Waste (Sanitary Napkin/Diaper) was also mixed with MSW.
- vii. The boundary wall of Processing Plant was partially damaged.

*Photo-3.29: RDF at processing plant
(29 October 2022)*

While accepting the facts it was informed by the Additional Secretary in the Exit Conference (September 2023) that an estimate for removal of RDF from the Landfill site has been prepared and after approval of the same RDF will be removed. The State Government further replied (December 2023) that 62 Solid Waste Management Action Plans/ DPRs have been approved by the Government of India covering 89 Municipal Bodies of the State, out of which seven Solid Waste Management Plants have been completed and in the remaining works are in progress.

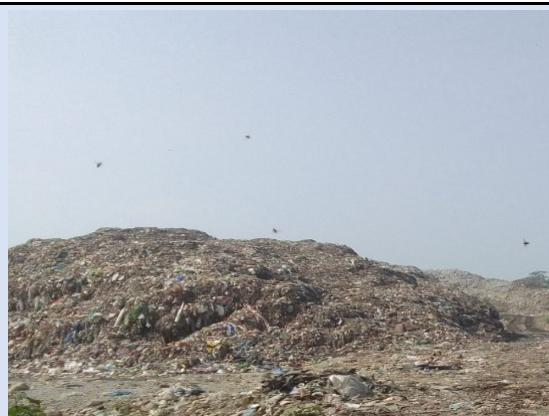
*Photo-3.30: RDF and inert at SLF
(29 October 2022)*

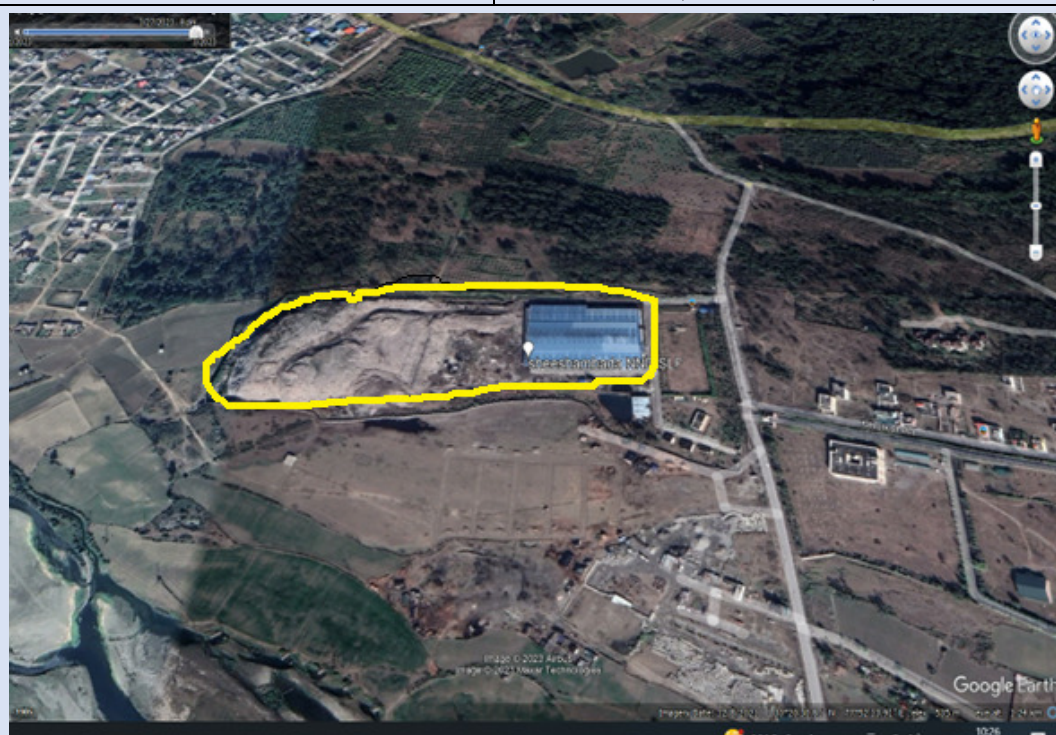
Photo-3.31: Aerial View (Geo tagged) of SLF Dehradun (27 February 2023)
