Report of the Comptroller and Auditor General of India on Performance Audit on Degradation of Kshipra River for the year ended 31 March 2021

**Government of Madhya Pradesh** *Report No. 6 of the year 2023*

Performance Audit on Degradation of Kshipra River for the year ended 31 March 2021

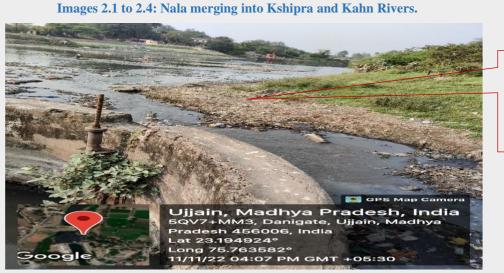
During physical verification of ULBs, Indore, Ujjain and Dewas, it was observed that multiple nalas carrying sewage waste of ULBs were merging into Kahn and Kshipra Rivers as shown in **Images 2.1-2.4**.

Nala merging into Kshipra River at Ramghat.

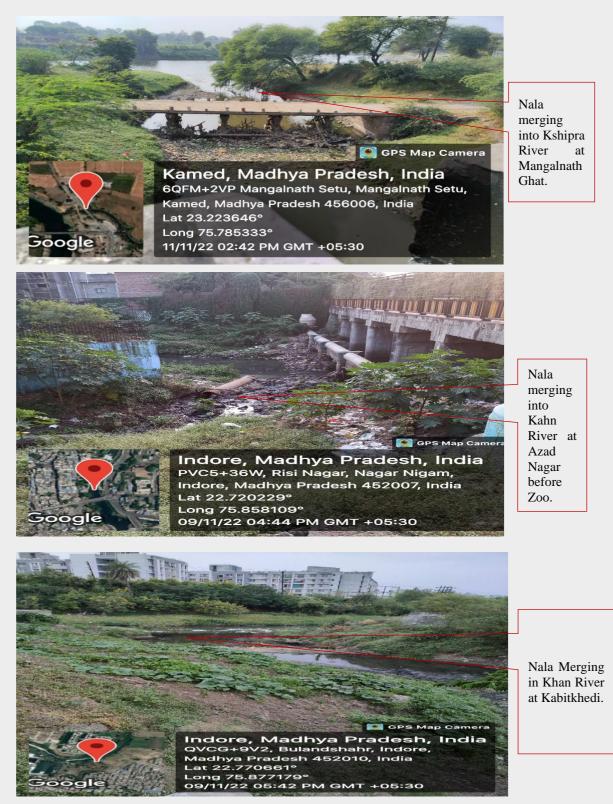
Further, water quality tests conducted by MPPCB and IIT, Indore (detailed in Chapter 3) also confirm the fact that water quality is not as per prescribed standards as sewage waste is merging into River.

The UDHD, GoMP replied (January 2023) that in ULB, Ujjain, presently 83 MLD sewage was treated at Sadawal Oxidation Pond and 92.5 MLD sewage treatment plant is under construction and will be functional by 31 March 2023.

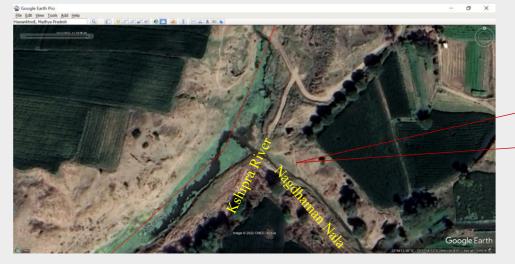
Image 2.5: Nagdhaman Nala merging into Kshipra River near Village Hawankhedi (Google Earth)

Nagdhaman Nala merging into Kshipra River near Village Hawankhedi.

It is clear from **images 2.5, 2.6 and 2.7** that drains from villages carrying sewage waste merge into Kshipra River, which are polluting Kshipra River.

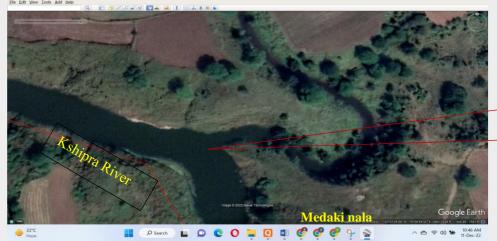
Image 2.6: Medaki nala merging in Kshipra River near village Marethi (Google Earth)

Medaki nala merging in Kshipra River near village Marethi.

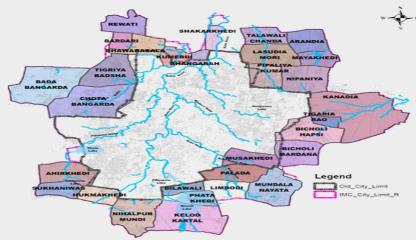
The total area of ULB, Indore is 280 sq km. DPR of sewerage network of Indore City was prepared (2017) without provisioning for the 29 newly added (2014) villages in the city limit. This indicated that the planning process was inadequate. Thus, the total population of 3,17,153 residing in newly added area of 29 villages had been skipped from this sewerage network. The villages that were not covered in the sewerage network have been shown in coloured shade in **Map 2.1** below.

Aforesaid excluded population is presently generating 18 MLD<sup>14</sup> sewage. This sewage is merging into Kahn River through various channels.

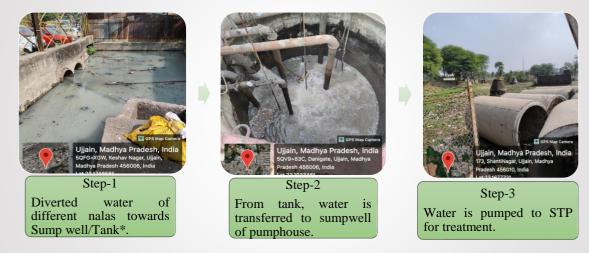
Nala Tapping at Ujjain- Sewage wastewater had been pumped from the pump houses and had been sent to wastewater stabilization pond STP at Sadawal for treatment.

\* A sump well/tank is used to store water collected from nala which is then pumped to STP for treatment.

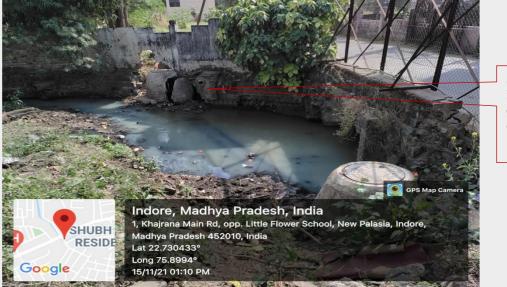
Showing leakage from the chamber at cross drainage

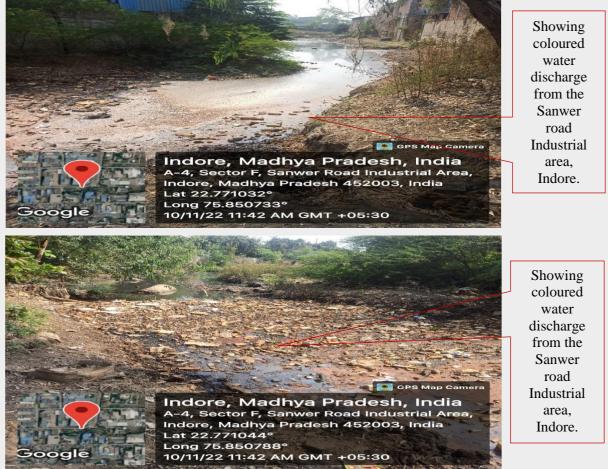
Further, during physical verification carried out at Industrial area of Indore, it was observed that nalas of industrial area were filled with colored water as shown in below images:

Image: 3.1 and 3.2 Nala filled with coloured water at Sanwer Road Industrial area

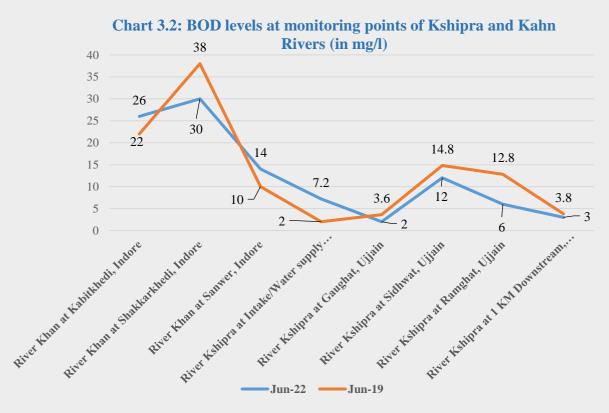
But against the claim made by MPPCB, BOD, which is a major indicator of deciding status of water quality of River, was still much higher than the permissible limits. Comparison of BOD level at various monitoring stations on Kahn and Kshipra Rivers are depicted in **Chart-3.2**.

From the **Chart 3.2**, it is clear that in three out of eight monitoring points, BOD levels had increased since June 2019. Further, in seven out of eight locations (as on June 2022), BOD

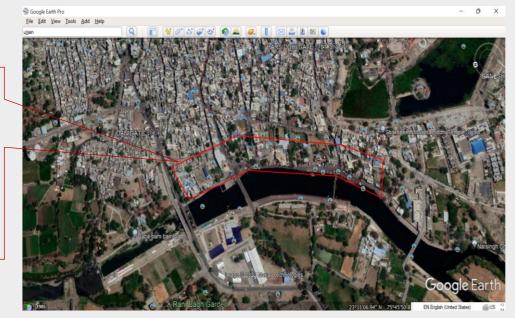
## Image 4.1: Google Earth image of Ramghat, Ujjain depicting (Red lines) cluster of construction/encroachment near Kshipra River

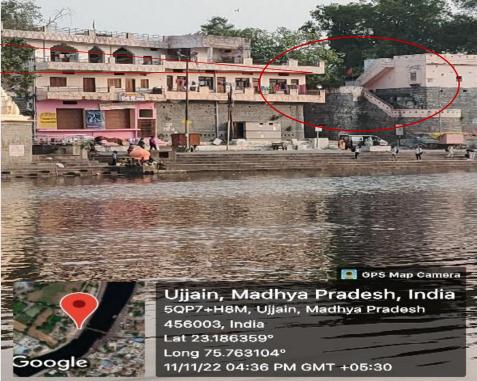
Images 4.2 and 4.3: Showing encroachment along Kshipra River at Ramghat during Joint Physical Verification

Google Earth image of Ramghat, Ujjain depicting (Red lines) cluster of construction/ encroachment near Kshipra River.

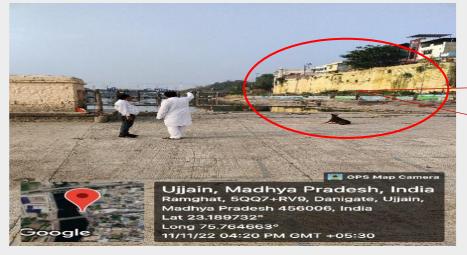
Residential encroachment along Kshipra River at Ramghat, Ujjain.

Physical verification and Google Earth images above indicated encroachments along the Kshipra and Kahn Rivers within the FPZ.

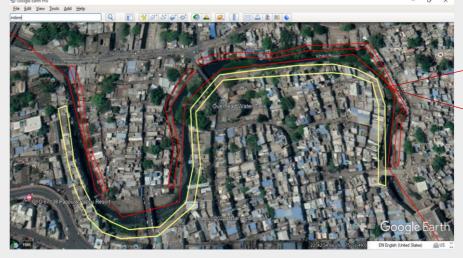
Image 4.4: Google Earth image of Kahn River in Indore near Serwate Bus Stand depicting construction/encroachment with red and yellow lines

Encroachment along Kahn River in Indore near Serwate Bus Stand (depicting construction/ with red and yellow lines).

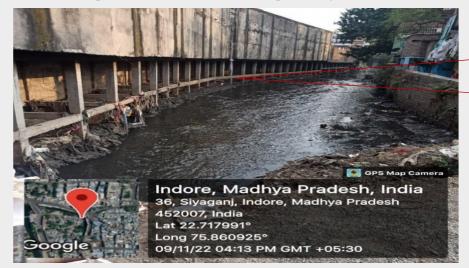
Image 4.5: Joint Physical Verification at ULB, Indore showing construction of shops inside Kahn River itself (Shops built by ULB itself)

Encroachment/ construction of shop inside Kahn River itself (Shops built by ULB itself).

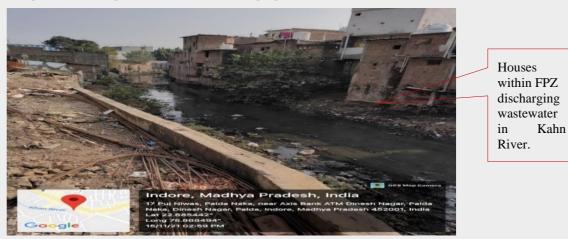
Image 4.6: Showing encroachment and merging wastewater in the Kahn River

Thus, effective implementation of the River Rejuvenation Plans as well as NGT's instructions regarding abatement of pollution from the rivers could not be ensured due to non-removal of encroachments from the riverbanks as wastewater from encroachments is still polluting the River as shown in **Image 4.6**. As a result, water quality parameters of Kahn and Kshipra Rivers could not achieve the targeted standards as mentioned in Paragraphs **3.5.5 and 3.5.6** *ante*.

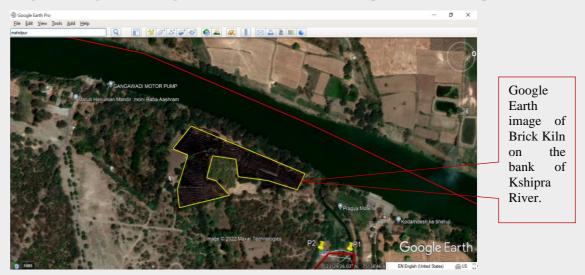
#### Image 4.9: Google Earth image of brick kiln at the bank of Kshipra River in Mahidpur

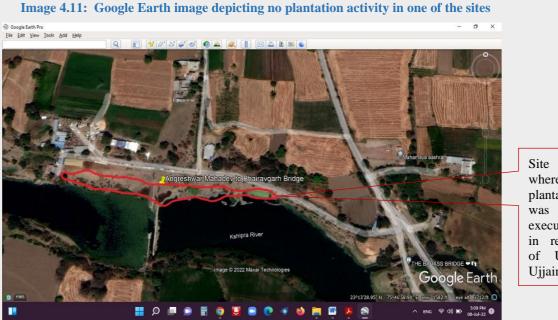
Audit observed from the Google Earth images (December 2021 and May 2022) that in eight out of these 28 sites, no plantation was found. Details of these eight locations are detailed in Appendix 4.3, one location is referred in Image 4.11. The project implementation period of the eight sites was between 2018-19 and 2020-21.

where plantation executed in record of ULB, Ujjain.

ULB, Indore accepted the fact and stated that work on the above-mentioned sites had not been executed as per programme. However, the reply was silent about the remedial action taken/proposed to be taken.

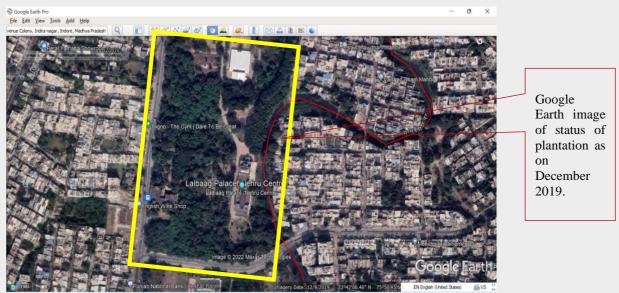
Image 4.12: Google Earth image depicting existing plants in yellow outline in site at Lalbagh as of December 2019 before working program for plantation

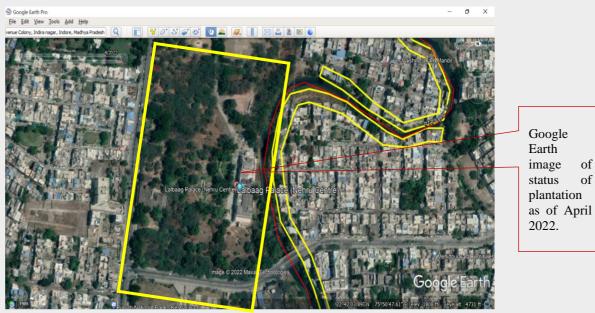
Image 4.13: Google Earth image depicting current position of plantation in yellow outline at Lalbagh as of April 2022

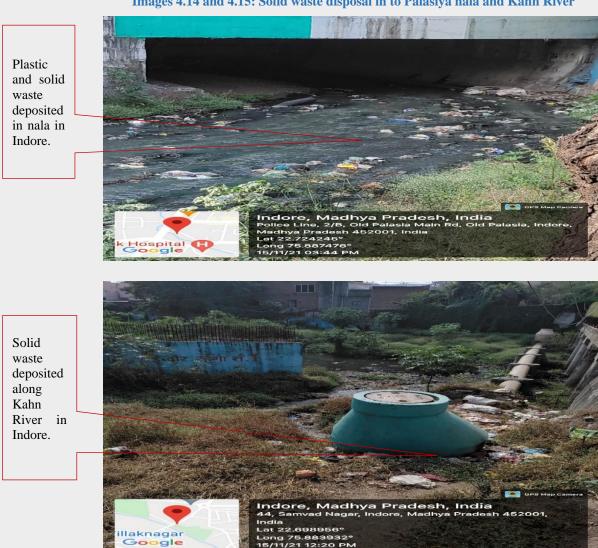
Saraswati River and six<sup>9</sup> major nalas are merging in Kahn River, which ultimately merges into Kshipra River. Physical verification during audit was done at Kahn River and Palasiya Nala, the results are given in **Images 4.14 and 4.15**:

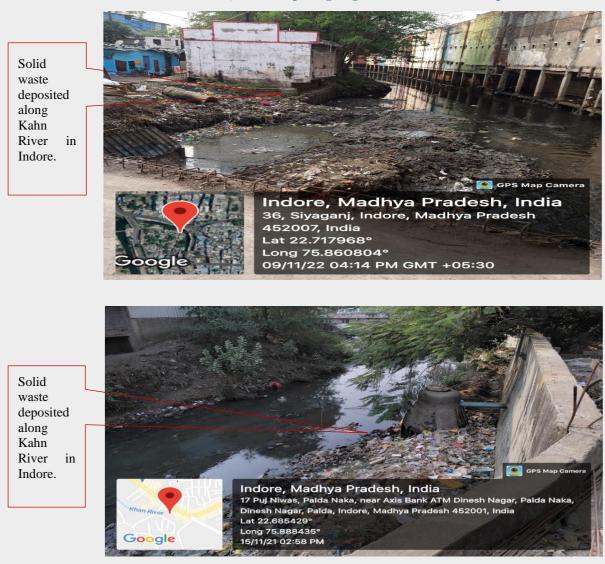
Images 4.16 and 4.17: Photographs captured during Physical Verification of water bodies in ULB, Indore depicting large number of solid waste pollutants

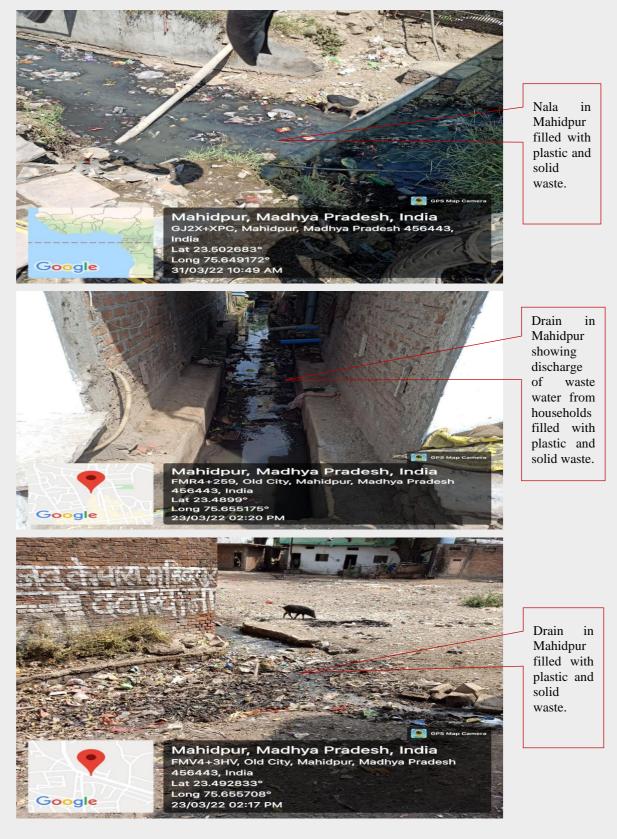
There is one major nala in Mahidpur named as *Bada nala* in which small drains of Mahidpur merge and this ultimately merges into Kshipra River. Photographs captured during Joint Physical Verification of *Bada Nala* are shown below.

## Images 4.18 to 4.21: Photographs captured during Physical Verification of Bada Nala at ULB, Mahidpur showing huge amount of solid waste pollutants

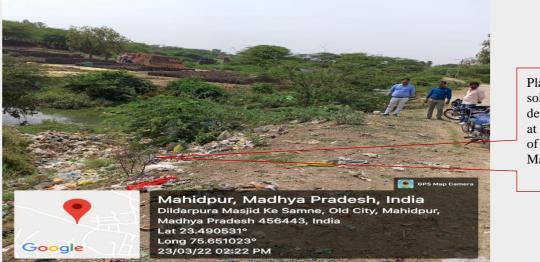
Plastic and solid waste deposited at the bank of nala in Mahidpur.

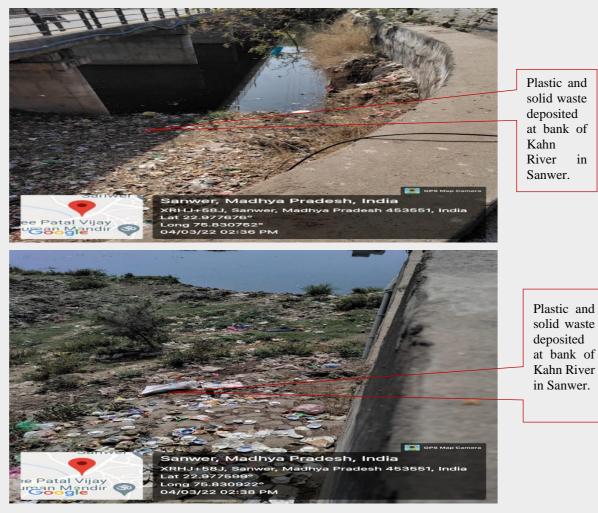
Images 4.22 and 4.23: Images captured during Physical Verification of Kahn River in ULB, Sanwer showing solid waste pollutants in water bodies

There are six major nalas along with Katkiya River that merge into Kahn River. Photographs of Joint Physical Verification at Kahn River in ULB, Sanwer have been shown below:

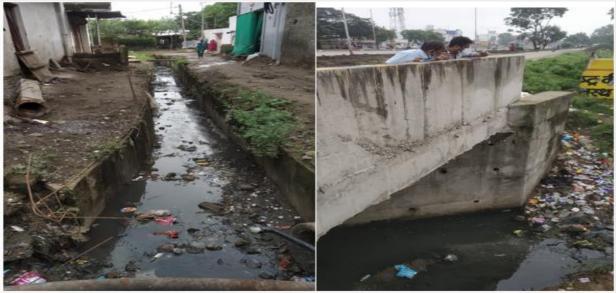
Images 4.24 and 4.25: Images captured during Physical Verification of Nagdhaman Nala at ULB, Dewas showing solid waste pollutants in the water body

It is evident from the above that in violation of Municipal Solid Waste Management Manual, the solid waste was flowing through the drains/water bodies in above ULBs. However, no actions were taken in this regard by the concerned ULBs, despite huge expenditure on the processing of solid waste.

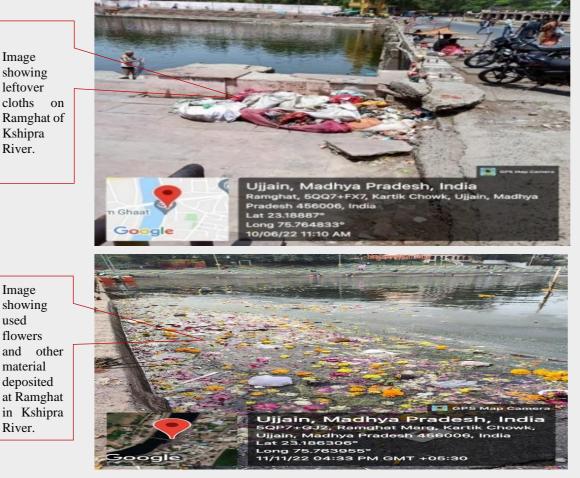
### Images 4.26 and 4.27: Photographs captured at Ramghat, Ujjain

During physical visit of four Ghats at Kshipra River in these ULBs, Audit observed that these four Ghats were not cleaned properly, and the waste was eventually getting into the Kshipra River.

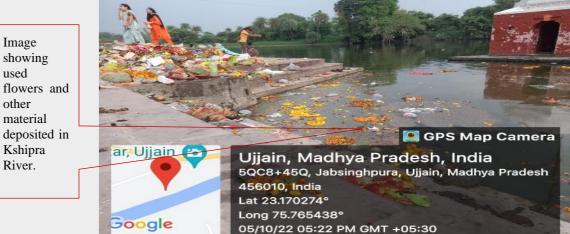
Image 4.28: Photograph captured at Jabsingpura, Gaughat, Ujjain

showing used flowers and other material deposited in Kshipra River.

Reply is not acceptable as no documentary evidence and time schedule of the same were provided and the waste lying on the ghats can also be seen from the **Images 4.26-4.31** as well.

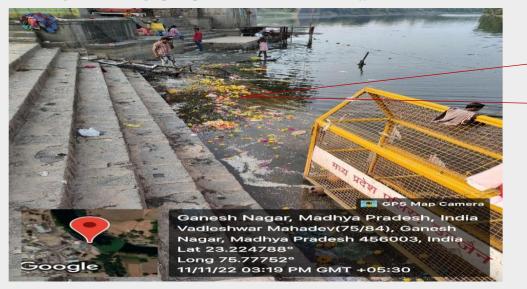
Image 4.30: Photograph captured at Siddhawat Ghat, Ujjain (P-3)

Image showing used flowers and other deposited material in Kshipra River.

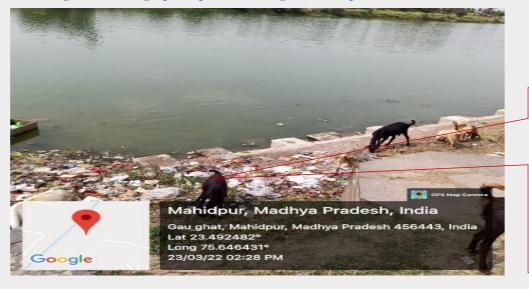
Image 4.31: Photographs captured at Gaughat, Mahidpur

Image showing plastic and solid waste at bank of Kshipra River. The UDHD replied (January 2023) that in case of ULB, Ujjain, daily ghat cleaning work is ensured by ULB with the help of 50 workers.

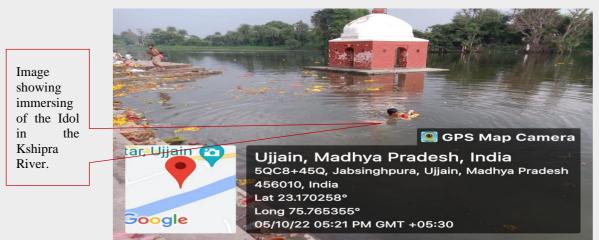
Devotees come to Ujjain to take holy dip in Kshipra River throughout the year on the occasion of various religious festivals. People also visit Ujjain from different places of the country for other religious activities such as last rites and during this period, flowers and other ritualistic materials are immersed in the Kshipra River. Further, during the festivals, idols are commonly immersed in the Kshipra River as shown in **Image 4.32**.

Image 4.32: Image showing immersing the Idol in the Kshipra

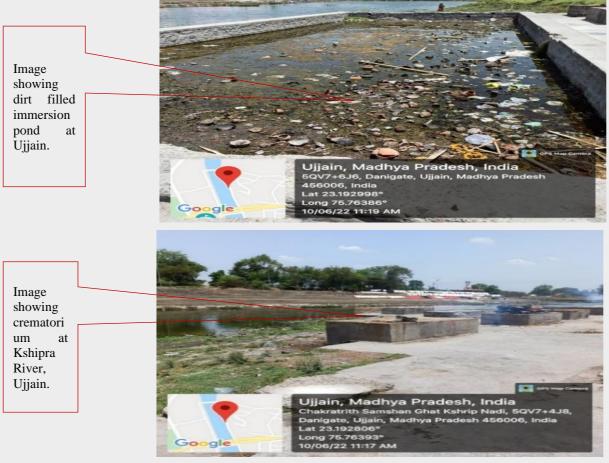
Images 4.33 and 4.34: Crematorium and dirt filled immersion pond at Ujjain

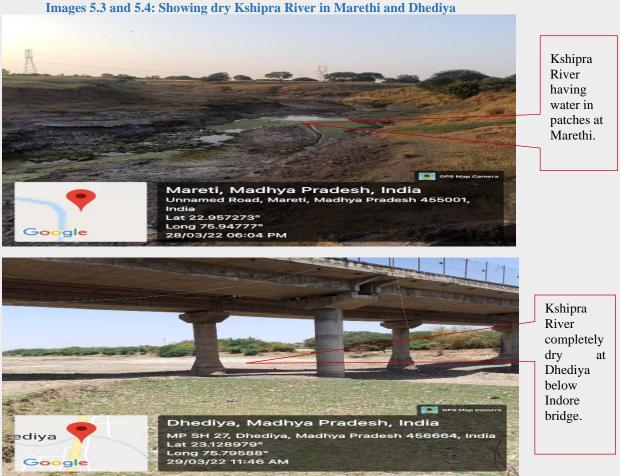
(Source: Image taken by Audit team during sampling of Kshipra water)

Further, during sampling process for water analysis of Kshipra River, along with ULBs and MPPCB's personnel and IIT Indore's team in March 2022, it was also observed that River was almost dry, and water was found in few patches only as could be seen from the **Images 5.3 and 5.4**.

Therefore, the NKSL project was not fulfilling the purpose of making Kshipra a perennial river as also evident from the **Images 5.3 and 5.4**.

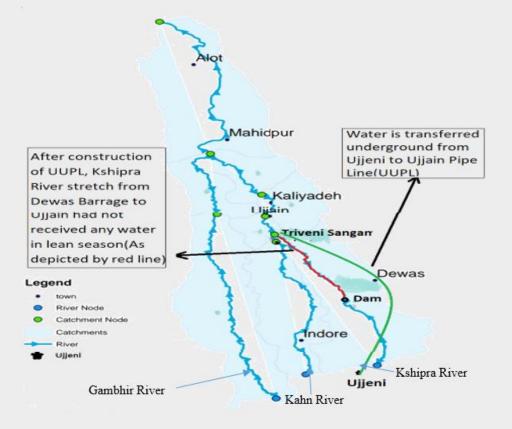
Image 5.9: Showing impact of UUPL on Kshipra River

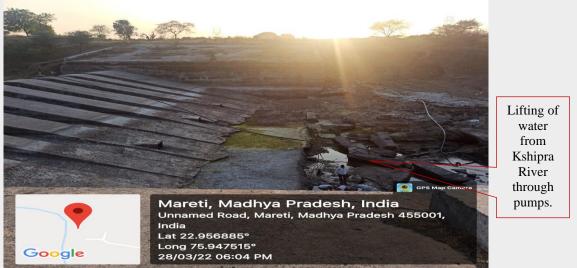
Audit team, along with IIT, Indore's team and officials of MPPCB/ULBs during sampling for analysis of water of Kshipra River, observed that even though there was very small quantity of water in Kshipra River but water was still being pumped for irrigation purpose as can be seen in the **Image 5.10**.

Therefore, as of now, dependency of farmer on Kshipra River as well as groundwater is higher due to lack of adequate alternative irrigation facility. This is one of the causes for lack of water flow in Kshipra River.

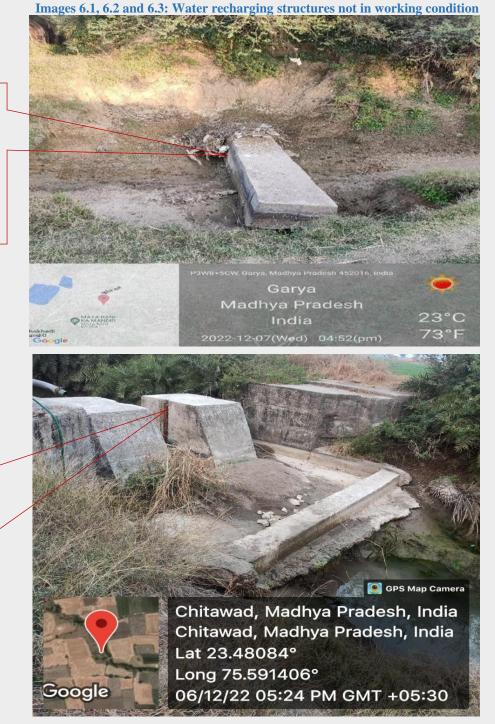
Physical verification photos of some water recharging structure which were not in working condition is shown in the **Images 6.1 to 6.3**.

Stop Dam in Garya village, Indore in completely damaged state.

From the above, it is very clear that due to improper functioning of these water recharging structures, purpose of recharging/ enhancing groundwater in the vicinity of Kshipra sub-basin was not fulfilled.

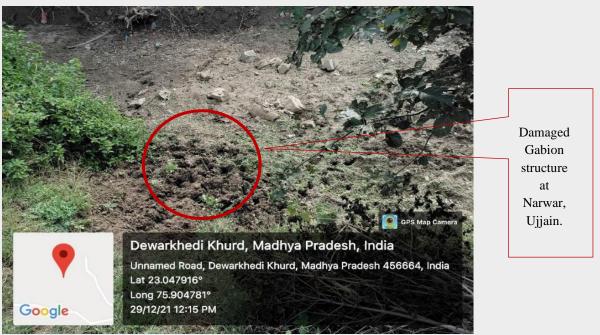
Image 6.4: View of damaged Gabion structure at Harnvada village

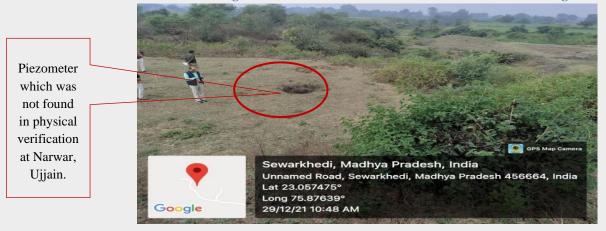
Image 6.5: Piezometer which was not found at Bhanwari Village

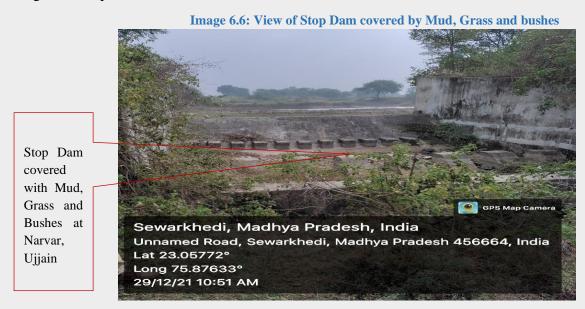
Stop dams, recharge shafts and ponds were constructed at the places mentioned in the DPR. However, level of pond had increased due to heavy silting. Mud, grass and bushes were found around the constructed stop dams and recharge shafts. Recharge shaft was not found at Bhanwari and Bolasa village. It was stated by the department officials that the said shaft was submerged in the pond.

The EE, PHE Division, Ujjain stated (December 2021) that this work was constructed using the Central Fund of CGWB and after construction, no allotment was received either from Central or State Government. Therefore, proper maintenance of these structures was not carried out. Piezometers were not in the scope of work, however, nine Piezometers were constructed by the Mechanical Division to check water level of the particular vicinity.
