# Chapter 1 Disaster Management in Indian Railways

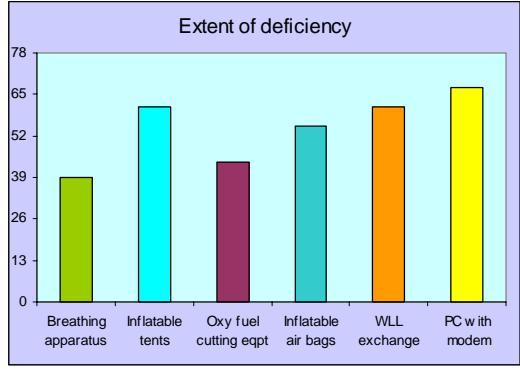
- A joint inspection of 78 ARTs and 67 ARMVs across IR further revealed that:
  - Equipment such as self contained breathing apparatus, inflatable tents, oxy fuel cutting equipment and inflatable air bags were not available in

- 39, 61, 44 and 55 ARTs respectively.
  - Equipment facilitating maintenance of communications such as WLL exchange and PC with high speed satellite modem was not available in 61 and 67 ARTs respectively. Further, the WLL exchange was not

commissioned in four ARTs and the PC was without the modem in two ARTs.

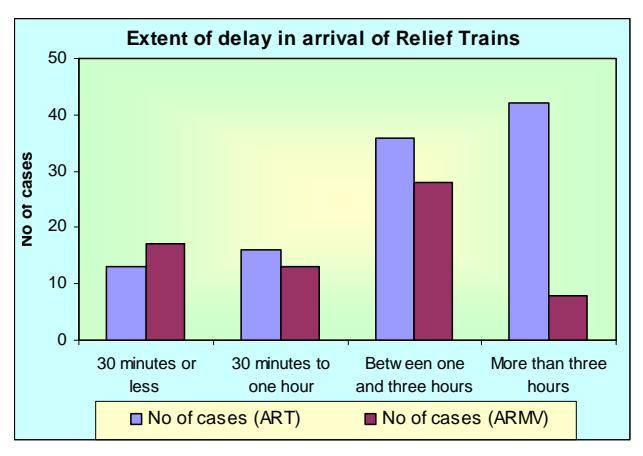
The time required for ordering and movement of the ARTs/ARMVs together with the requisite time to travel the distance to disaster the site invariably took the response time beyond the golden hour. Out of the 138 incidents that

warranted either an ART or an ARMV for rescue and relief, in 124 cases the ART/ARMV the site after the golden hour. The assistance provided by IR during the golden hour was thus more by default than by design. For instance, in an accident involving a truck and train no 9304 Bhopal-Indore Intercity express at Ujjain station in Ratlam Division of WR on 27 June 2004, the ART ordered at 20:30 hours, departed only at 21:54 hours and took 48 minutes to reach the site, which was only six and a half kilometers away. Even during the bomb blasts in seven local trains that took place on 11 July 2006, in Mumbai suburban section of Mumbai Central Division of WR the ARMVs located at Mumbai Central, Valsad and Udhana were ordered but before arrival of the ARMVs, the victims at all the locations had already been shifted to nearby hospitals by the volunteers from amongst the passengers and medical relief was not required to be done by the ARMVs. Due to non-availability of diesel locomotive in the vicinity of 75 Kilometers on Mumbai Division, ARMV capable of running at a speed of 100 Kilometers per hour had to be hauled with WDS 4 locomotive with a speed capacity of 45 Kilometers per hour only.
