Report of the
Comptroller and Auditor General of India
on

Capacity Utilisation, Electricity Generation, Sale and Collection of Revenue
including Disaster Management by Hydro Power CPSEs
(NHPC Limited, SJVN Limited, THDC India Limited and NHDC Limited)

Union Government (Commercial)
Ministry of Power
No. 41 of 2015
(Performance Audit)

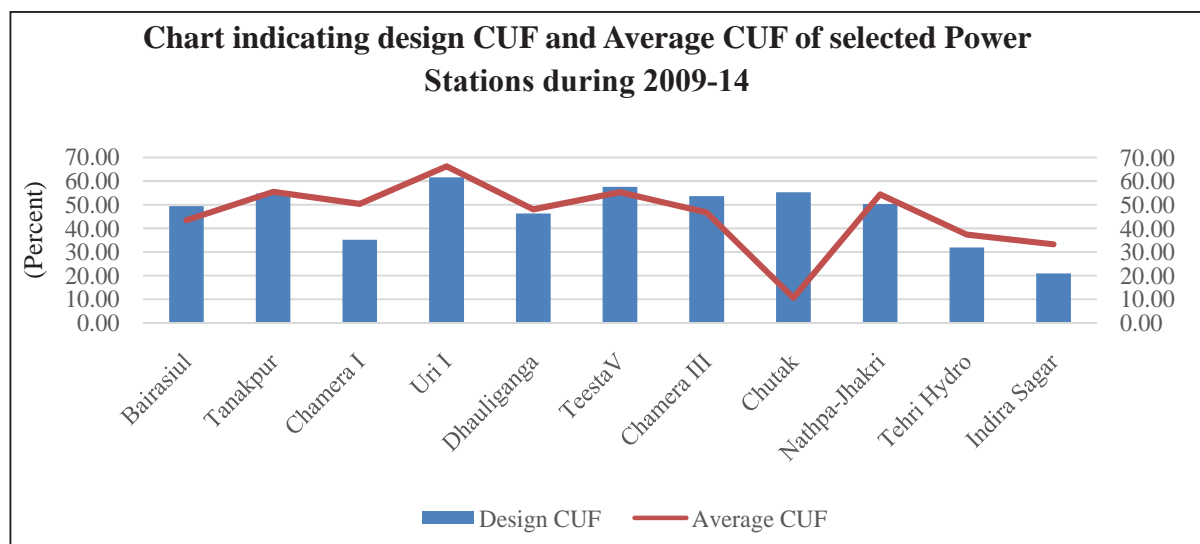
The chart below depicts the average CUF of power stations selected for performance audit during 2009-14:

It may be observed from the above table that average CUF of Bairasiul, Teesta-V, Chamera-III and Chutak power stations of NHPC were below their respective design CUFs by 2.27 to 44.65 percentage points.

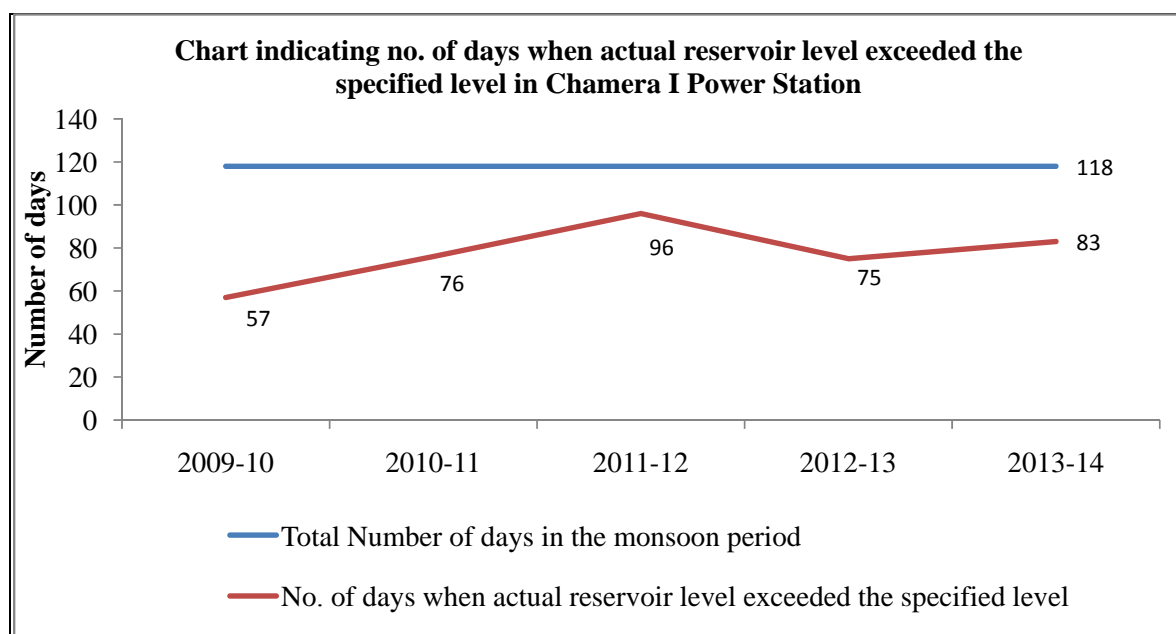
Audit noticed that Chamera-I power station did not maintain the specified reservoir level¹⁵ during monsoon seasons 2009-14 as detailed in Chart below:

Non-maintenance of prescribed reservoir level resulted in reduction in gross and live reservoir

¹⁵ 15 to 30 June -757 metres, 1 July to 15 September-750 metres, 16 to 30 September -755 metres and 1 to 10 October – 757 metres.
