## Chapter 5

### Quality of water injection

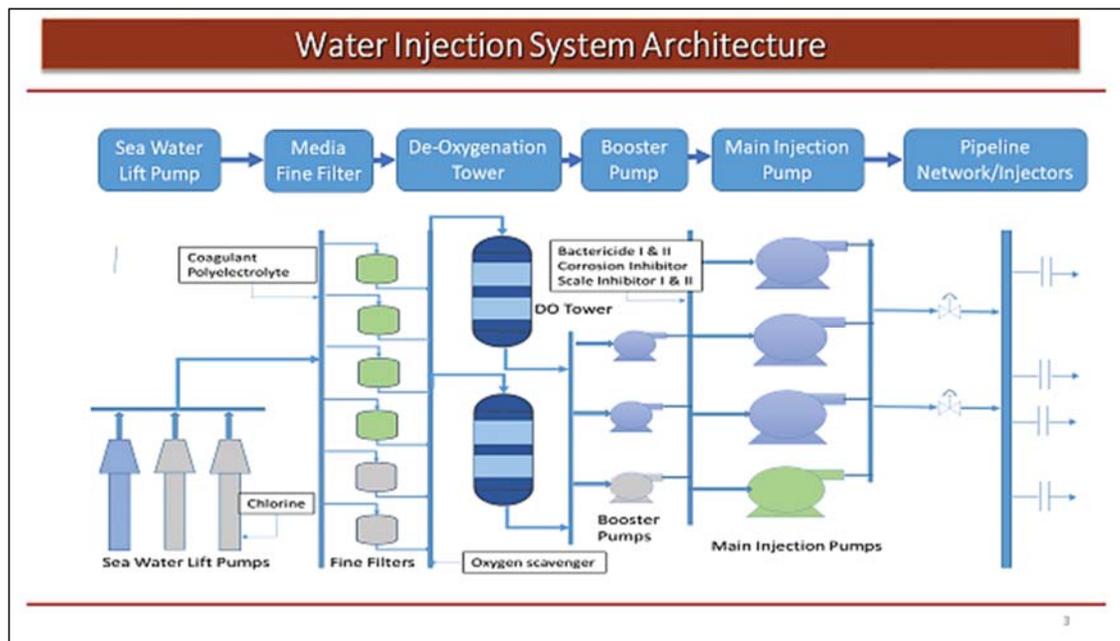
**Fig 5.1 Water injection system architecture**

The equipment used in the water injection process has been described in Para 4.2. The treatment of seawater on water injection platform mainly comprises of following sub-processes:

- **Seawater lifting:** Seawater is lifted by seawater lift pumps and pumped to the coarse filters. Hypochlorite solution generated in chlorinator units is injected at the pump suctions to control marine growth in the seawater piping system.

- **Filtration:** The seawater is then passed through fine filters to remove suspended solids. The fine filter elements are automatically cleaned in a continuous backwash cycle with filtered water while operating. Coagulant/ polyelectrolyte are dosed into the filter inlet to help coagulate suspended solids.

- **De-oxygenation:** The filtered water is passed through de-oxygenation towers to reduce oxygen level to 200 ppb and oxygen scavenger chemical further reduces the dissolved oxygen to a permissible limit of <20 ppb. This prevents internal corrosion of equipment and pipelines. Dissolved oxygen ideally should be ‘nil’ in injection water.

- **Chemical injection:** A chemical injection system is provided for storing and injecting various chemicals into the water flood stream at various points in the system.
